NEWMAR CORPORATION WARRANTY DEPARTMENT

TECHNICAL SERVICE BULLETIN						
DATE ISSUED	MODEL YEAR(S) AFFECTED	MODEL(S) AFFECTED	TSB #			
2/20/89	1988-1989	ALL	15			
BRAND		TYPE				
All <input type="checkbox"/>	American Star <input type="checkbox"/>	Kountry Star <input checked="" type="checkbox"/>	Dutch Star <input type="checkbox"/>	All <input type="checkbox"/>	T T <input type="checkbox"/>	F W <input type="checkbox"/>
NewAire <input type="checkbox"/>	Mountain Aire <input type="checkbox"/>	Kountry Aire <input checked="" type="checkbox"/>	London Aire <input checked="" type="checkbox"/>	C A <input checked="" type="checkbox"/>	D P <input type="checkbox"/>	D B <input type="checkbox"/>
<input type="checkbox"/> Air Conditioning & Heating				<input checked="" type="checkbox"/> Electrical Components		
<input type="checkbox"/> Appliances & Accessories				<input type="checkbox"/> Exterior Components		
<input type="checkbox"/> Cabinets & Furniture				<input type="checkbox"/> Interior Components

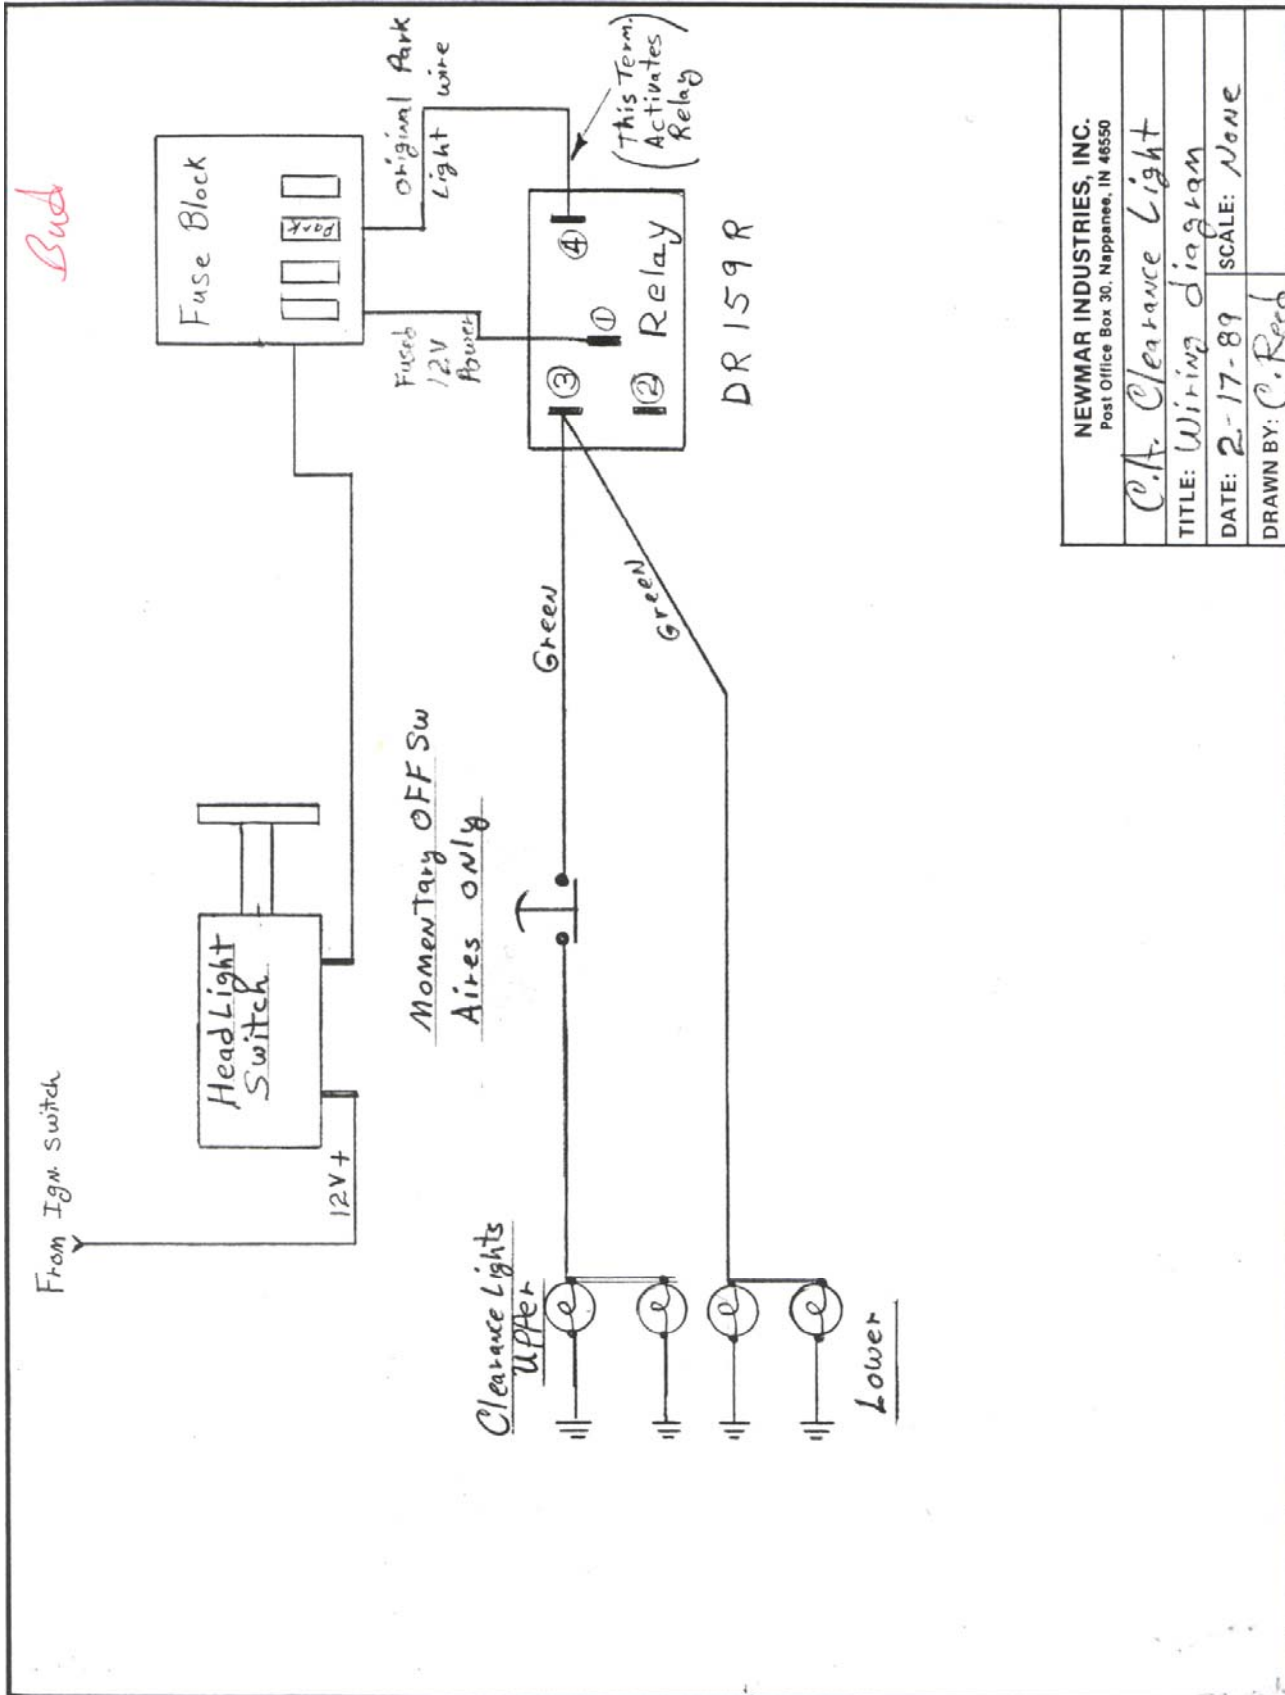
<input type="checkbox"/> Chassis Components				<input type="checkbox"/> Plumbing & Bath Components		
<input type="checkbox"/> Construction Components				<input type="checkbox"/> Windows, Awnings, Vents, & Doors		
DESCRIPTION OF PROBLEM						
Headlight switches burning up or getting hot.						
RECOMMENDED SOLUTION						
Hook up relay or add relay to electrical system. See attached diagram.
