NEWMAR CORPORATION WARRANTY DEPARTMENT

TECHNICAL SERVICE BULLETIN						
DATE ISSUED	MODEL YEAR(S) AFFECTED	MODEL(S) AFFECTED	TSB #			
9/14/98	1998-1999	ALL	162			
BRAND		TYPE				
All <input type="checkbox"/>	American Star <input type="checkbox"/>	Kountry Star <input type="checkbox"/>	Dutch Star <input checked="" type="checkbox"/>	All <input type="checkbox"/>	T T <input type="checkbox"/>	F W <input type="checkbox"/>
NewAir <input type="checkbox"/>	Mountain Air <input checked="" type="checkbox"/>	Kountry Air <input checked="" type="checkbox"/>	London Air <input checked="" type="checkbox"/>	C A <input type="checkbox"/>	D P <input checked="" type="checkbox"/>	D B <input type="checkbox"/>
<input type="checkbox"/> Air Conditioning & Heating				<input checked="" type="checkbox"/> Electrical Components		
<input type="checkbox"/> Appliances & Accessories				<input type="checkbox"/> Exterior Components		
<input type="checkbox"/> Cabinets & Furniture				<input type="checkbox"/> Interior Components

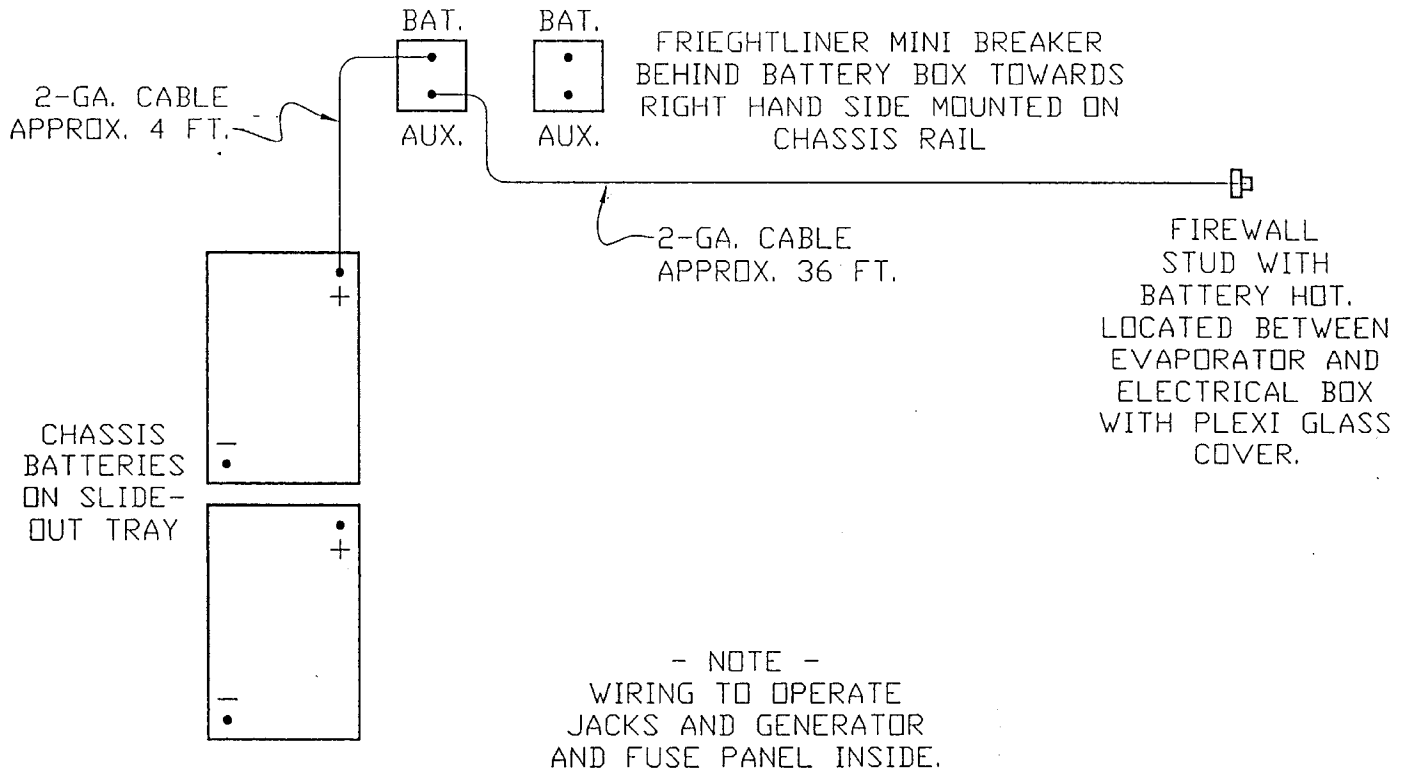
<input checked="" type="checkbox"/> Chassis Components				<input type="checkbox"/> Plumbing & Bath Components		
<input type="checkbox"/> Construction Components				<input type="checkbox"/> Windows, Awnings, Vents, & Doors		
DESCRIPTION OF PROBLEM						
Intermittent operation of jacks and steps caused by low voltage on Freightliner chassis produced from 9-97 – 9-98.						
RECOMMENDED SOLUTION						
Inspect wiring from battery to front fuse panel for proper gauge wires. See the attached diagram.
