NEWMAR CORPORATION WARRANTY DEPARTMENT

TECHNICAL SERVICE BULLETIN			
DATE ISSUED	MODEL YEAR(S) AFFECTED	MODEL(S) AFFECTED	TSB #
11/13/98	1998-1999	ALL	167
BRAND		TYPE	
All <input checked="" type="checkbox"/> American Star <input type="checkbox"/> Kountry Star <input type="checkbox"/> Dutch Star <input type="checkbox"/>		All <input checked="" type="checkbox"/> T T <input type="checkbox"/> F W <input type="checkbox"/>	
NewAire <input type="checkbox"/> Mountain Aire <input type="checkbox"/> Kountry Aire <input type="checkbox"/> London Aire <input type="checkbox"/>		C A <input type="checkbox"/> D P <input type="checkbox"/> D B <input type="checkbox"/>	
<input type="checkbox"/> Air Conditioning & Heating			
<input type="checkbox"/> Appliances & Accessories			
<input type="checkbox"/> Cabinets & Furniture			
<input type="checkbox"/> Chassis Components			
<input type="checkbox"/> Construction Components			
<input type="checkbox"/> Electrical Components

Bulletin Number : 1001
Effective Date: August 1, 1998

Traveler® Toilet Odor

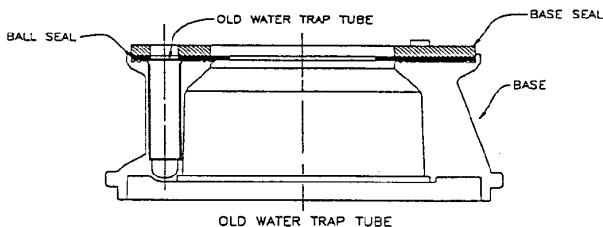
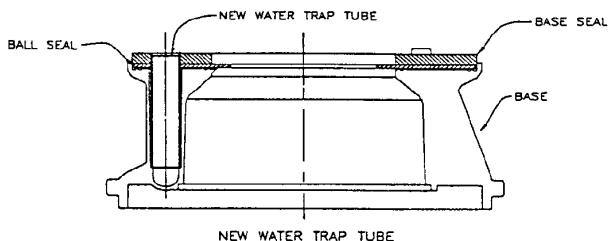
- Cause:** On some toilet installations, the toilet bowl may have been rotated to compensate for a misaligned floor flange. If the bowl was not separated from the base when rotated, the seals may have rotated with the bowl causing the seals to be out of alignment with the water trap tube. This misalignment could create a path for odor to travel from the holding tank through the overflow holes.

- Corrective Action:** If odor is present, remove the bowl from the base and realign the seal hole with the base hole.
- To eliminate this problem from occurring in the future, SeaLand Technology has redesigned the water trap tube to index the seals in the correct position. The tube previously fit below the seals and now it extends up into them. The tube helps prevent the seals from being moved out of position if the bowl is not separated from the base before rotating. Figures below illustrate the old water trap tube and the new redesigned water trap tube.
