NEWMAR CORPORATION WARRANTY DEPARTMENT

TECHNICAL SERVICE BULLETIN			
DATE ISSUED	MODEL YEAR(S) AFFECTED	MODEL(S) AFFECTED	TSB #
2/24/99	1998-1999	ALL	171
BRAND		TYPE	
All <input checked="" type="checkbox"/> American Star <input type="checkbox"/> Kountry Star <input type="checkbox"/> Dutch Star <input type="checkbox"/>		All <input checked="" type="checkbox"/> T T <input type="checkbox"/> F W <input type="checkbox"/>	
NewAire <input type="checkbox"/> Mountain Aire <input type="checkbox"/> Kountry Aire <input type="checkbox"/> London Aire <input type="checkbox"/>		C A <input type="checkbox"/> D P <input type="checkbox"/> D B <input type="checkbox"/>	
<input type="checkbox"/> Air Conditioning & Heating			
<input type="checkbox"/> Electrical Components			
<input type="checkbox"/> Appliances & Accessories			
<input type="checkbox"/> Exterior Components			
<input type="checkbox"/> Cabinets & Furniture			
<input type="checkbox"/> Interior Components

Bulletin Number : 1002
Effective Date: August 1, 1998

Traveler® Toilet Odor

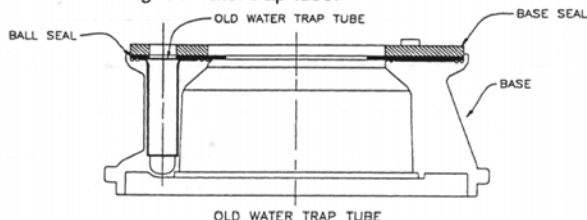
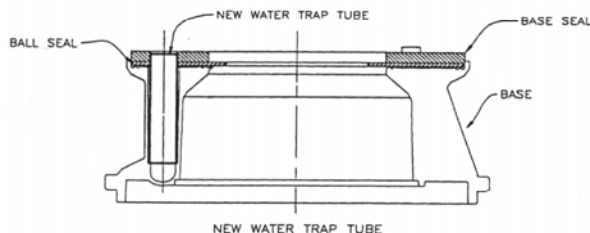
Symptom: Odor comes out of the overflow holes in the toilet bowl when the RV is in a forward motion.

Cause: On some toilet installations, the toilet bowl may have been rotated to compensate for a misaligned floor flange. If the bowl was not separated from the base when rotated, the seals may have rotated with the bowl causing the seals to be out of alignment with the water trap tube. This misalignment could create a path for odor to travel from the holding tank through the overflow holes.

To eliminate this problem from occurring in the future, SeaLand Technology has redesigned the water trap tube to index the seals in the correct position. The tube previously fit below the seals and now extends up into them. The tube helps prevent the seals from being moved out of position if the bowl is not separated from the base before rotating. Figures below illustrate the old water trap tube and the new redesigned water trap tube.

Corrective Action: If odor is present, remove the bowl from the base and realign the seal hole with the base hole.
