# NEWMAR CORPORATION WARRANTY DEPARTMENT

TECHNICAL SERVICE BULLETIN													
DATE ISSUED		MODEL YEAR(S) AFFECTED			MODEL(S) AFFECTED			TSB #					
5/27/99		1999			CLASS A'S			173					
BRAND					TYPE								
All	<input type="checkbox"/>	American Star	<input type="checkbox"/>	Kountry Star	<input checked="" type="checkbox"/>	Dutch Star	<input checked="" type="checkbox"/>	All	<input type="checkbox"/>	T T	<input type="checkbox"/>	F W	<input type="checkbox"/>
NewAire	<input type="checkbox"/>	Mountain Aire	<input checked="" type="checkbox"/>	Kountry Aire	<input type="checkbox"/>	London Aire	<input type="checkbox"/>	C A	<input checked="" type="checkbox"/>	D P	<input type="checkbox"/>	D B	<input type="checkbox"/>
<input type="checkbox"/> Air Conditioning & Heating					<input type="checkbox"/> Electrical Components								
<input type="checkbox"/> Appliances & Accessories					<input type="checkbox"/> Exterior Components								
<input type="checkbox"/> Cabinets & Furniture					<input type="checkbox"/> Interior Components

### **F-53 FORD CHASSIS TECHNICAL BULLETIN PARTS LIST**

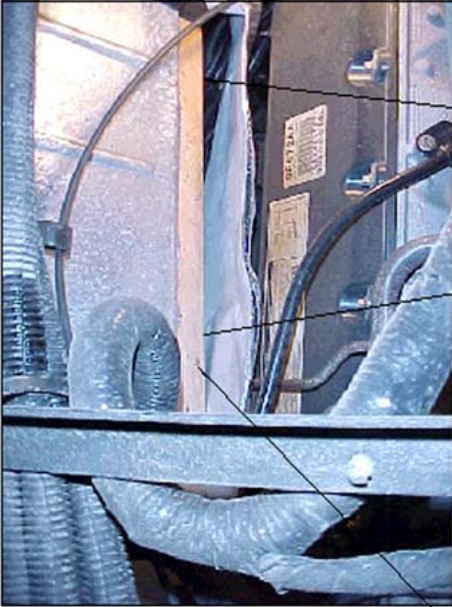
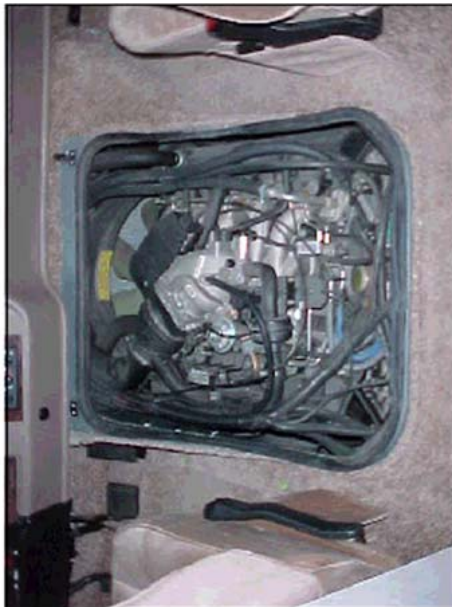
<input type="checkbox"/> Chassis Components					<input type="checkbox"/> Plumbing & Bath Components								
<input checked="" type="checkbox"/> Construction Components					<input type="checkbox"/> Windows, Awnings, Vents, & Doors								
DESCRIPTION OF PROBLEM													
Exposed raw plywood on the driver side of the engine compartment. This only affects the new style F53 Ford V-10 chassis.													
RECOMMENDED SOLUTION													
Follow the attached instructions. If you have any questions, please contact your technical representative. Labor code number 15901801 – Engine compartment heat shield retrofit. Labor repair time: .7.

2) USE A MILD DETERGENT TO REMOVE ANY FOREIGN MATERIAL FROM THE AREA OF APPLICATION. ALLOW DRYING TIME TO INSURE ADHESIVE TO MAKE BEST CONTACT.

1) REMOVE ENGINE COVER FROM INSIDE THE MOTORHOME. LOCATE THE AREA NEAR THE GAS PEDAL FOR THE REPAIR AS SEEN ON PRINT AND PICTURE ILLUSTRATION.

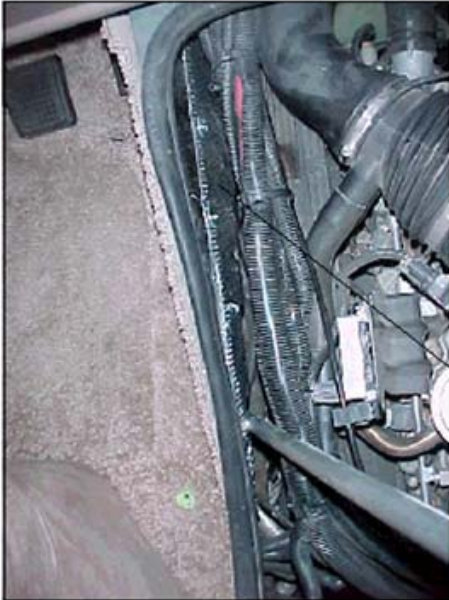
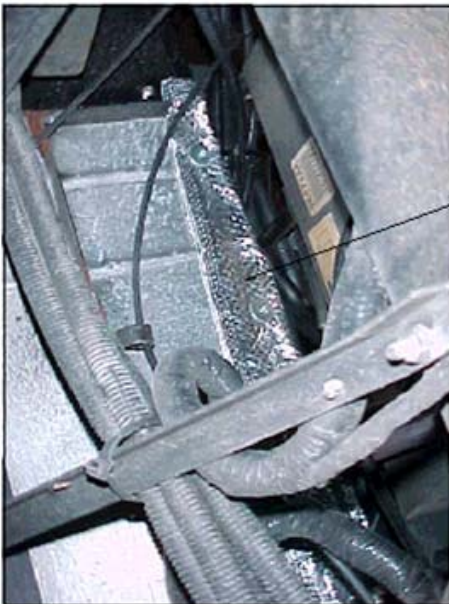
THE FINISHED PRODUCT
