NEWMAR CORPORATION WARRANTY DEPARTMENT

TECHNICAL SERVICE BULLETIN							
DATE ISSUED	MODEL YEAR(S) AFFECTED	MODEL(S) AFFECTED	TSB #				
12/21/99	2000	Optional Equipment	184				
BRAND		TYPE					
All <input checked="" type="checkbox"/>	American Star <input type="checkbox"/>	Kountry Star <input type="checkbox"/>	Dutch Star <input type="checkbox"/>	All <input checked="" type="checkbox"/>	T T <input type="checkbox"/>	F W <input type="checkbox"/>	
NewAire <input type="checkbox"/>	Mountain Aire <input type="checkbox"/>	Kountry Aire <input type="checkbox"/>	London Aire <input type="checkbox"/>	C A <input type="checkbox"/>	D P <input type="checkbox"/>	D B <input type="checkbox"/>	
<input type="checkbox"/> Air Conditioning & Heating				<input type="checkbox"/> Electrical Components			
<input checked="" type="checkbox"/> Appliances & Accessories				<input type="checkbox"/> Exterior Components			
<input type="checkbox"/> Cabinets & Furniture				<input type="checkbox"/> Interior Components

DBS Technical Bulletin #35

Instructions for using a computer to perform diagnostics on the DBS-4500-100 series Land antenna system.

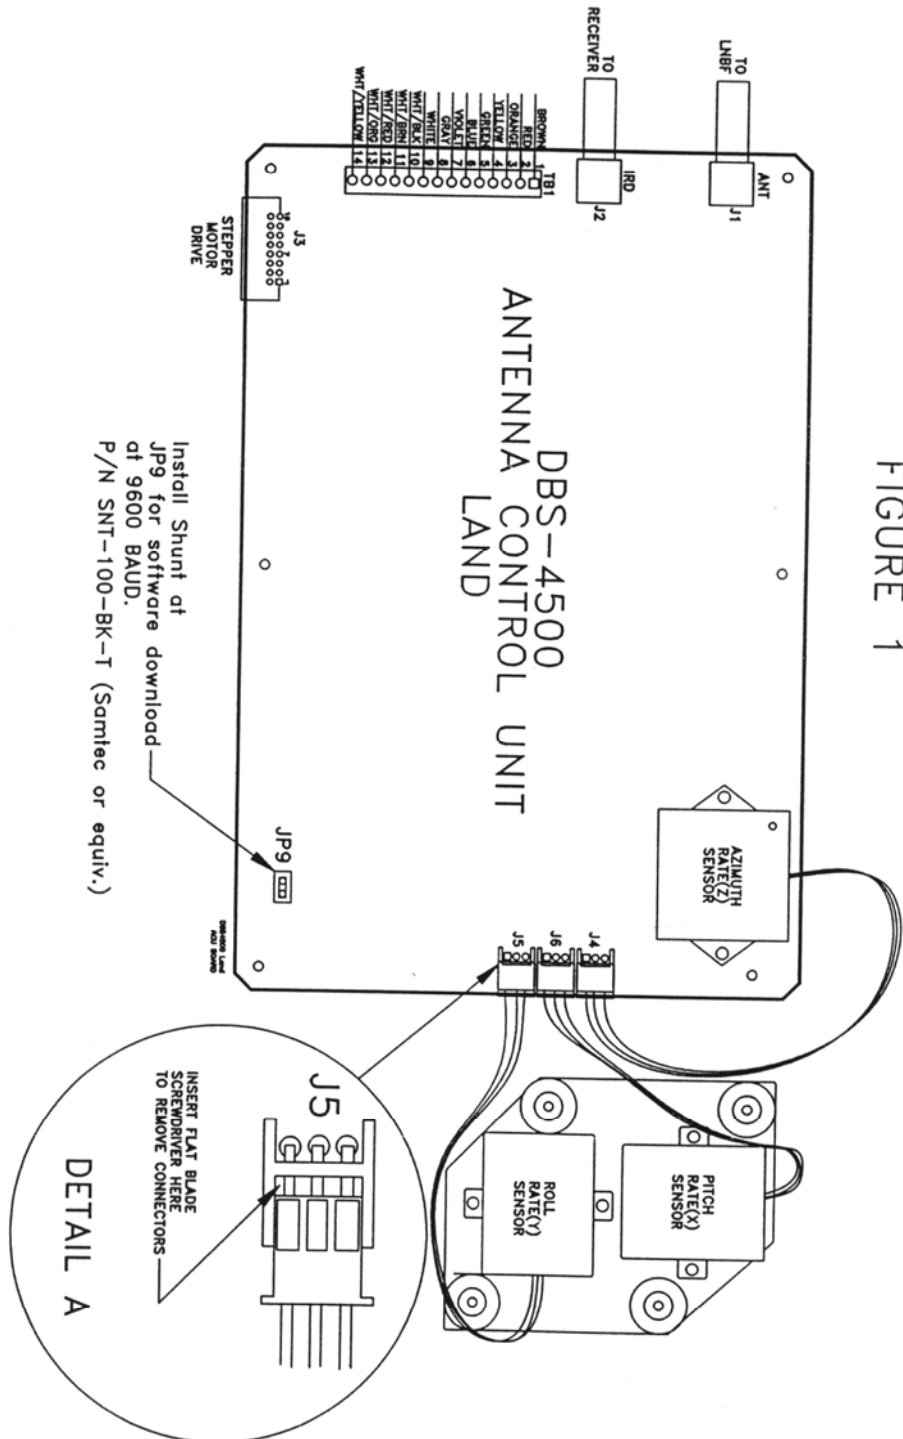
Note: If you do not see "RAM TESTING", but instead see illegible characters, then the DBS-4500 is operating at 38400 baud. If you would like to change the default baud rate of the antenna to 9600, you must install a shunt at JP9 on the ACU PCB. See Figure 1 at the end of this document for JP9 location information. This change is not necessary at this time.

(C71,69) displays the signal strength. The signal strength should in the 50s or 60s to track well. If the signal strength is -1, then the antenna is not communicating with the receiver. Check the DB-9 connector to the receiver and make sure the wires are connected correctly per installation manual M-01334. Also if there is still a problem, buzz out the serial communication wires to the ACU board using the Table 1 and Figure 1:

If the wiring is correct, try replacing the receiver. If a new receiver does not fix the problem, replace the ACU board (P/N 130892-101).
