TECHNICAL SERVICE BULLETIN																			
DATE ISSUED		MODEL YEAR(S) AFFECTED			MODEL(S) AFFECTED			TSB #											
2/7/00		1998-2000			Diesel Pushers			190											
BRAND					TYPE														
All	<input type="checkbox"/>	American Star	<input type="checkbox"/>	Kountry Star	<input type="checkbox"/>	Dutch Star	<input checked="" type="checkbox"/>	All	<input type="checkbox"/>										
NewAir	<input type="checkbox"/>	Mountain Air	<input checked="" type="checkbox"/>	Kountry Air	<input type="checkbox"/>	London Air	<input checked="" type="checkbox"/>	T T	<input type="checkbox"/>										
								F W	<input type="checkbox"/>										
								C A	<input type="checkbox"/>										
								D P	<input checked="" type="checkbox"/>										
								D B	<input type="checkbox"/>

Recall Campaign Information

Subject: **XC Side Radiator Hydraulic System**
FL243AD U.S.
FC243AD Canada

Subject: XC Side Radiator Hydraulic System

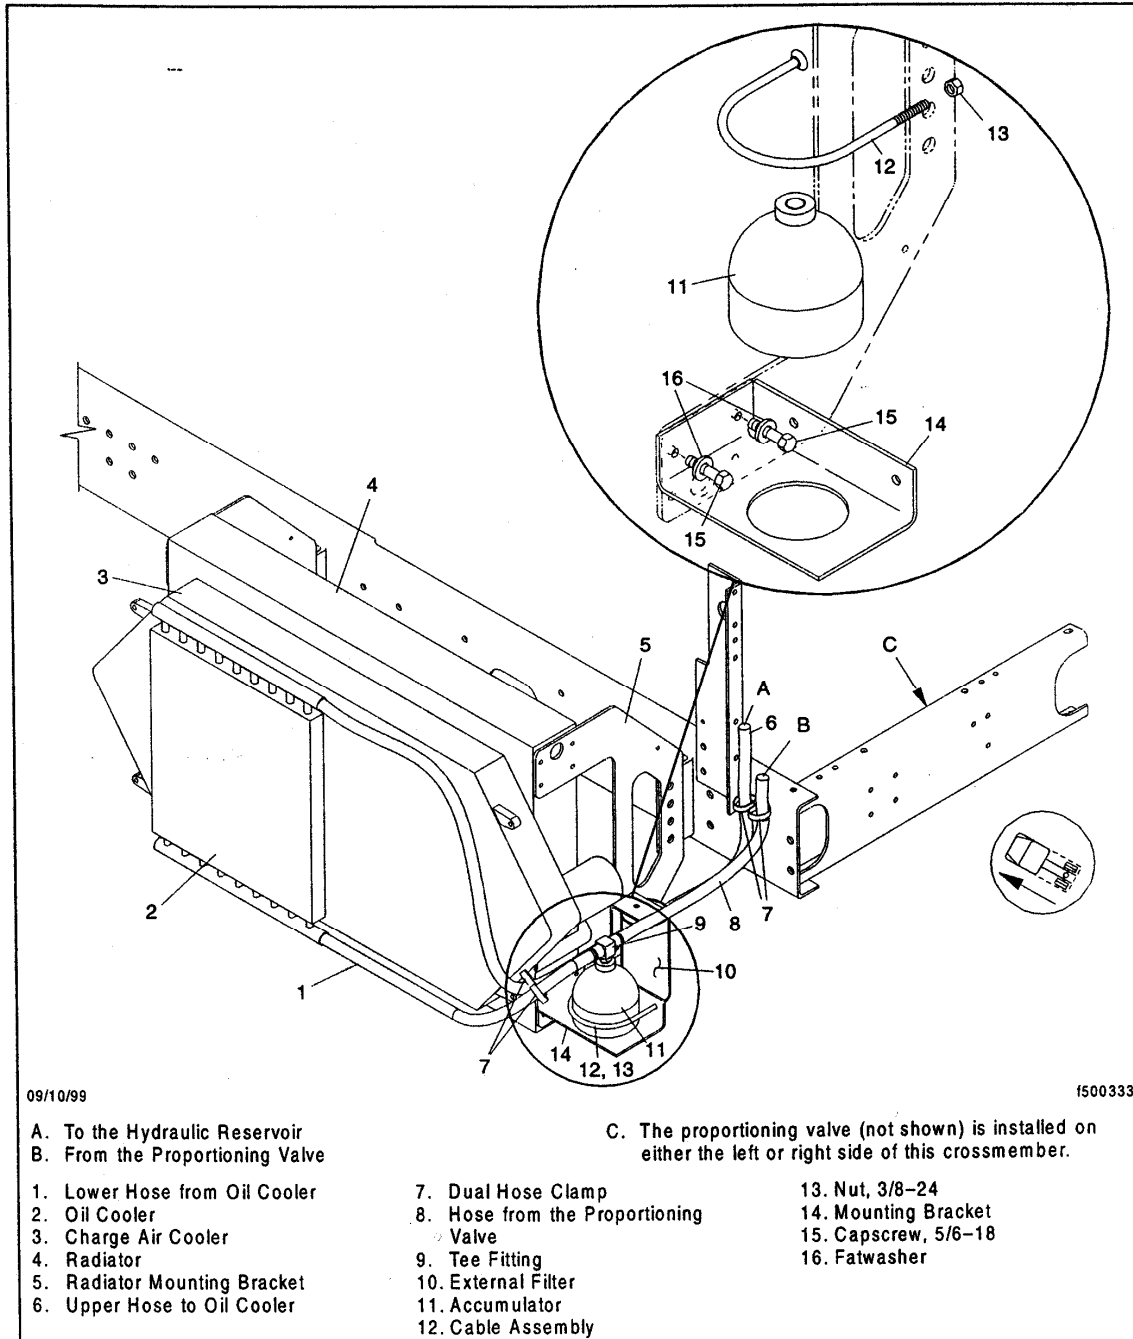
Fig. 1, Installation of Hydraulic System Accumulator

The filter gasket for the power steering hydraulic fluid may blow out due to pressure spikes in the system. This can result in a loss of power steering fluid and an eventual loss of power assist to the steering if the leak is undetected. The vehicle will retain mechanical steering capability.

4. Put a clean container under the power steering reservoir and disconnect the supply hose from the reservoir to drain the system.
5. Disconnect and remove the hose connecting the proportioning valve to the lower end of the oil cooler. See Fig. 1.

8. Install the Tee-fitting onto the accumulator and tighten 20 lbf-ft (27 N·m).
9. Seat the accumulator onto the mounting bracket. See Fig. 1.
10. Using the cable assembly and the 3/8-24 nut, secure the accumulator to the bracket. See Fig. 1. Tighten the nut 30 lbf-ft (40 N·m).

13. Using two dual hose clamps, secure the hoses together. See Fig. 1.
14. Check the type of power steering reservoir.

If equipped with a 12-quart metal reservoir, check for an external filter near the oil cooler, in the hydraulic hose running from the top of the oil cooler to the reservoir. See Fig. 1.
