NEWMAR CORPORATION WARRANTY DEPARTMENT

TECHNICAL SERVICE BULLETIN							
DATE ISSUED	MODEL YEAR(S) AFFECTED	MODEL(S) AFFECTED	TSB #				
2/7/00	1994-2000	Spartan Diesel Pushers	191				
BRAND		TYPE					
All <input type="checkbox"/>	American Star <input type="checkbox"/>	Kountry Star <input checked="" type="checkbox"/>	Dutch Star <input checked="" type="checkbox"/>	All <input type="checkbox"/>	T T <input type="checkbox"/>	F W <input type="checkbox"/>	
NewAire <input type="checkbox"/>	Mountain Aire <input checked="" type="checkbox"/>	Kountry Aire <input checked="" type="checkbox"/>	London Aire <input checked="" type="checkbox"/>	C A <input type="checkbox"/>	D P <input checked="" type="checkbox"/>	D B <input type="checkbox"/>	
<input type="checkbox"/> Air Conditioning & Heating				<input type="checkbox"/> Electrical Components			
<input type="checkbox"/> Appliances & Accessories				<input type="checkbox"/> Exterior Components			
<input type="checkbox"/> Cabinets & Furniture				<input type="checkbox"/> Interior Components

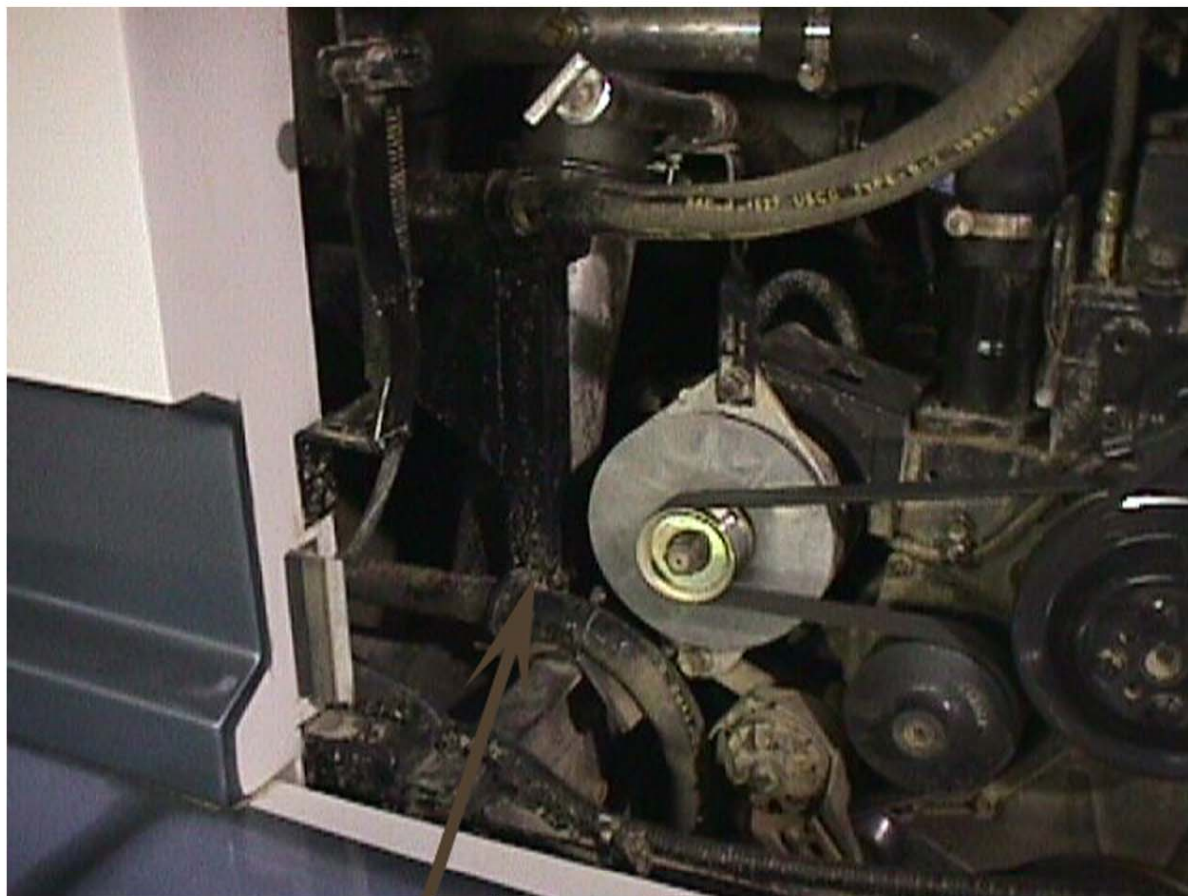
Pict. 1

Rear Engine Door View

**Affected structure tube,
lower front outside corner.**

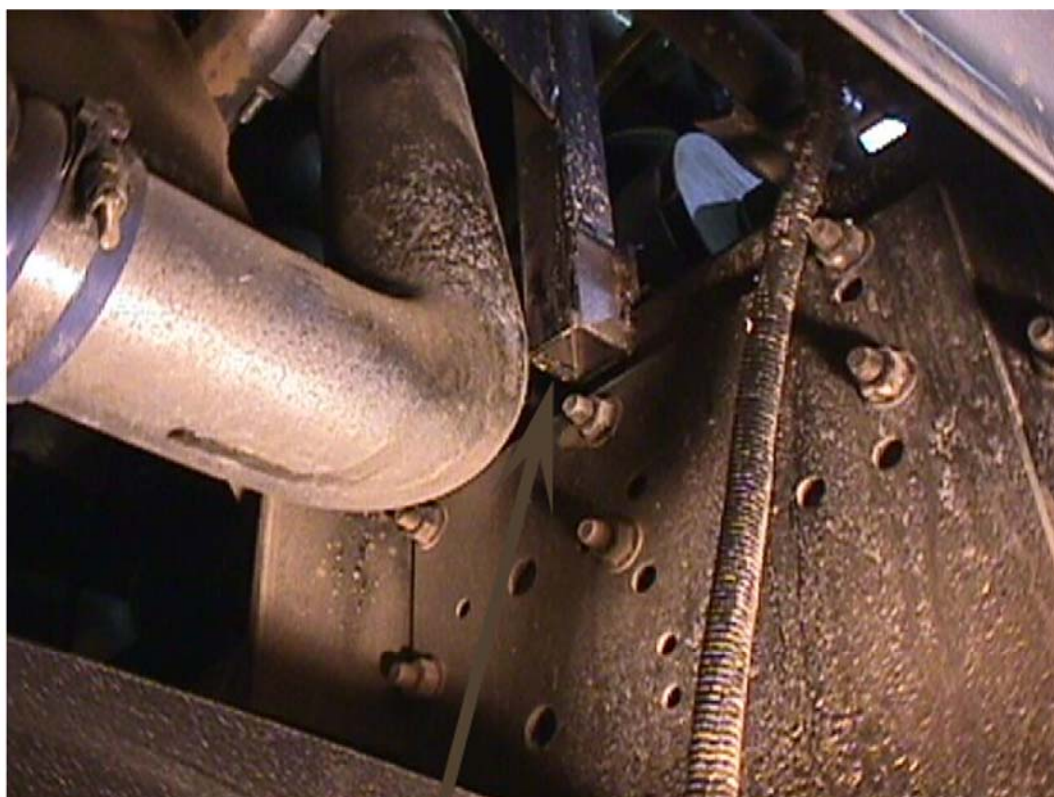
Pict. 2

View from Below Bumper

**Possible contact point,
requires 1/2" clearance.**
