NEWMAR CORPORATION WARRANTY DEPARTMENT

TECHNICAL SERVICE BULLETIN							
DATE ISSUED	MODEL YEAR(S) AFFECTED	MODEL(S) AFFECTED	TSB #				
05/17/01	1996-2001	ALL	219				
BRAND		TYPE					
All <input checked="" type="checkbox"/>	American Star <input type="checkbox"/>	Kountry Star <input type="checkbox"/>	Dutch Star <input type="checkbox"/>	All <input checked="" type="checkbox"/>	T T <input type="checkbox"/>	F W <input type="checkbox"/>	
NewAire <input type="checkbox"/>	Mountain Aire <input type="checkbox"/>	Kountry Aire <input type="checkbox"/>	London Aire <input type="checkbox"/>	C A <input type="checkbox"/>	D P <input type="checkbox"/>	D B <input type="checkbox"/>	
<input checked="" type="checkbox"/> Air Conditioning & Heating				<input type="checkbox"/> Electrical Components			
<input type="checkbox"/> Appliances & Accessories				<input type="checkbox"/> Exterior Components			
<input type="checkbox"/> Cabinets & Furniture				<input type="checkbox"/> Interior Components

TSB #219

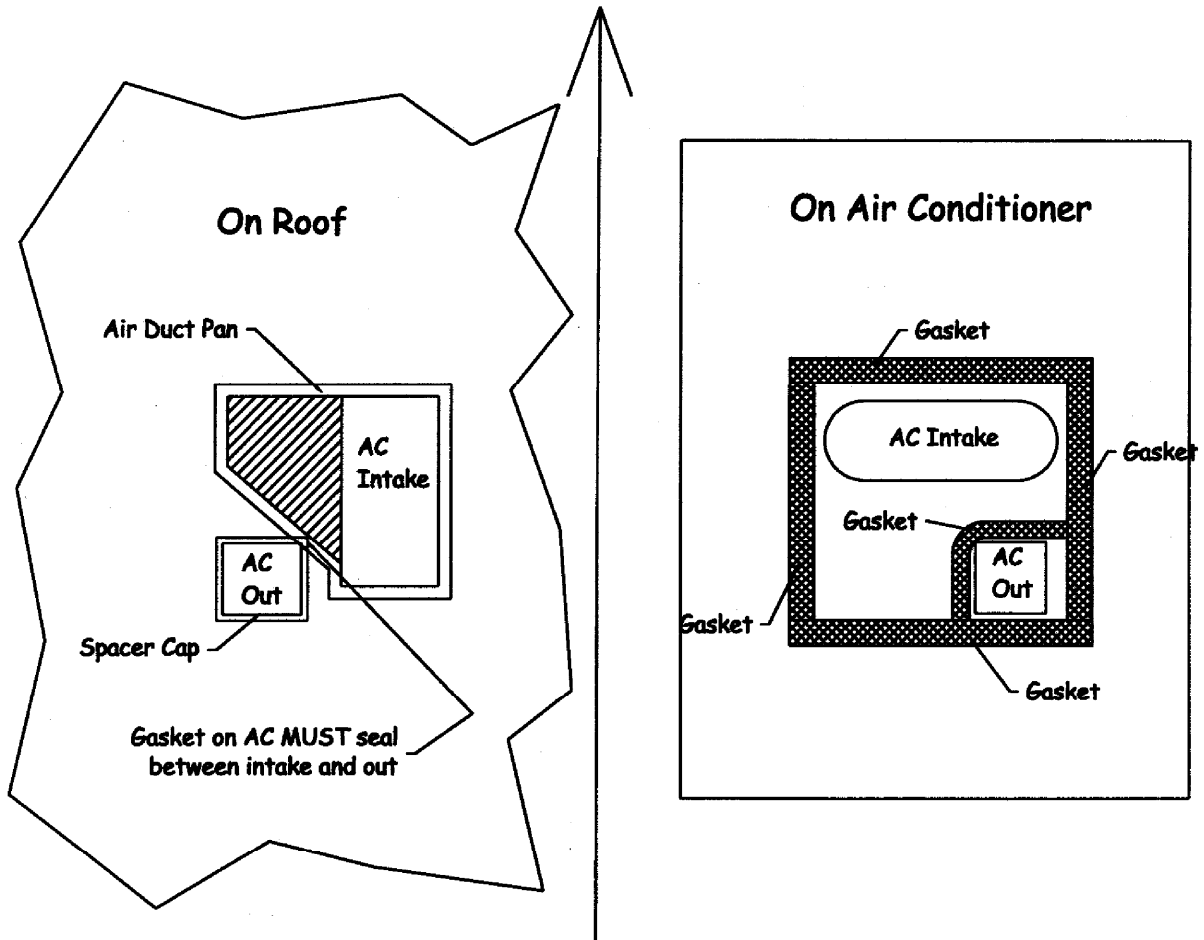
<input type="checkbox"/> Chassis Components				<input type="checkbox"/> Plumbing & Bath Components			
<input type="checkbox"/> Construction Components				<input type="checkbox"/> Windows, Awnings, Vents, & Doors			
DESCRIPTION OF PROBLEM							
Newmar is finding that roof A/C gasket installation work in the field is not being re-installed properly causing the A/C to freeze up.							
RECOMMENDED SOLUTION							
Install the perimeter gasket, along with a secondary gasket, to seal the output area from the intake area. Please see the attached drawing and if you have any questions, please call a Newmar representative.

Air Conditioner Sealing Gasket Front of Unit
