NEWMAR CORPORATION FAX. WARRANTY DEPARTMENT

TECH	NICAL	SERVICE	RIIII	ETIN
IECH	NICAL	SERVICE	DUL	_E

Date Issued 09/13/01	Model Year(s) Affected 2001-2002	Model(s) Affected 35 LKSA	TSB # 226				
		Туре						
ALL O	American Star	○ Kountry Star ●	Dutch Star O	All O TTO FW®				
	Mountain Aire	€ Kountry Aire ○	London Aire O	CAO DPO DBO				
O A	Air Conditioning & Dappliances & Accessor Cabinets & Furniture Chassis Components Construction Compo	ories e		omponents				
Description of Problem								
	cient return air duct d up to August 24, 2		nis will pertain to 35 l	LKSA models only that were

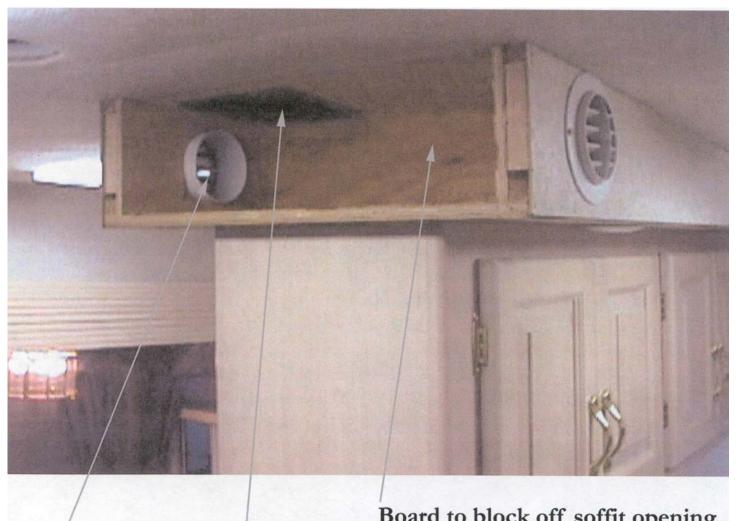
Board to block off soffit opening.

6" X 6" opening.

4" round vent.

Remove the forward end panel from the soffit area and install a board 18" back from the front edge. Next, seal off the perimeter of the soffit area around the board. Install two 4" louvered vents and cut 6" X 6" access to return air duct through the ceiling board. Tape the edges to seal from the duct to the opening in the soffit cavity. Install filter material over the 6" X 6" opening and re-install the end panel. When you are finished, test the system. This should pull return air into the cavity. Please use the attached diagram as a reference.
