# NEWMAR CORPORATION

### TECHNICAL SERVICE BULLETIN

Model(s) Affected  
NewAire

TSB #  
227

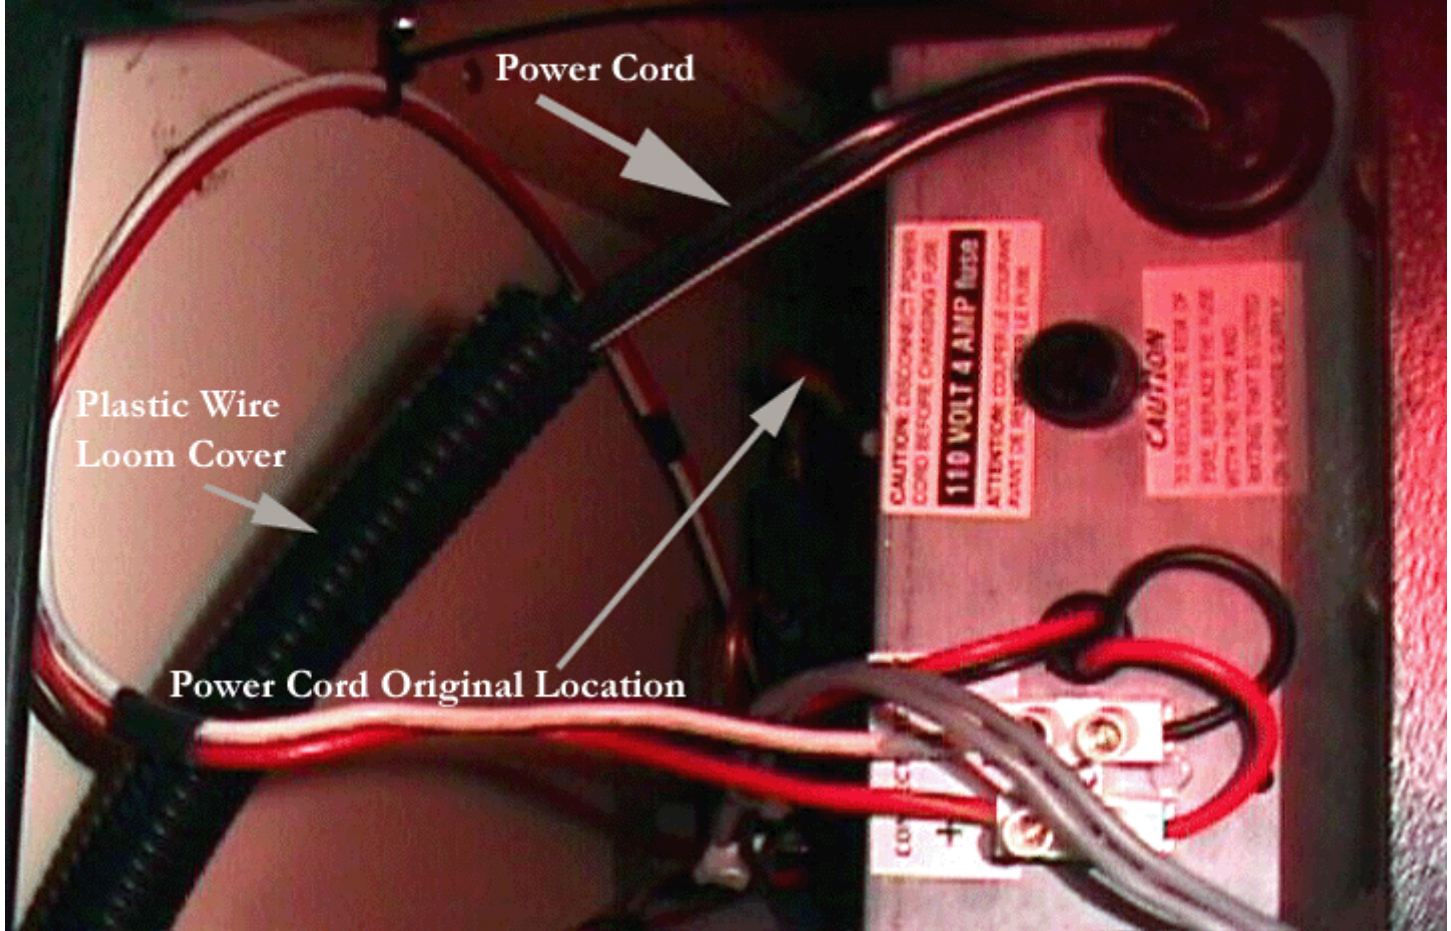
The power cord for the refrigerator may be routed incorrectly. This will pertain to units 40004-40025.

Remove the access cover on the top left corner of the refrigerator. Next, move the location of the power cord to the side of the refrigerator. By moving the cord this will prevent it from hanging over the coils at the rear of the opening.

Install a plastic wire cover over the cord, approximately 2' of plastic conduit. Cover the slide over the cord to assist with protection.

Please use the attached picture as a reference.
