NEWMAR CORPORATION WARRANTY DEPARTMENT

TECHNICAL SERVICE BULLETIN

Model(s) Affected
NewAire

TSB #
228

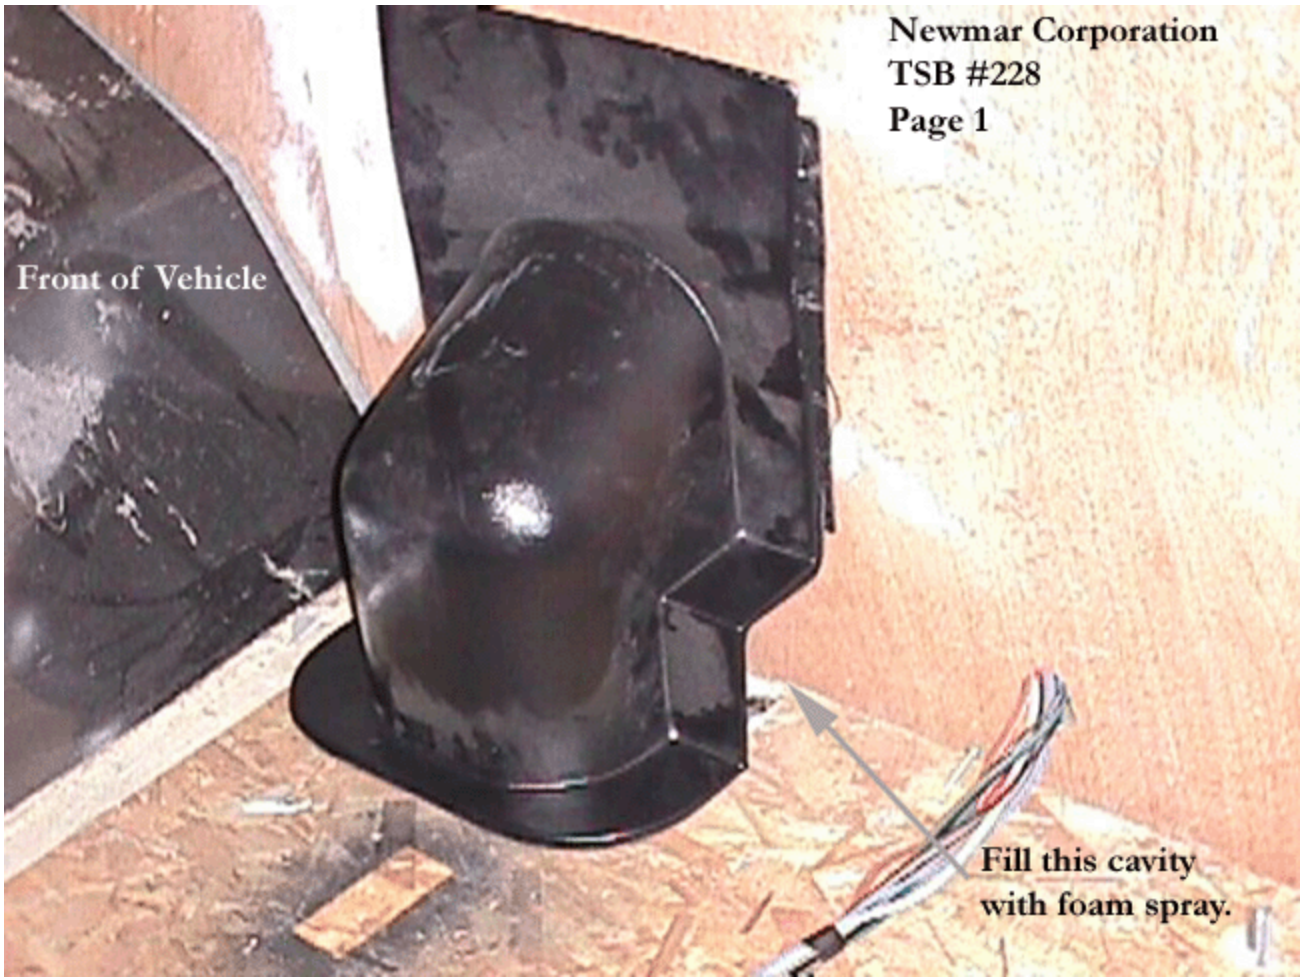
The interior fuel fill cover located on the passenger side under the sofa may not be properly sealed to the floor. This will pertain to units 40011-40025.

Front of Vehicle

First, close off front end of opening area. Then fill the cavity from the rear with spray foam. Removal of the sofa kick panel or base may be required to gain access to this area. Please refer to the attached picture.

Fill this cavity
with foam spray.
