NEWMAR CORPORATION

WARRANTY DEPARTMENT

Authorized Repair Procedure: Newmar Products

Scope: This procedure is developed to address the issue of a specific number of Newmar RV's that require repair of the OEM installed Sika sealant.

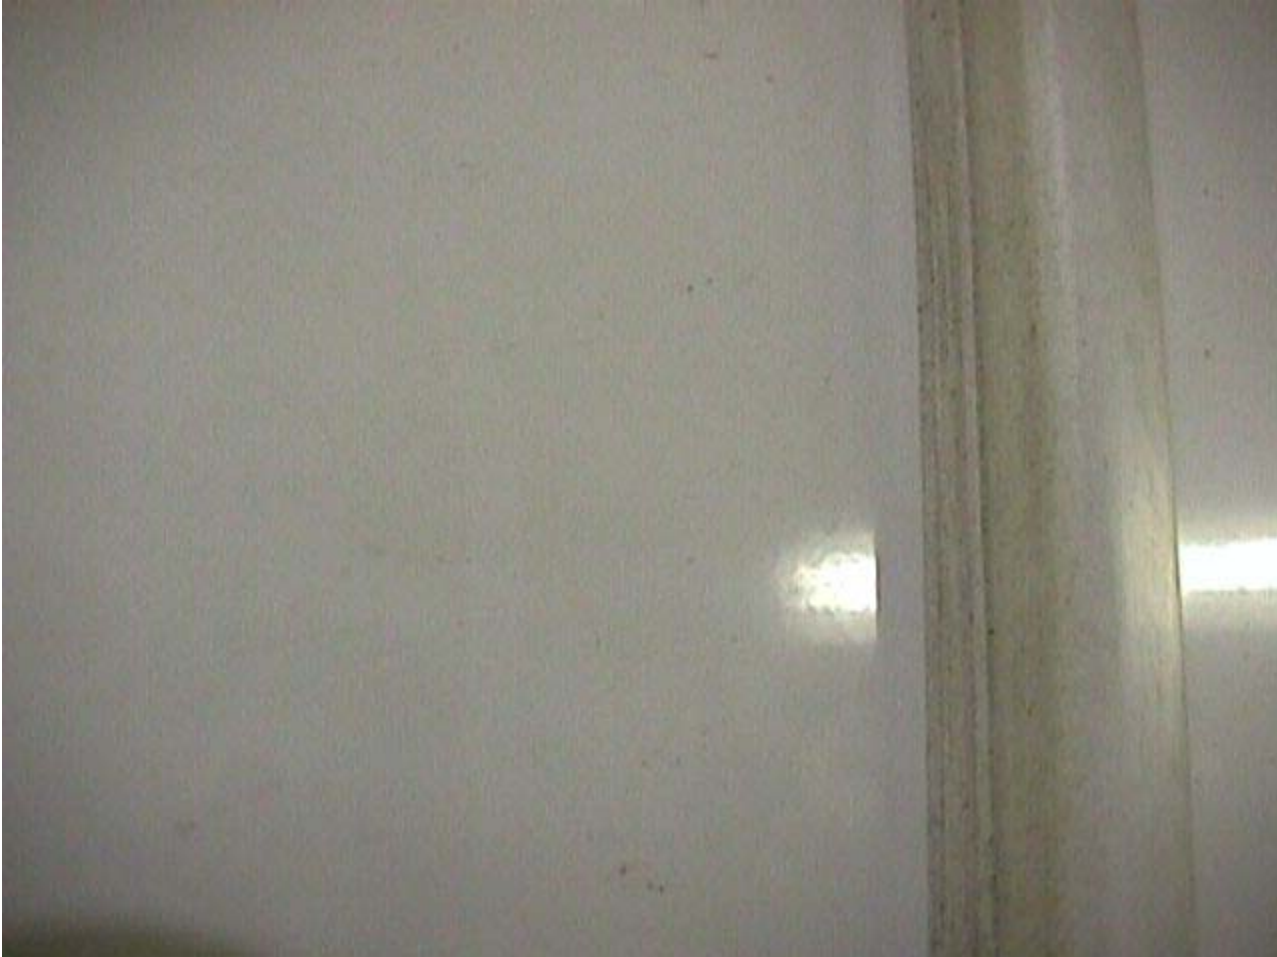
This is an example of correctly applied material that is dirty from road use. This is not approved for repair:

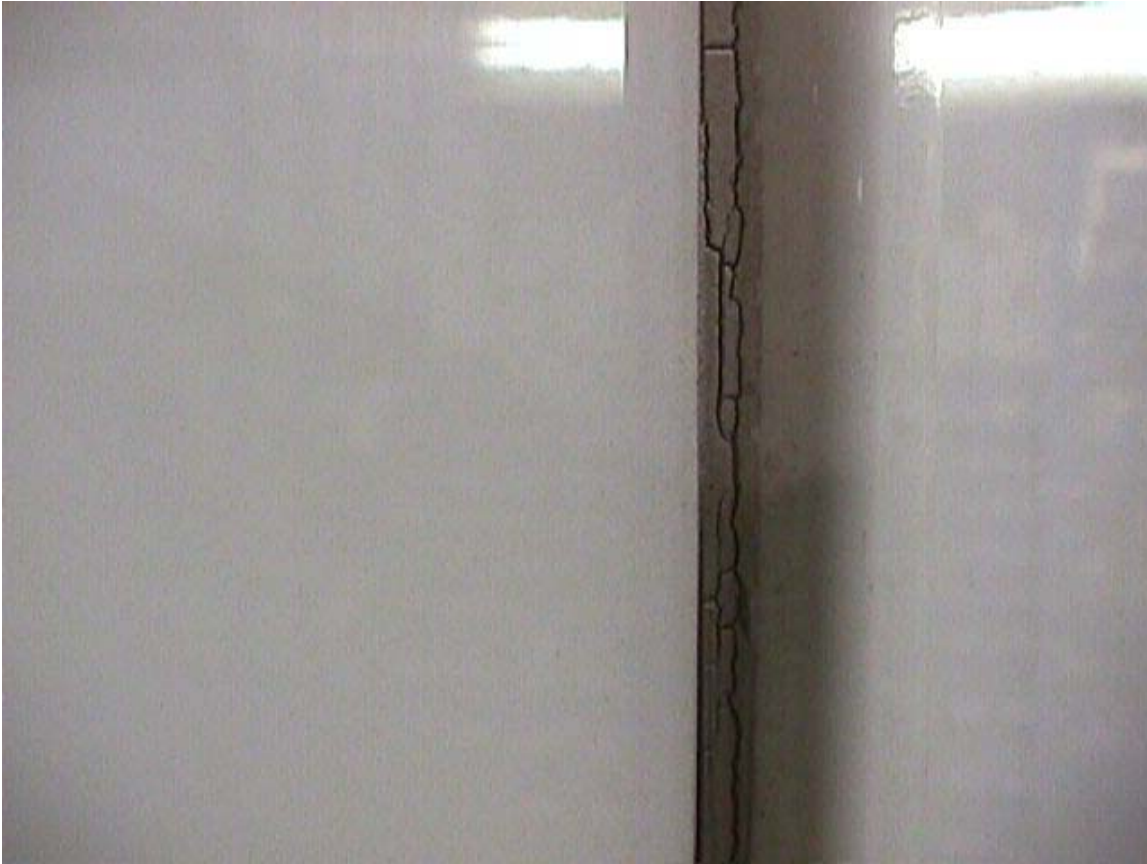
The below is an example of a seam approved for repair.

- 1) Mask both sides of effected area to prevent paint damage.
- 2) Remove loose SIKAFLEX® particles from body seams with a polystick, dry wipe to remove loose SIKAFLEX®, dust, dirt and debris.
- 3) If material is “gummy” use acetone or “Scrubs in a Bucket” wipes to remove. No other solvent will be approved.

- 3) Apply SIKAFLEX® 521 UV material to prepared seam Use a minimum of 3/16" bead across the void at 45 degree angle.
- 4) Allow sealant to become tack free (skinned on top), about one hour, before subjecting to severe movement, racking, dusty conditions and heavy rainfall.

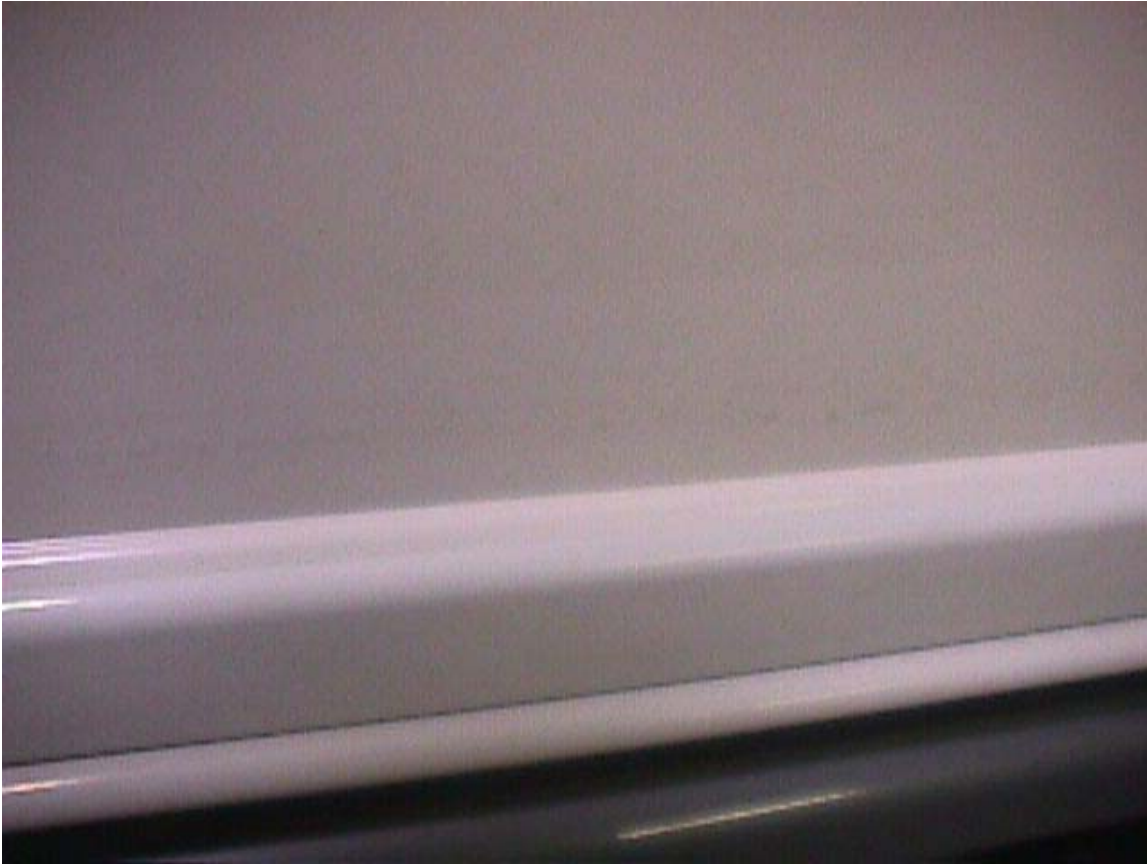
The below example demonstrates a well applied seam seal:
