# NEWMAR CORPORATION

## WARRANTY DEPARTMENT

NewAire Third Brake Light modification per ECO 2002 #448

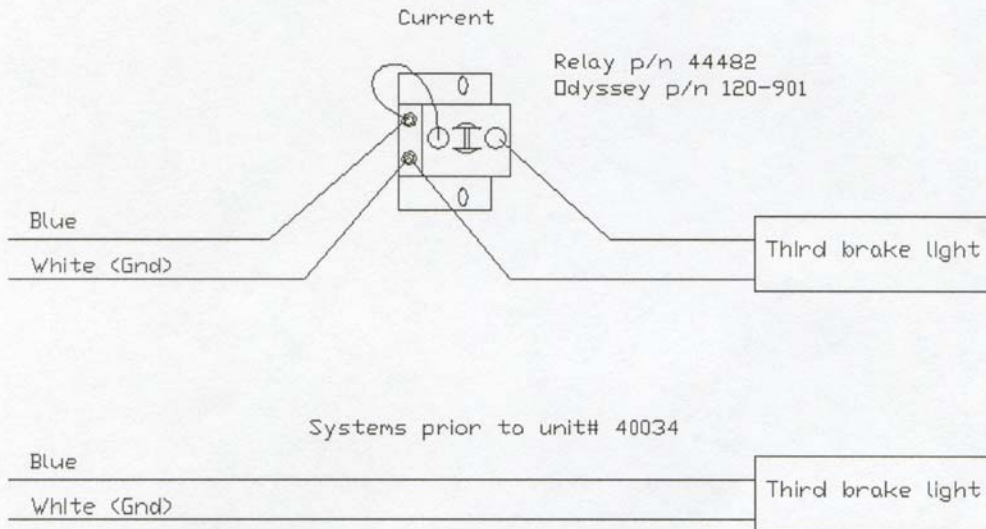
<input type="checkbox"/> Chassis Components				<input type="checkbox"/> Plumbing & Bath Components		
<input type="checkbox"/> Construction Components				<input type="checkbox"/> Windows, Awnings, Vents, & Doors		
DESCRIPTION OF PROBLEM						
Short flashes of the third brake light.						
RECOMMENDED SOLUTION						
Locate and install a relay, part number 44482, in the tail light harness third brake light circuit to prevent unpredictable short flashes. This relay can be found on the passenger side of the engine compartment below the chassis disconnect switch. (See the attached diagram). It has not been confirmed that all units experience this condition.						
When making this repair, please use flat rate code number 20914601 and allow .8 hour to complete.

Locate relay on passenger side of engine compartment below chassis disconnect switch.
