Newmar Corporation Warranty Department

Technical Service Bulletin							
Date Issued		Model Year(s) Affected		Model(s) Affected		TSB #	
10/19/2006		11/8/05 – 3/2/06		All Spartan Chassis		267	
Brand						Type	
All	<input checked="" type="checkbox"/>	American Star	<input type="checkbox"/>	Mountain Aire	<input type="checkbox"/>	All	<input type="checkbox"/>
		Dutch Star	<input type="checkbox"/>	Kountry Aire	<input type="checkbox"/>	F W	<input type="checkbox"/>
		Kountry Star	<input type="checkbox"/>	Essex	<input type="checkbox"/>	D P	<input checked="" type="checkbox"/>
Scottsdale	<input type="checkbox"/>	Northern Star	<input type="checkbox"/>	London Aire	<input type="checkbox"/>	D B	<input checked="" type="checkbox"/>
<div style="display: flex; justify-content: space-between;"> <div> <input type="checkbox"/> Air Conditioning & Heating <input type="checkbox"/> Appliances & Accessories <input type="checkbox"/> Cabinets & Furniture <input checked="" type="checkbox"/> Chassis Components <input type="checkbox"/> Construction Components </div> <div> <input checked="" type="checkbox"/> Electrical Components <input type="checkbox"/> Exterior Components <input type="checkbox"/> Interior Compon

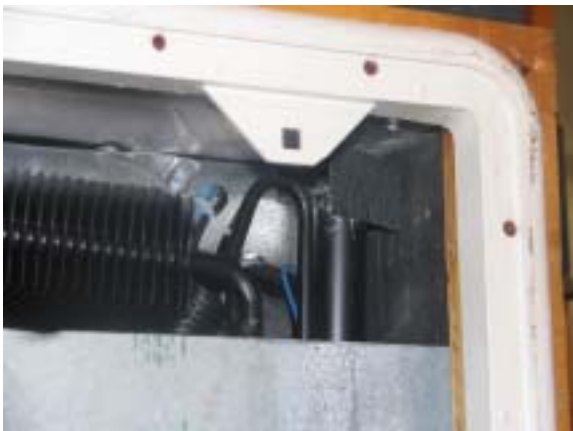
INCORRECT INSTALLATION

The long edge of flue cap is NOT parallel with the refrigerator cabinet back.

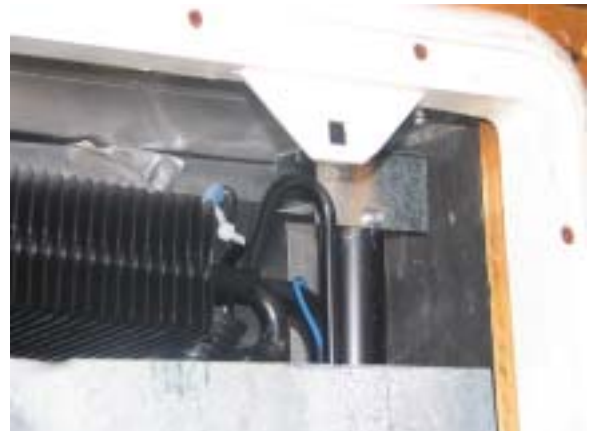
CORRECT INSTALLATION

The long edge of flue cap IS parallel with the refrigerator cabinet back.
