Newmar Corporation

Warranty Department

Description of Problem							
<p>TRW, a supplier of tie rod and cross tube assemblies notified ArvinMeritor that a number of tie rod assemblies supplied to us will experience an environmental degradation of the rubber boot seal assembled to the tie rod.....It has been described as boot seals not holding grease do to cracks or a “dry-rot” appearance. TRW has determined that this issue is not a safety related concern as the tie rod has sufficient capacity to function for multiple greasing cycles, even after boot degradation but it does affect customer satisfaction.</p>							
Recommended Solution							
<p>Alert the effected customers of the potential condition and to recommend that at the next greasing cycle the tie rod end be inspected for the condition. See Manufacturers attached repair directions. Contact manufacturer directly for additional information or instructions.</p>

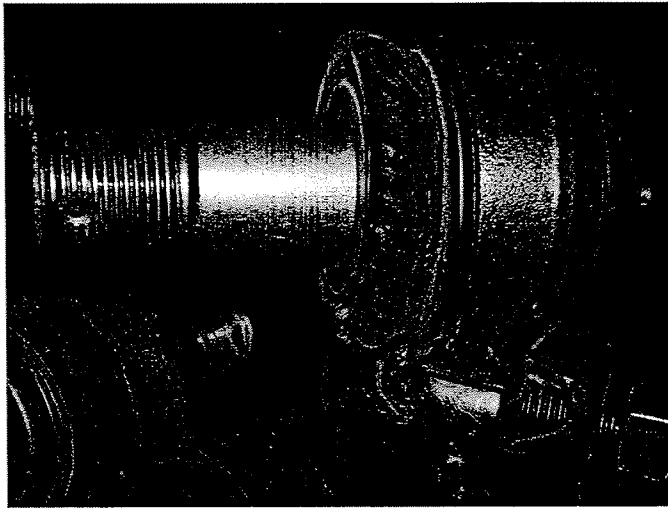
The failure mode, if it exists, will be observed during normal tie rod greasing intervals. It has been described as boot seals not holding grease due to cracks or a "dry-rot" appearance. TRW has determined that this issue is not a safety related concern as the tie rod has sufficient capacity to function for multiple greasing cycles, even after boot degradation. However, it needs to be remedied as it does affect customer satisfaction. The environmental attack will show up as early as seven months after the boot seal manufacture date if the condition exists.

NOTE: There is a potential for a false diagnosis to occur. Many times the tie rod will receive exposure to primer and / or topcoat paint. This paint will subsequently crack in the field. Cracked paint by itself does not indicate anything wrong with the boot; the issue describe herein is contained in the rubber compound itself. Refer to figures one and two for examples of boot degradation.

Figure #1 - Typical condition after environmental attack, disassembled from vehicle:

The suggested remedy is to alert the affected customers of the potential condition and to recommend that at the next greasing cycle the tie rod end be inspected for the condition shown in the figures one and two below. If the degradation condition is found, then replacement of the tie rod end only (not the cross tube) should be accomplished. It has been observed that one or both tie rod ends could be affected per vehicle. Also, inspect the tie rod end to ensure it

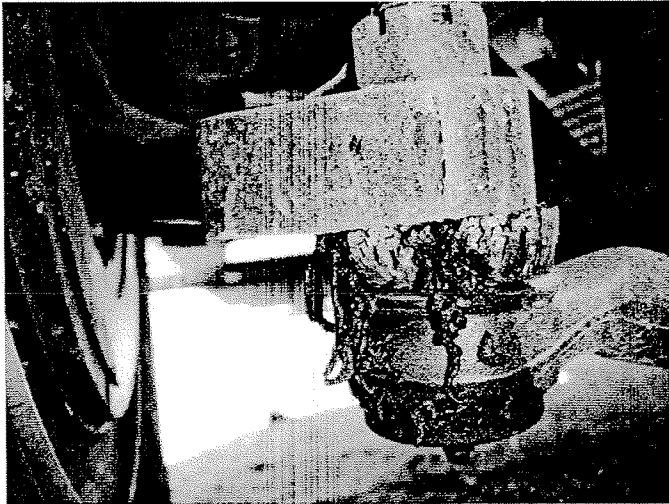
#2 - Typical condition after environmental attack, as viewed on vehicle:

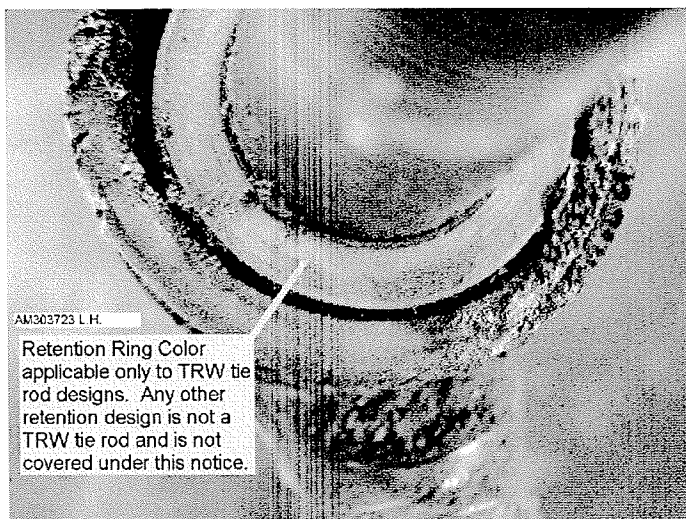
is a TRW component. Please refer to figures 3 and 4 for identification of TRW tie rod end assemblies.

Figure #3 – Identification of TRW tie rods (green, pink, yellow or tan color of the nylon ring that is molded into the top of the boot seal varies by part

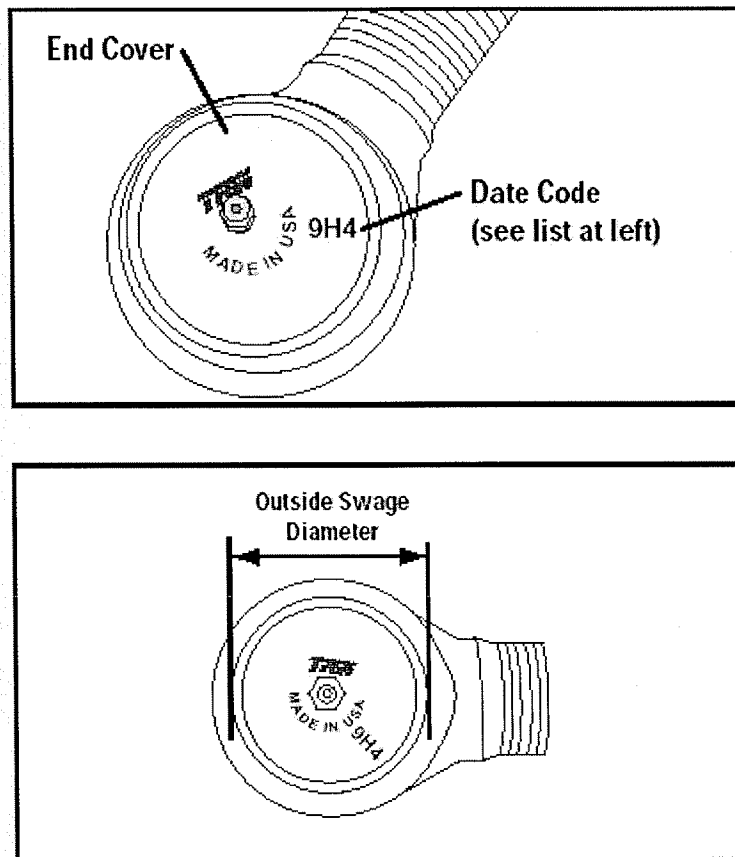
TRW, a supplier of tie rod and cross tube assemblies notified ArvinMeritor that a number of tie rod assemblies supplied to us will experience an environmental degradation of the rubber boot seal assembled to the tie rod. This error potentially affects ArvinMeritor axles built from April 2004 through December 2004 with **tie rod ends displaying a 3 digit date code beginning with 4D, 4E, 4F, 4G or 4H stamped on the ball socket assembly cap**. See figure 4 for details of date code stamping.

Figure 4: Identify the tie rod end as a TRW part before the removal of the ball stud from the arm. This can be done with a measurement of the swage diameter while the part is still assembled on the vehicle. A measurement of 1-7/8" or 2-1/8", along with the "TRW" stamp and the date code on the cap, can verify that it is a TRW part
