CSB06-320-001 June, 2006 Page 1 of 3

CAMPAIGN SERVICE BULLETIN

SUBJECT: Brake Chambers – Bendix

APPLIES TO: Certain Spartan Chassis Models Manufactured with Bendix Brake

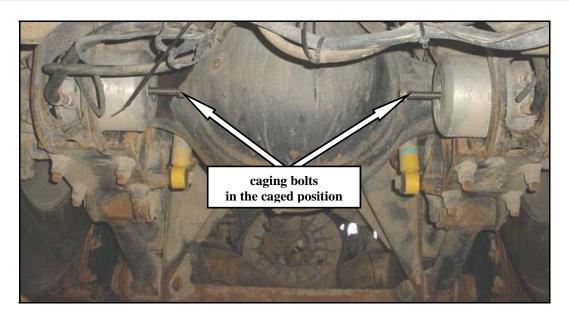
FIG. 3-1

CONDITION: The rear axle brake chambers are installed with the vent hole

incorrectly positioned.

- 3. Release the parking brake.
- 4. Refer to FIG. 3-1. Cage both brake chambers. Turn the bolt counter clockwise until it is fully extended.
- 5. Mark the brake hoses on each brake chamber identifying the service and parking brake connections.
