Technical Service Bulletin							
Date Issued		Model Year(s) Affected		Model(s) Affected		TSB #	
10/20/2006		2004 - 2005		Spartan Chassis		278	
Brand						Type	
All	<input type="checkbox"/>	American Star	<input type="checkbox"/>	Mountain Aire	<input checked="" type="checkbox"/>	All	<input type="checkbox"/>
		Dutch Star	<input checked="" type="checkbox"/>	Kountry Aire	<input type="checkbox"/>	T T	<input type="checkbox"/>
		Kountry Star	<input type="checkbox"/>	Essex	<input type="checkbox"/>	F W	<input type="checkbox"/>
Scottsdale	<input type="checkbox"/>	Northern Star	<input type="checkbox"/>	London Aire	<input type="checkbox"/>	D P	<input checked="" type="checkbox"/>
<div style="display: flex; justify-content: space-between;"> <div> <input type="checkbox"/> Air Conditioning & Heating <input type="checkbox"/> Appliances & Accessories <input type="checkbox"/> Cabinets & Furniture <input checked="" type="checkbox"/> Chassis Components <input type="checkbox"/> Construction Components </div> <div> <input type="checkbox"/> Electrical Components <input type="checkbox"/> Exterior Components <input type="checkbox"/> Interior Components <input type="checkbox"/> Plumbing & Bath Components <in

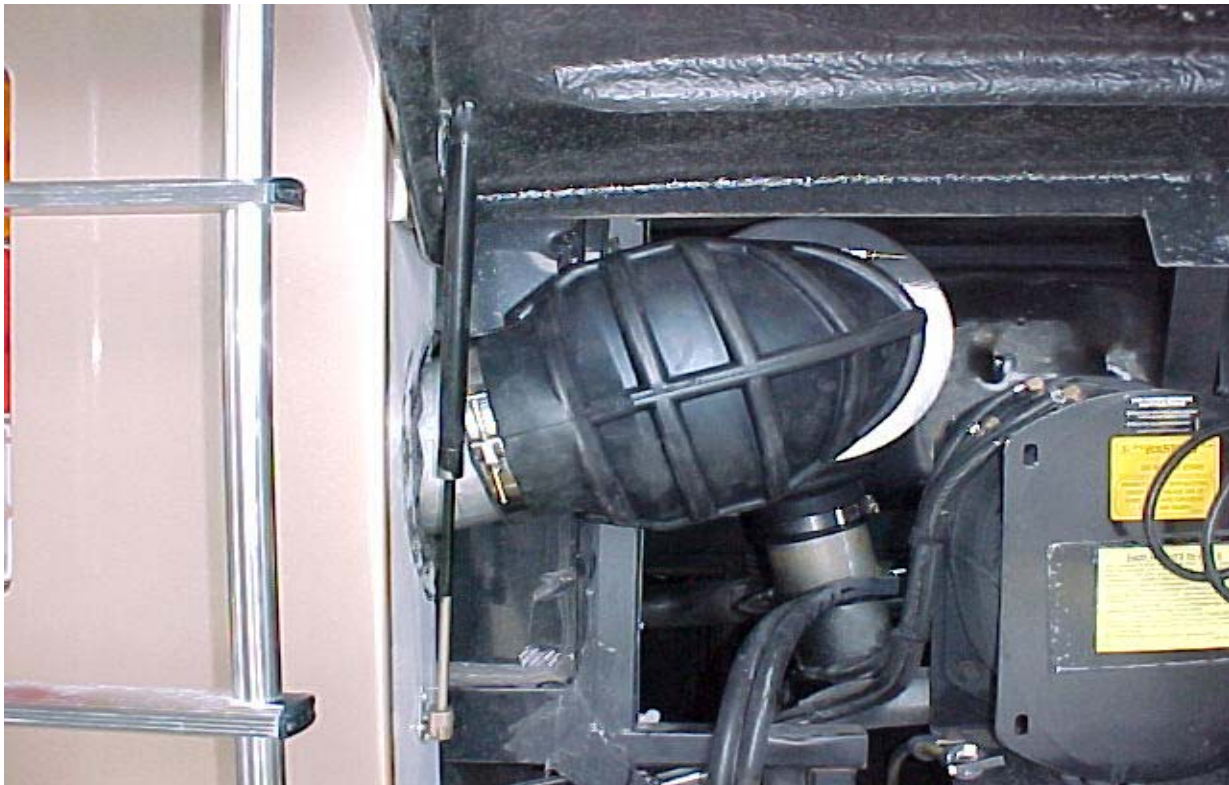
Purpose: The flexible ducting installed by Newmar between the air plenum outlet and the air cleaner inlet is causing a vibration.

A vibration similar to a tire vibration occurring at engine RPM's between 1500 and 1800. This vibration occurs at highway speeds and can also be felt when the vehicle is parked with the air compressor not pumping and at highway RPM's.

- Remove the flexible hose between the air cleaner and the plenum box.
- Install the 6x6 Cobra head elbow on the air cleaner inlet.
- Slide the air cleaner forward to align the elbow with the plenum box. This may require the use of the 0775-HH2 Cobra head at the turbo.
- Install the 6" OD tube between the air cleaner and the plenum box. Ensure the tube protrudes into the plenum box a minimum of 1 inch. Also ensure the bottom of the tube is above the bottom of the plenum box.
- Seal around the tube where it enters the plenum box.
