# Newmar Corporation Warranty Department

Technical Service Bulletin							
Date Issued		Model Year(s) Affected		Model(s) Affected		TSB #	
10/20/2006		2005 - 2006		Series W20/22/24 Workhorse Chassis		290	
Brand						Type	
All	<input type="checkbox"/>	American Star	<input type="checkbox"/>	Mountain Aire	<input checked="" type="checkbox"/>	All	<input type="checkbox"/>
		Dutch Star	<input checked="" type="checkbox"/>	Kountry Aire	<input type="checkbox"/>	T T	<input type="checkbox"/>
		Kountry Star	<input checked="" type="checkbox"/>	Essex	<input type="checkbox"/>	F W	<input type="checkbox"/>
Scottsdale	<input checked="" type="checkbox"/>	Northern Star	<input type="checkbox"/>	London Aire	<input type="checkbox"/>	C A	<input checked="" type="checkbox"/>
						D P	<input type="checkbox"/>
						D B	<input type="checkbox"/>
<div> <input type="checkbox"/> Air Conditioning &amp; Heating <input type="checkbox"/> Electrical Components </div> <div> <input type="checkbox"/> Appliances &amp; Accessories <input type="checkbox"/> Exterior Components </div> <div> <input type="checkbox"/> Cabinets &amp; Furniture <input type="checkbox"/> Interior Components </div> <div> <input checked="" type="check

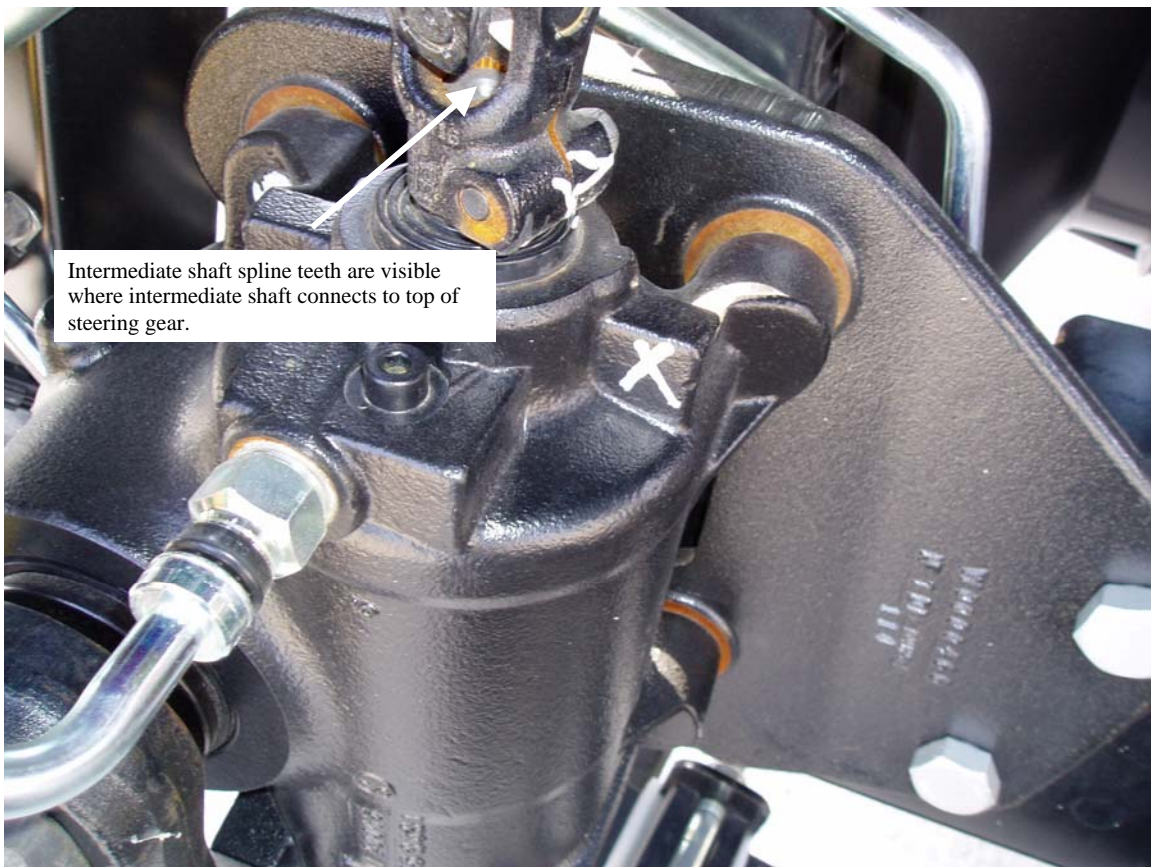
Inspect the intermediate shaft where it is connected to the input shaft at the top of the steering gear. The spline on the intermediate shaft is visible above the tip of the steering gear input shaft, as indicated in the photograph below:

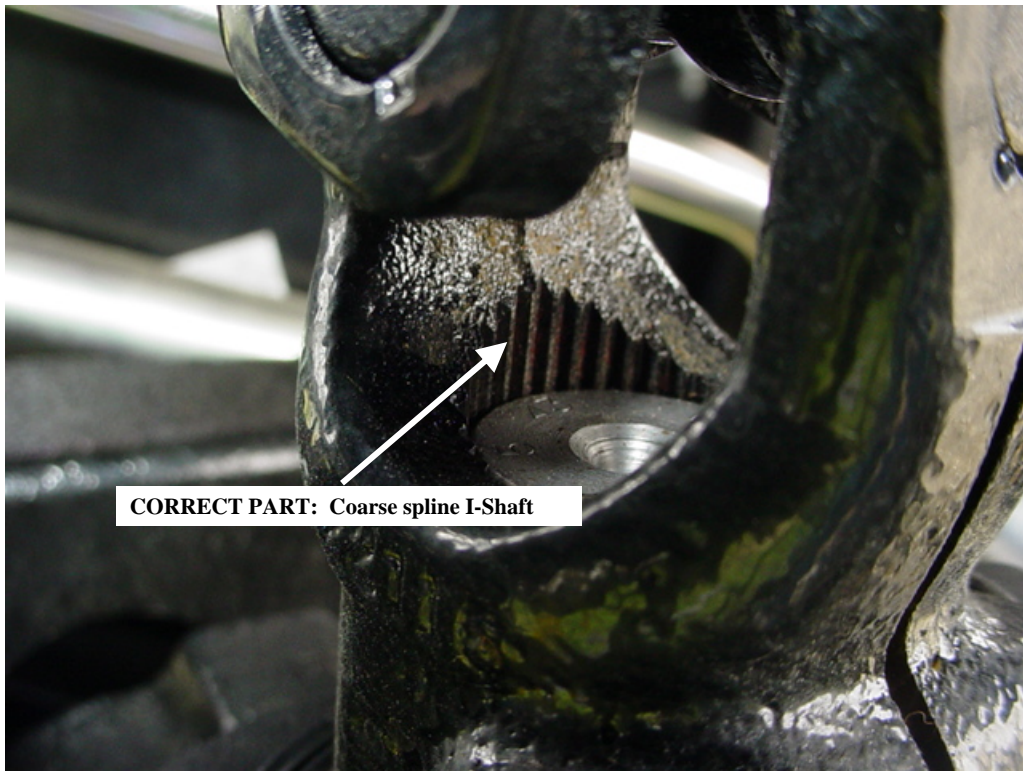
The coarse spline I-shaft is shown above. This is correct for W20/22/24 models.

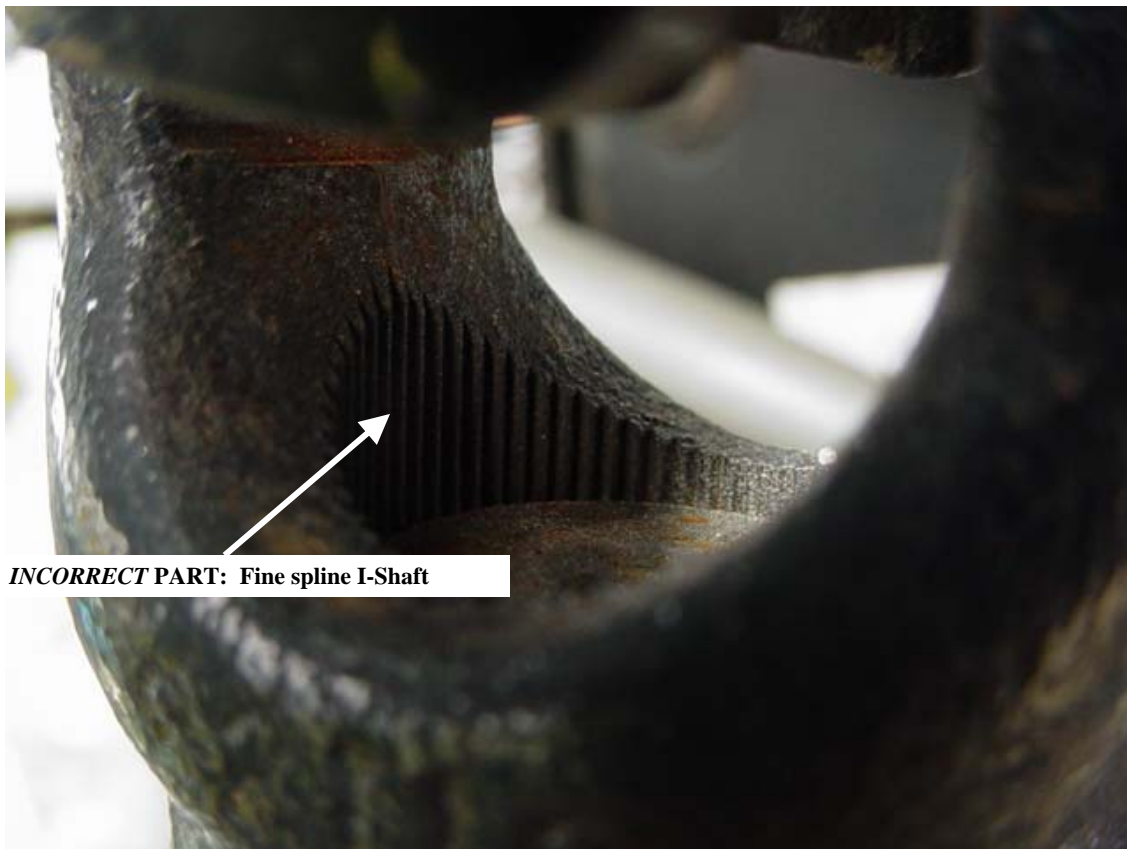
An incorrect steering intermediate shaft may have been installed on some of the subject chassis during the relevant production period. The incorrect part (W0007621) has a finer pitch spline than the correct part (W0000450). Use of the incorrect part may cause the spline not to match correctly with the corresponding steering gear input shaft. On vehicles equipped with the incorrect part, the spline can strip if the steering wheel is turned with a significant amount of force. The force required to strip the spline (i.e., steering wheel input of 10 to 90 ft-lbs of torque) is more than ordinary users will experience. This failure is likely only to occur when the vehicle is stopped or during tight turning maneuvers at very low speeds. This condition may result in a loss of steering control.

The fine spline I-shaft is shown above. This is *incorrect* for W20/22/24 models.

The service procedure for this recall requires inspection of the steering intermediate shaft to determine if the correct part was installed (as shown in the attached Inspection Procedure). If an incorrect shaft is identified, it should be replaced with the correct part (Part Number W0000450). Torque pinch bolt to 36-40 ft-lbs.
