NEWMAR CORPORATION WARRANTY DEPARTMENT

TECHNICAL SERVICE BULLETIN							
DATE ISSUED		MODEL YEAR(S) AFFECTED		MODEL(S) AFFECTED		TSB #	
5/17/07		2007		X-Aire FW		316	
BRAND						TYPE	
All	<input type="checkbox"/>	American Star	<input type="checkbox"/>	Mountain Aire	<input type="checkbox"/>	All	<input type="checkbox"/>
		Dutch Star	<input type="checkbox"/>	Kountry Aire	<input type="checkbox"/>	T T	<input type="checkbox"/>
X-Aire	<input checked="" type="checkbox"/>	Kountry Star	<input type="checkbox"/>	Essex	<input type="checkbox"/>	F W	<input checked="" type="checkbox"/>
Scottsdale	<input type="checkbox"/>	Northern Star	<input type="checkbox"/>	London Aire	<input type="checkbox"/>	C A	<input type="checkbox"/>
						D P	<input type="checkbox"/>
						D B	<input type="checkbox"/>
<input type="checkbox"/>	Air Conditioning & Heating	<input type="checkbox"/>	Electrical Components	<input type="checkbox"/>	Exterior Components	<input type="checkbox"/>	Interior Components

Technical Service Bulletin 316 Parts Information How to determine which kit to order for the fuel fill modification

Modifications To Improve Fuel Tank Filling

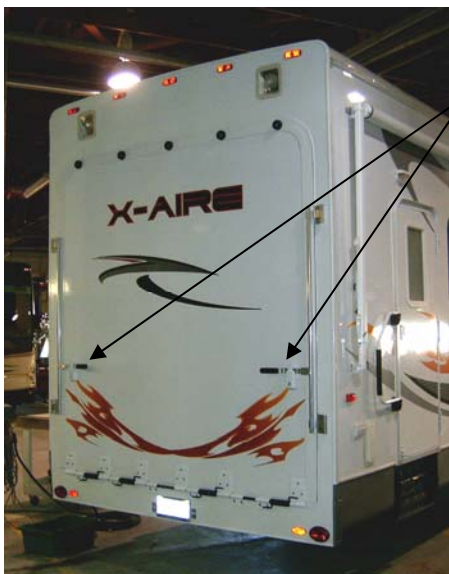
“Generation 1” X-Aire units will have exposed hardware on the exterior of the ramp door.

For the TSB 316 Fuel Fill Updates to a Generation 1 unit, order Kit # 012594.

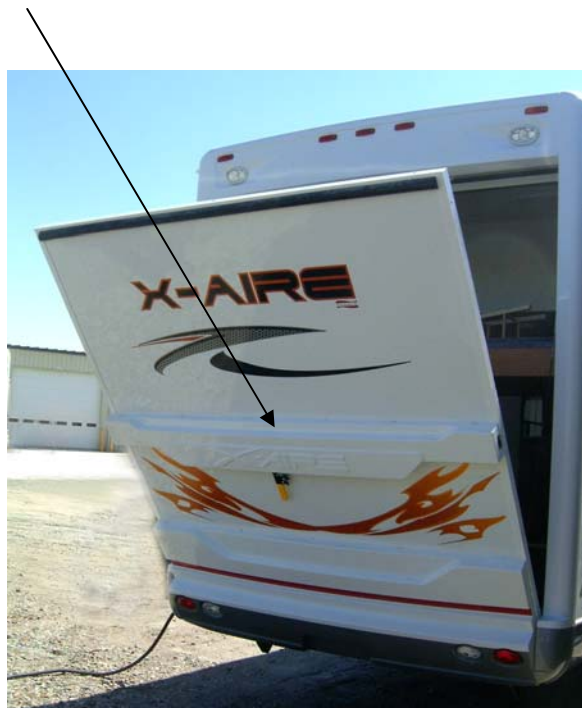
Generation 2 X-Aire units have covered rear ramp door hardware. The rear looks more like a conventional fifth wheel rear cap when closed.

For Generation 2 units, order **kit #012589**.
