NEWMAR CORPORATION WARRANTY DEPARTMENT

TECHNICAL SERVICE BULLETIN									
DATE ISSUED		MODEL YEAR(S) AFFECTED			MODEL(S) AFFECTED			TSB #	
7/19/90		1989-1990			Fifth Wheel			34	
BRAND					TYPE				
All <input type="checkbox"/>	American Star <input type="checkbox"/>	Kountry Star <input checked="" type="checkbox"/>	Dutch Star <input type="checkbox"/>	All <input type="checkbox"/>	T T <input type="checkbox"/>	F W <input checked="" type="checkbox"/>			
NewAire <input type="checkbox"/>	Mountain Aire <input type="checkbox"/>	Kountry Aire <input checked="" type="checkbox"/>	London Aire <input checked="" type="checkbox"/>	C A <input type="checkbox"/>	D P <input type="checkbox"/>	D B <input type="checkbox"/>			
<input type="checkbox"/> Air Conditioning & Heating					<input type="checkbox"/> Electrical Components				
<input type="checkbox"/> Appliances & Accessories					<input type="checkbox"/> Exterior Components				
<input type="checkbox"/> Cabinets & Furniture					<input type="checkbox"/> Interior Components

SECURING BED BASE IN CABOVER TYPE SLIDE OUT

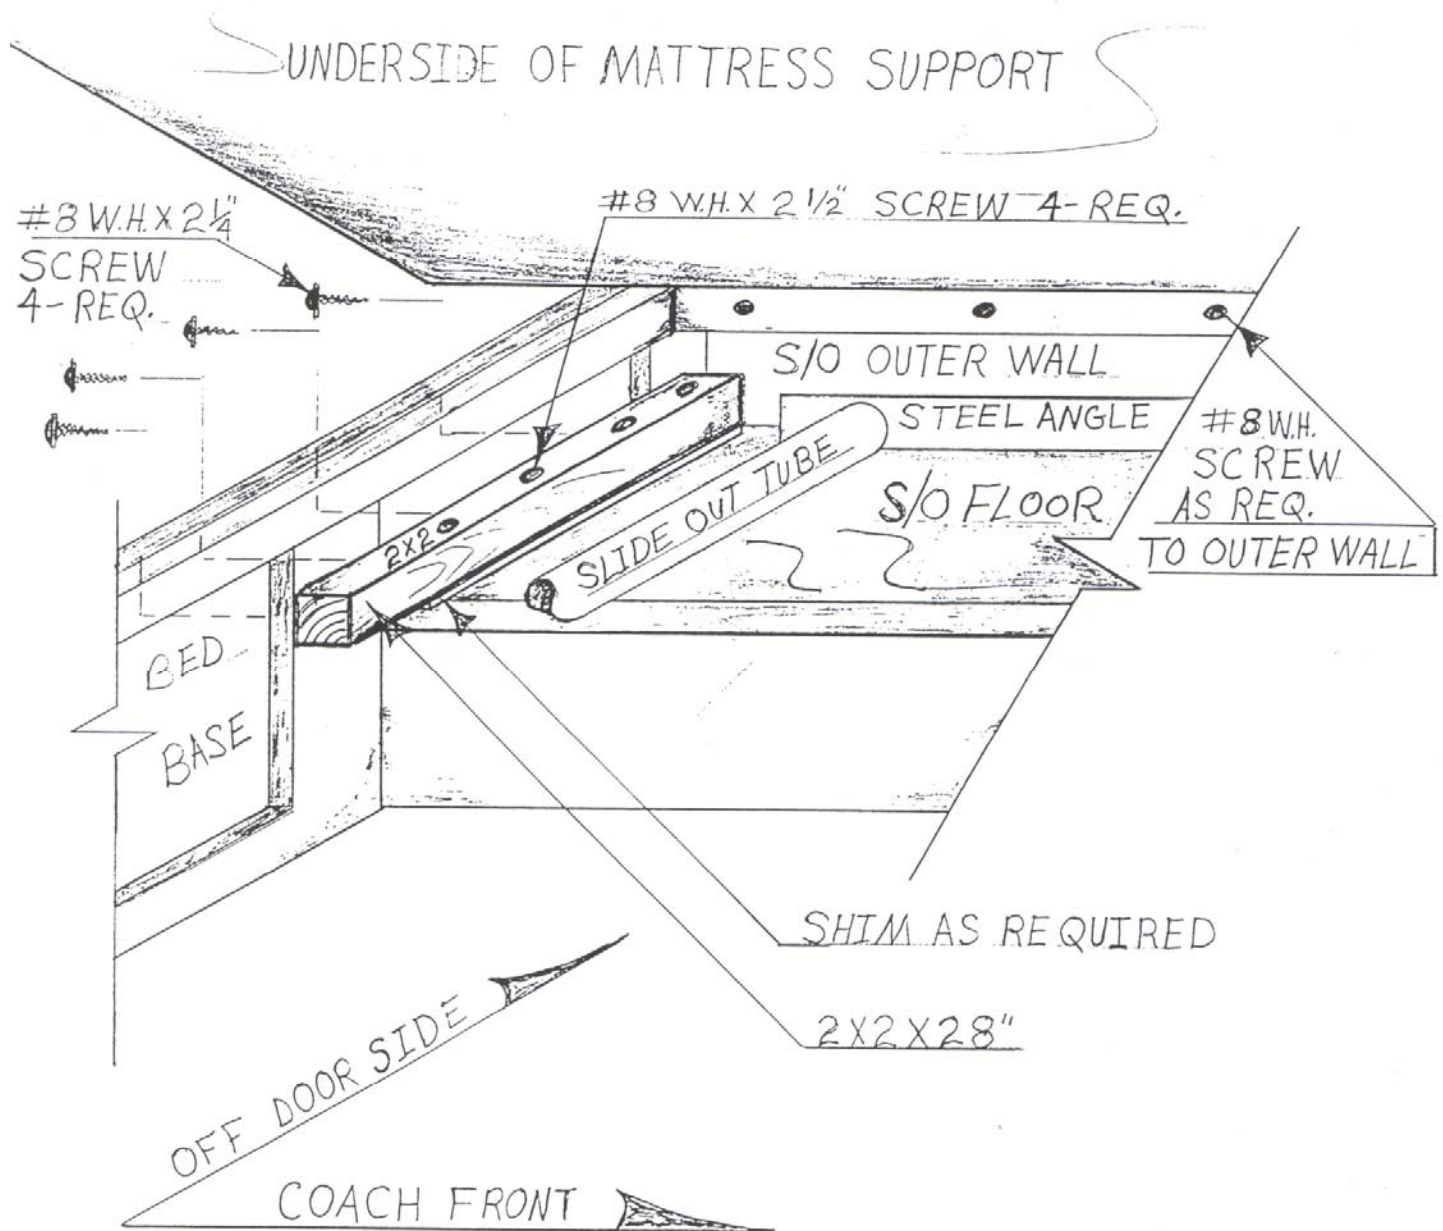
<input type="checkbox"/> Chassis Components					<input type="checkbox"/> Plumbing & Bath Components				
<input checked="" type="checkbox"/> Construction Components					<input type="checkbox"/> Windows, Awnings, Vents, & Doors				
DESCRIPTION OF PROBLEM									
The bed that is in the cab over fifth wheel slide out is coming loose from the slide out floor.									
RECOMMENDED SOLUTION									
Remove 3/4" X 3/4" cleat material. Add 2" X 2" in its place. Please refer to the attachment on how to install 2 X 2 to the bed base and the slide out floor. If this change is not made, it could result in leaks in the slide out area.
