# NEWMAR CORPORATION WARRANTY DEPARTMENT

## Oshkosh Chassis Division Service Bulletin

**DATE:** October 25, 1990  
**Bulletin No.:** OCD-16-90  
**Type:** Service Bulletin  
**Model:** M-Line

**SUBJECT:** Fuel Leak at Carburetor

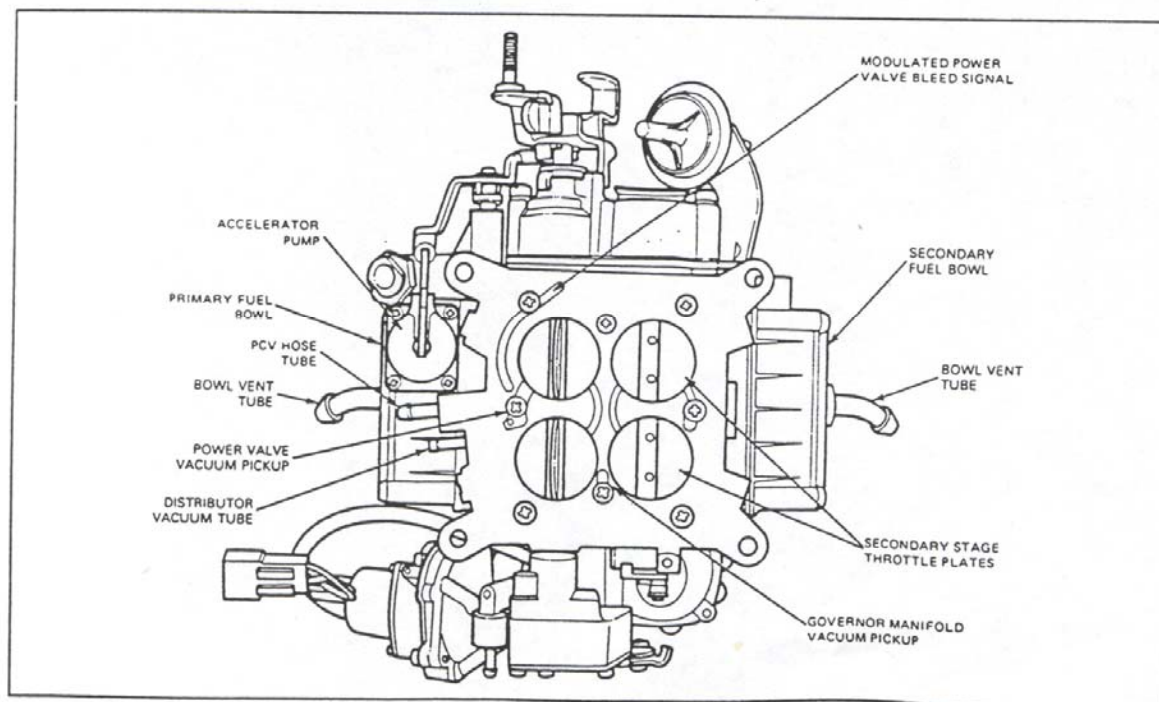
4-V Bottom View (California Model Shown, 49 State Model Similar)

It has come to our attention that some carbureted chassis are experiencing fuel leaks at the carburetor after extensive storage time at the OEM or the retail dealer. This is due to the accelerator pump diaphragm deteriorating during storage.

All carbureted chassis should be checked for possible fuel leaks before they leave the OEM and again before they are delivered to the end user. If any leaks are found, the accelerator pump diaphragm should be replaced using Ford part #FOPZ9B559-A and the charges submitted on an Oshkosh warranty claim.
