NEWMAR CORPORATION WARRANTY DEPARTMENT

TECHNICAL SERVICE BULLETIN							
DATE ISSUED	MODEL YEAR(S) AFFECTED	MODEL(S) AFFECTED	TSB #				
8/26/92	1993	ALL	59				
BRAND		TYPE					
All <input checked="" type="checkbox"/>	American Star <input type="checkbox"/>	Kountry Star <input type="checkbox"/>	Dutch Star <input type="checkbox"/>	All <input checked="" type="checkbox"/>	T T <input type="checkbox"/>	F W <input type="checkbox"/>	
NewAire <input type="checkbox"/>	Mountain Aire <input type="checkbox"/>	Kountry Aire <input type="checkbox"/>	London Aire <input type="checkbox"/>	C A <input type="checkbox"/>	D P <input type="checkbox"/>	D B <input type="checkbox"/>	
<input type="checkbox"/> Air Conditioning & Heating				<input type="checkbox"/> Electrical Components			
<input type="checkbox"/> Appliances & Accessories				<input type="checkbox"/> Exterior Components			
<input type="checkbox"/> Cabinets & Furniture				<input type="checkbox"/> Interior Components

EMERGENCY EXTENSION AND RETRACTION OF THE RACK & PINION S/O ROOM

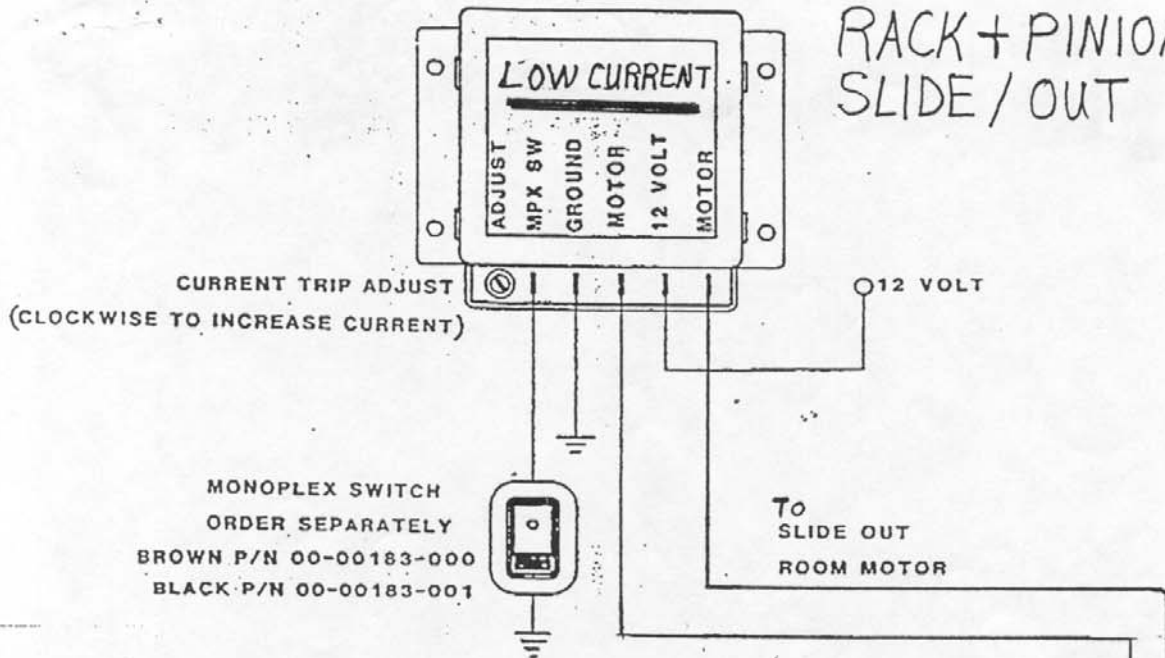
RACK + PINION
SLIDE / OUT

SLIDE OUT ROOM CONTROLLER

P/N 00-00193-100

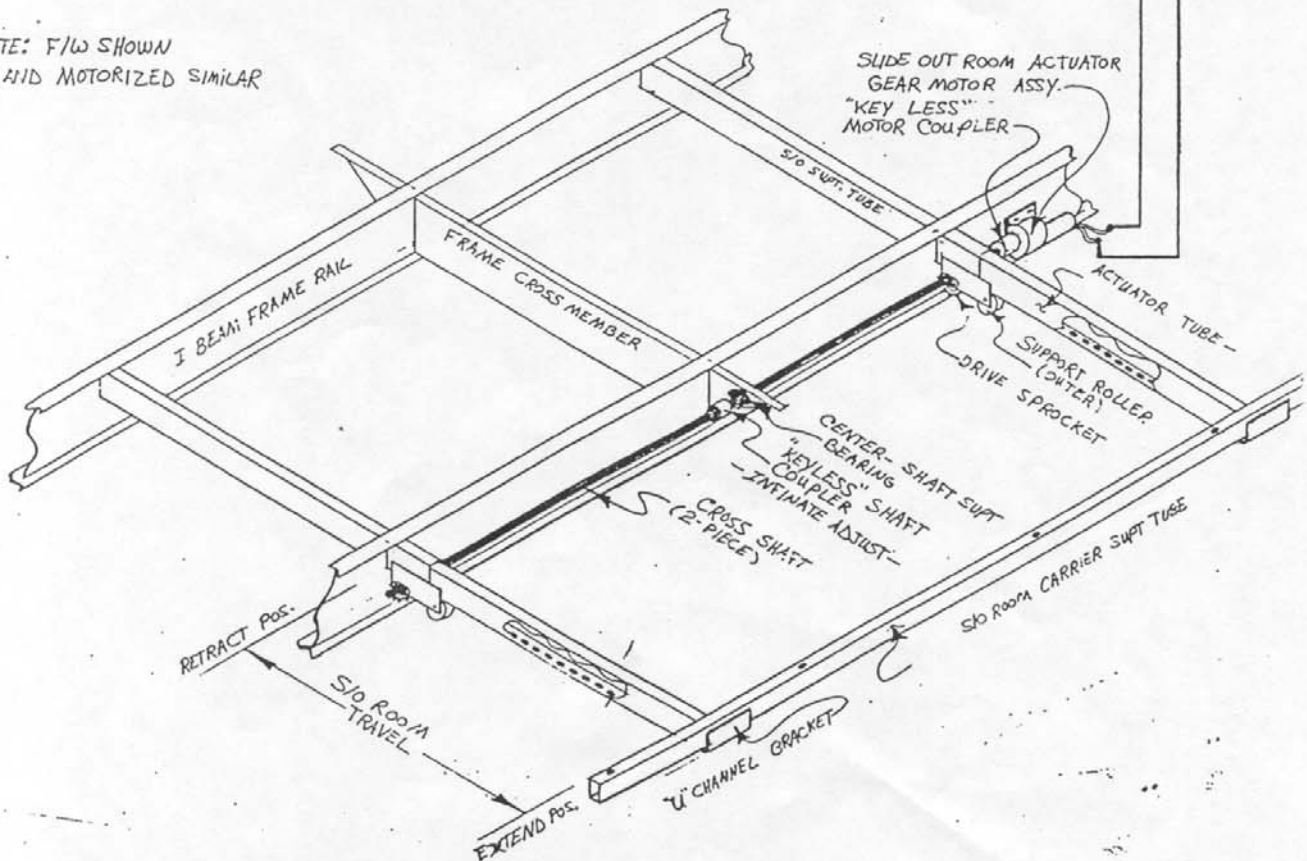
MONOPLEX SWITCH
ORDER SEPARATELY
BROWN P/N 00-00183-000
BLACK P/N 00-00183-001

NOTE: F/W SHOWN
T.T. AND MOTORIZED SIMILAR
