NEWMAR CORPORATION WARRANTY DEPARTMENT

TECHNICAL SERVICE BULLETIN							
DATE ISSUED	MODEL YEAR(S) AFFECTED	MODEL(S) AFFECTED	TSB #				
12/7/92	1992-1993	ALL	68				
BRAND		TYPE					
All <input checked="" type="checkbox"/>	American Star <input type="checkbox"/>	Kountry Star <input type="checkbox"/>	Dutch Star <input type="checkbox"/>	All <input checked="" type="checkbox"/>	T T <input type="checkbox"/>	F W <input type="checkbox"/>	
NewAire <input type="checkbox"/>	Mountain Aire <input type="checkbox"/>	Kountry Aire <input type="checkbox"/>	London Aire <input type="checkbox"/>	C A <input type="checkbox"/>	D P <input type="checkbox"/>	D B <input type="checkbox"/>	
<input type="checkbox"/> Air Conditioning & Heating				<input checked="" type="checkbox"/> Electrical Components			
<input type="checkbox"/> Appliances & Accessories				<input type="checkbox"/> Exterior Components			
<input type="checkbox"/> Cabinets & Furniture				<input type="checkbox"/> Interior Components

Winegard
F.Y.I.

November 1992

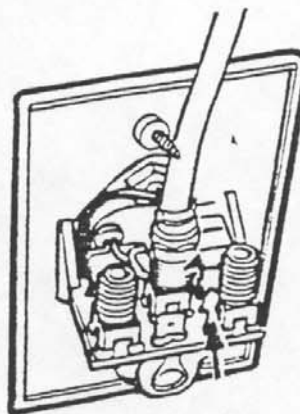
Problem: The customer complains of poor reception when the on/off switch is in the "cable" position. The mounting screws supplied with the RV-0710/0731/0741/7010/7031 may be too long. The mounting screw may have penetrated the coax cable when installing unit in wall. This problem began with a design revision in October 1992 when the fuse was removed and jack configuration changed.

Solution: Back out the 1" top screw and either cut off 3/8" or replace with our part no. 2160145 ivory, 2160146 brown or 2160147 white. These replacement screws are available at no charge upon request. New production (begun 11/23/92) will be using shorter length screws. Cable should be replaced.
