# NEWMAR CORPORATION WARRANTY DEPARTMENT

TECHNICAL SERVICE BULLETIN						
DATE ISSUED	MODEL YEAR(S) AFFECTED	MODEL(S) AFFECTED	TSB #			
3/26/93	1992-1993	ALL	74			
BRAND		TYPE				
All <input type="checkbox"/>	American Star <input type="checkbox"/>	Kountry Star <input checked="" type="checkbox"/>	Dutch Star <input checked="" type="checkbox"/>	All <input type="checkbox"/>	T T <input type="checkbox"/>	F W <input type="checkbox"/>
NewAire <input type="checkbox"/>	Mountain Aire <input type="checkbox"/>	Kountry Aire <input type="checkbox"/>	London Aire <input checked="" type="checkbox"/>	C A <input type="checkbox"/>	D P <input checked="" type="checkbox"/>	D B <input type="checkbox"/>
<input type="checkbox"/> Air Conditioning & Heating				<input type="checkbox"/> Electrical Components		
<input type="checkbox"/> Appliances & Accessories				<input checked="" type="checkbox"/> Exterior Components		
<input type="checkbox"/> Cabinets & Furniture				<input type="checkbox"/> Interior Components

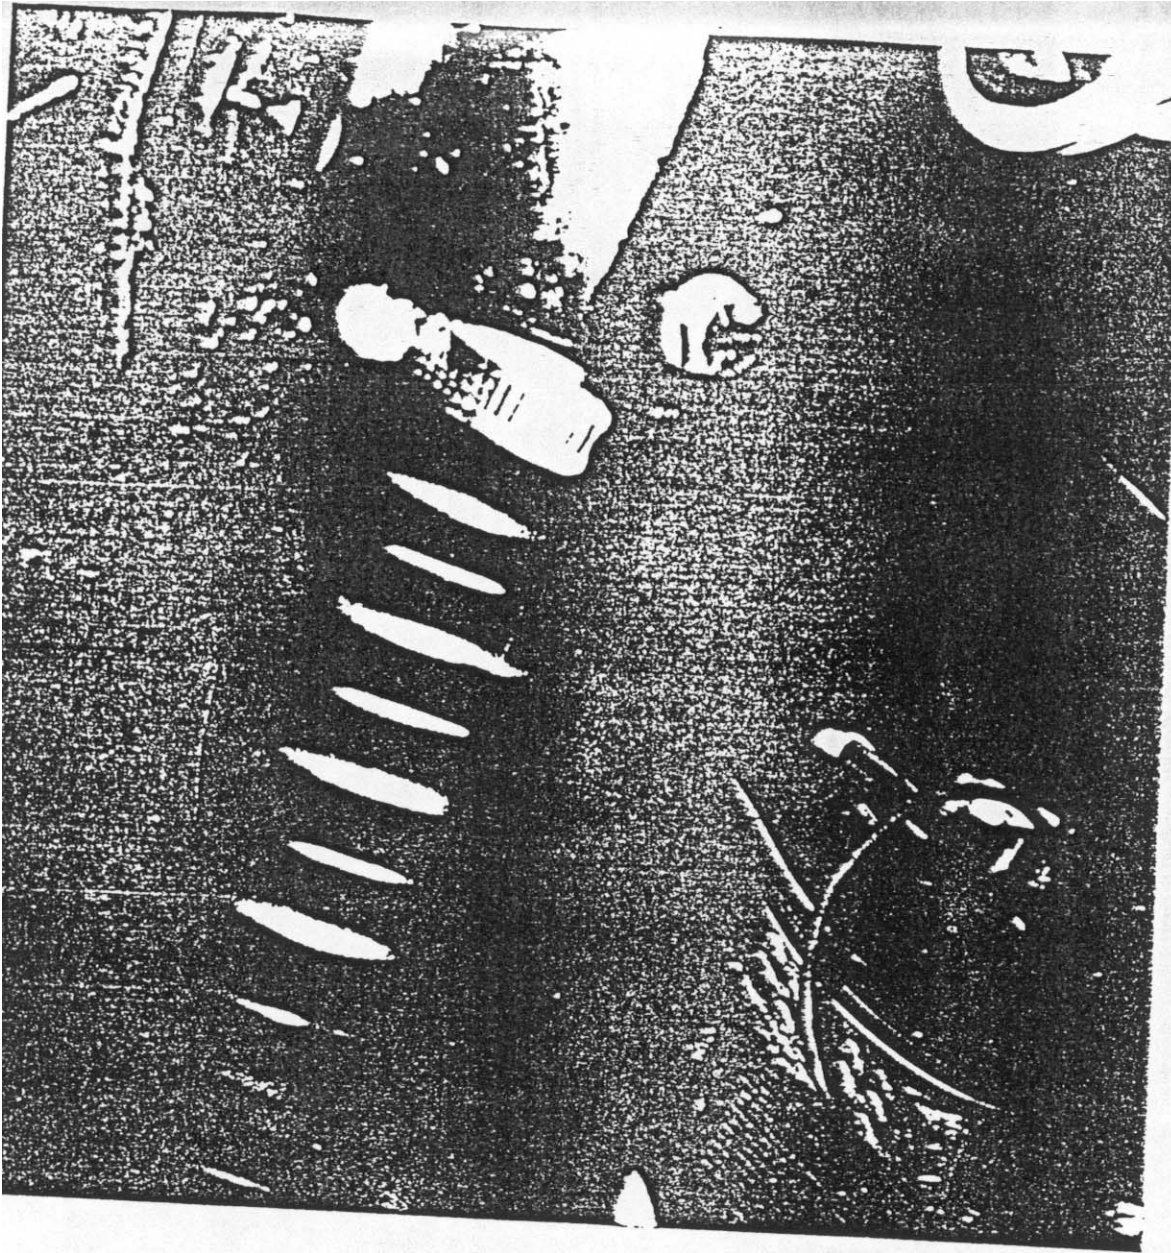
<input type="checkbox"/> Chassis Components				<input type="checkbox"/> Plumbing & Bath Components		
<input type="checkbox"/> Construction Components				<input type="checkbox"/> Windows, Awnings, Vents, & Doors		
DESCRIPTION OF PROBLEM						
Rubber steering shaft cover binding up on steering shaft.						
RECOMMENDED SOLUTION						
Check to see if the rubber cover has a clamp installed on it, per the attached picture. This will be under the vinyl cover. If this clamp is not on the cover, it must be installed. Newmar will pay .5 to add clamp. If you have any questions on this, contact your service representative.
