NEWMAR CORPORATION WARRANTY DEPARTMENT

TECHNICAL SERVICE BULLETIN									
DATE ISSUED		MODEL YEAR(S) AFFECTED			MODEL(S) AFFECTED			TSB #	
11/1/93		1992-1994			Diesel Pushers			88	
BRAND					TYPE				
All <input type="checkbox"/>	American Star <input type="checkbox"/>	Kountry Star <input checked="" type="checkbox"/>	Dutch Star <input type="checkbox"/>	All <input type="checkbox"/>	T T <input type="checkbox"/>	F W <input type="checkbox"/>			
NewAire <input type="checkbox"/>	Mountain Aire <input type="checkbox"/>	Kountry Aire <input type="checkbox"/>	London Aire <input checked="" type="checkbox"/>	C A <input type="checkbox"/>	D P <input checked="" type="checkbox"/>	D B <input type="checkbox"/>			
<input type="checkbox"/> Air Conditioning & Heating					<input type="checkbox"/> Electrical Components				
<input type="checkbox"/> Appliances & Accessories					<input checked="" type="checkbox"/> Exterior Components				
<input type="checkbox"/> Cabinets & Furniture					<input type="checkbox"/> Interior Components

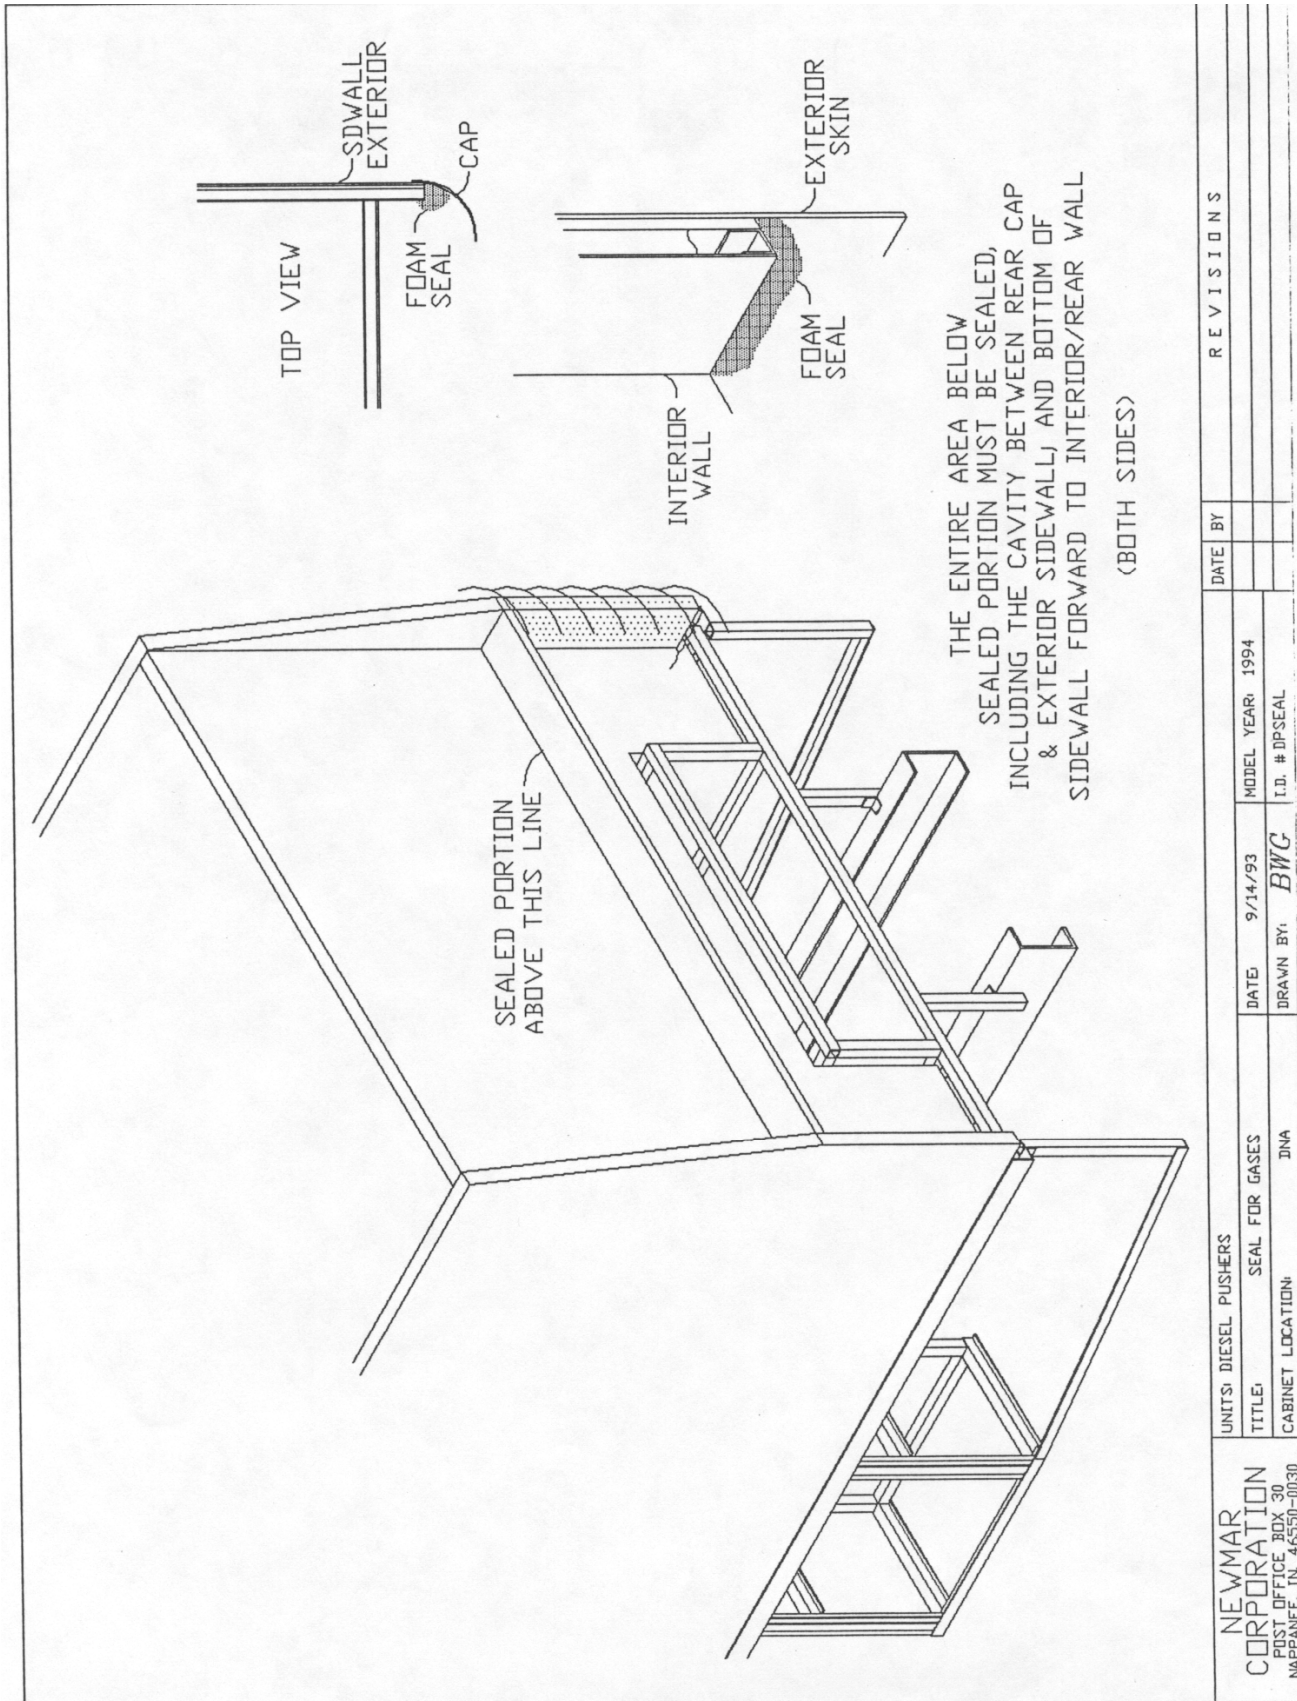
<input type="checkbox"/> Chassis Components					<input type="checkbox"/> Plumbing & Bath Components				
<input type="checkbox"/> Construction Components					<input type="checkbox"/> Windows, Awnings, Vents, & Doors				
DESCRIPTION OF PROBLEM									
Back engine compartment not sealed off on both sides.									
RECOMMENDED SOLUTION									
Reseal both sides of engine compartment per print. Reseal with spray foam, which can be purchased through the Newmar Parts Department. Newmar will pay up to two hours for repair.
