NEWMAR CORPORATION WARRANTY DEPARTMENT

TECHNICAL SERVICE BULLETIN						
DATE ISSUED	MODEL YEAR(S) AFFECTED	MODEL(S) AFFECTED	TSB #			
6/3/88	ALL	ALL	9			
BRAND		TYPE				
All <input checked="" type="checkbox"/>	American Star <input type="checkbox"/>	Kountry Star <input type="checkbox"/>	Dutch Star <input type="checkbox"/>	All <input type="checkbox"/>	T T <input type="checkbox"/>	F W <input type="checkbox"/>
NewAire <input type="checkbox"/>	Mountain Aire <input type="checkbox"/>	Kountry Aire <input type="checkbox"/>	London Aire <input type="checkbox"/>	C A <input checked="" type="checkbox"/>	D P <input checked="" type="checkbox"/>	D B <input type="checkbox"/>
<input checked="" type="checkbox"/> Air Conditioning & Heating				<input type="checkbox"/> Electrical Components		
<input type="checkbox"/> Appliances & Accessories				<input type="checkbox"/> Exterior Components		
<input type="checkbox"/> Cabinets & Furniture				<input type="checkbox"/> Interior Components

<input type="checkbox"/> Chassis Components				<input type="checkbox"/> Plumbing & Bath Components		
<input type="checkbox"/> Construction Components				<input type="checkbox"/> Windows, Awnings, Vents, & Doors		
DESCRIPTIO

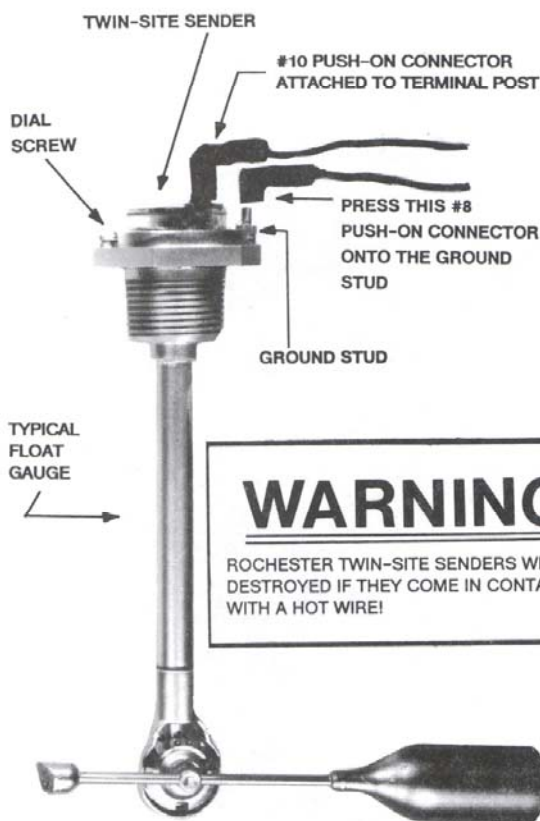
INSTRUCTIONS FOR CONNECTING A 0-90 OHM TWINSITE SENDER ON A VERTICAL DOT TANK TO A MATCHING PANEL RECEIVER IN YOUR RECREATIONAL VEHICLE

The most common causes of malfunction are defective wiring and loose grounds. Always check these areas first.

If the panel receiver reading is inconsistent with the reading on the Twin-Site sender, use an ohmmeter to verify that the receiver resistance is 0-90 ohms.

PANEL Receiver Shows	Look for this trouble
NO INDICATION	1. Empty fuel tank 2. No current from battery because of broken or disconnected wire. 3. Grounded wire between sender and receiver 4. Receiver not grounded 5. Sender defective 6. Panel receiver defective
ERRATIC READING	1. Loose connection 2. Defective sender
"FULL" SCALE READING AT ALL TIMES	1. Wire from sender broken 2. Sender not properly grounded, tank not grounded 3. Defective sender
INDICATES INACCURATELY	1. Defective sender or tank gauge 2. Receiver incompatible with sender, or vice versa

- 1) Disconnect battery cable.
- 2) Using the #10 push-on connector supplied, and a well-insulated #16 wire, connect the terminal post on the Twin-Site sender to the sender terminal on the panel receiver.
- 3) Install the double-ended ground stud in one of the dial screw holes. Then attach the #8 push-on connector to it. Run the #16 wire attached to the connector to the vehicle frame and ground it securely.
- 4) Using additional #16 wire, make the ground connection from the negative terminal of the panel receiver to the battery or frame.
- 5) Using additional #16 wire, connect the battery to the positive terminal on the panel receiver.
- 6) Reconnect the battery cable

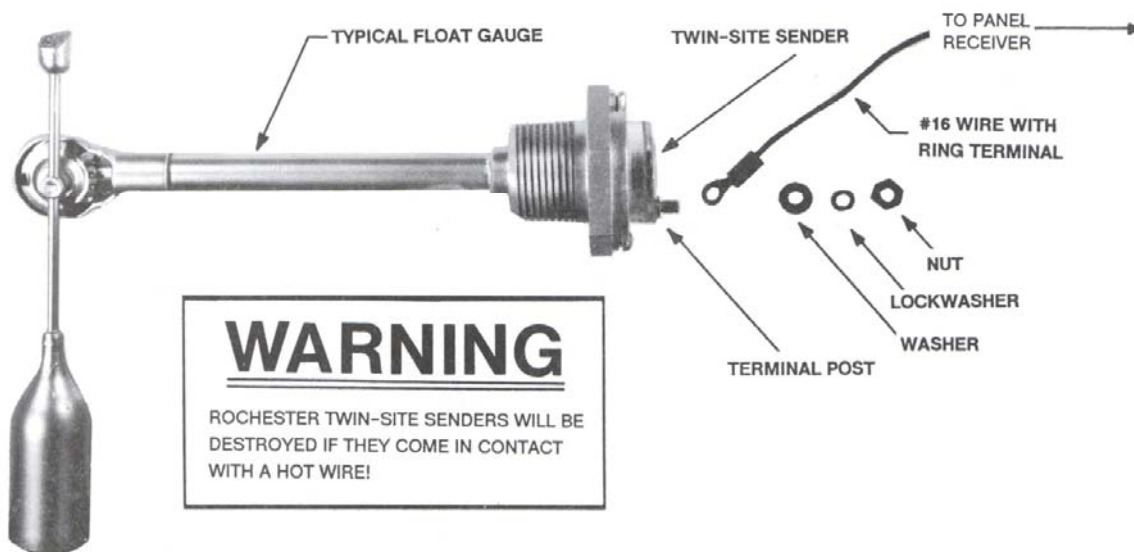
INSTRUCTIONS FOR CONNECTING A 0-90 OHM #5109S00801 TWINSITE SENDER ON A HORIZONTAL ASME TANK TO A MATCHING PANEL RECEIVER IN YOUR RECREATIONAL VEHICLE

The most common causes of malfunction are defective wiring and loose grounds. Always check these areas first.

If the panel receiver reading is inconsistent with the reading on the Twin-Site sender, use an ohmmeter to verify that the receiver resistance is 0-90 ohms.

PANEL Receiver Shows	Look for this trouble
NO INDICATION	1. Empty fuel tank 2. No current from battery because of broken or disconnected wire. 3. Grounded wire between sender and receiver 4. Receiver not grounded 5. Sender defective 6. Panel receiver defective
ERRATIC READING	1. Loose connection 2. Defective sender
"FULL" SCALE READING AT ALL TIMES	1. Wire from sender broken 2. Sender not properly grounded, tank not grounded 3. Defective sender
INDICATES INACCURATELY	1. Defective sender or tank gauge 2. Receiver incompatible with sender, or vice versa

- 1) Disconnect the battery cable.
- 2) Using a well-insulated #16 wire, connect the terminal post on the Twin-Site sender to the sender terminal on the panel receiver, securing both ends with the nuts and lockwashers provided.
- 3) Using the same type wire, establish a ground connection from the negative terminal on the panel receiver to the frame.
- 4) Using the same type wire, connect the battery to the positive terminal on the panel receiver.
- 5) Finally, reconnect the battery cable.
