# NEWMAR CORPORATION WARRANTY DEPARTMENT

TECHNICAL SERVICE BULLETIN						
DATE ISSUED	MODEL YEAR(S) AFFECTED		MODEL(S) AFFECTED		TSB#	
3/9/94 1993-1994			All		90	
BRAND			Түре			
All Americ	can Star 🛭 Kountry Star 🗷	Du	tch Star 🛚	All 🗖 T	T□ FW□	
NewAire □ Mountain Aire ■ Kountry Aire ■			ndon Aire□	C A ■ D	PD DBD	
☐ Air Conditioning & Heating			☐ Electrical Components			
☐ Appliances & Accessories			☐ Exterior Components			
☐ Cabinets & Furniture			☐ Interior Components			
☐ Chassis Components			☐ Plumbing & Bath Components			
■ Construction Components			☐ Windows, Awnings, Vents, & Doors			
DESCRIPTION OF PROBLEM  Batteries going dead on Class A motorhomes when unit is being stored.						
RECOMMENDED SOLUTION  Add relay per attached print and instructions. Relay may be purchased in the Newmar Parts Department. If						
	please contact a Newmar Servi			e Newmar Parts	Department. If

#### CORRECTION FOR GRANNING TAG AXLE UNITS

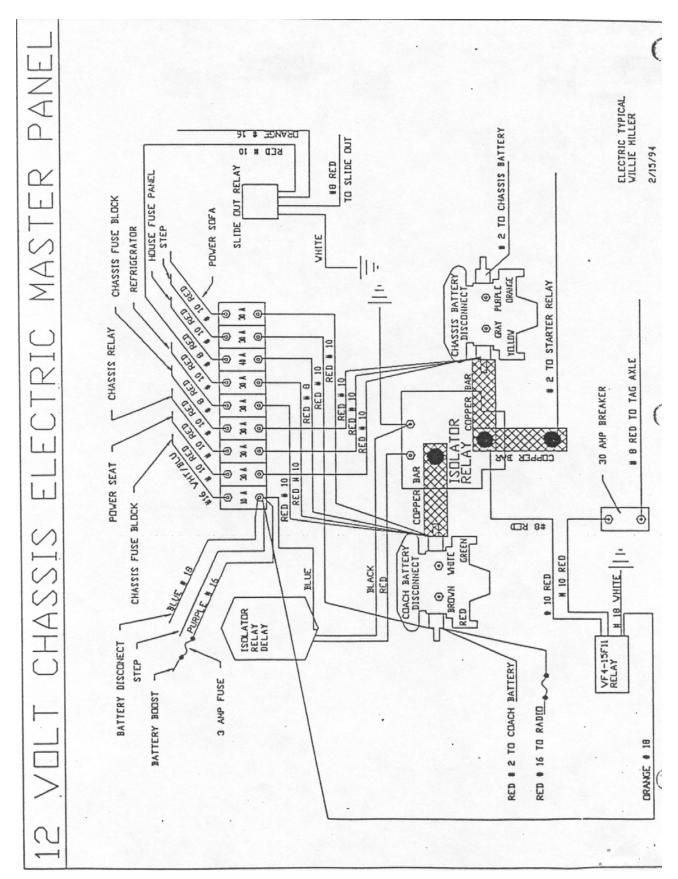
Recently several persons have had problems with the battery discharging while the unit is not in use and the temperature is below 40 degrees. The reason for the discharge is a moisture dryer that is in the compressor tank in the Granning air suspension system. The dryer is thermostatically activated at about 40 degrees. This dryer was accidently hooked up to a constant hot terminal instead of an ignition hot. Please follow these instructions to make the necessary correction to your unit. The correction will install an ignition activated relay between the power source and the dryer.

- 1. Remove the clear plastic cover on the 12 volt junction box in the front compartment of the motor home.
- 2. Disconnect the #8 red wire that feeds the tag axle components from the terminal post on the mini breaker.
- 3. Connect one of the red wires from the relay to the terminal that the #8 wire in step one was connected to.
- 4. Connect the other red wire from the relay to the #8 red wire that feeds the tag axle components. (the wire removed from the terminal in step one)
- 5. Attach the white wire from the relay to a solid ground to the chassis.
- 6. Attach the orange wire to the ignition hot breaker in the junction box.
- 7. Reattach the plastic cover to the 12 volt junction box.

The dryer will now receive power only when the ignition is in the on position.
