NEWMAR CORPORATION WARRANTY DEPARTMENT

TECHNICAL SERVICE BULLETIN									
DATE ISSUED		MODEL YEAR(S) AFFECTED			MODEL(S) AFFECTED			TSB #	
3/9/94		1993-1994			All			91	
BRAND						TYPE			
All <input type="checkbox"/>		American Star <input type="checkbox"/>	Kountry Star <input type="checkbox"/>	Dutch Star <input type="checkbox"/>	All <input checked="" type="checkbox"/>		T T <input type="checkbox"/>	F W <input type="checkbox"/>	
NewAire <input type="checkbox"/>		Mountain Aire <input checked="" type="checkbox"/>	Kountry Aire <input checked="" type="checkbox"/>	London Aire <input checked="" type="checkbox"/>	C A <input type="checkbox"/>		D P <input type="checkbox"/>	D B <input type="checkbox"/>	
<input checked="" type="checkbox"/> Air Conditioning & Heating					<input type="checkbox"/> Electrical Components				
<input type="checkbox"/> Appliances & Accessories					<input type="checkbox"/> Exterior Components				
<input type="checkbox"/> Cabinets & Furniture					<input type="checkbox"/> Interior Components

Motor Assembly-Fuse
Models Affected-SF-42
and SF-42F Furnaces

TSI: RV94-357

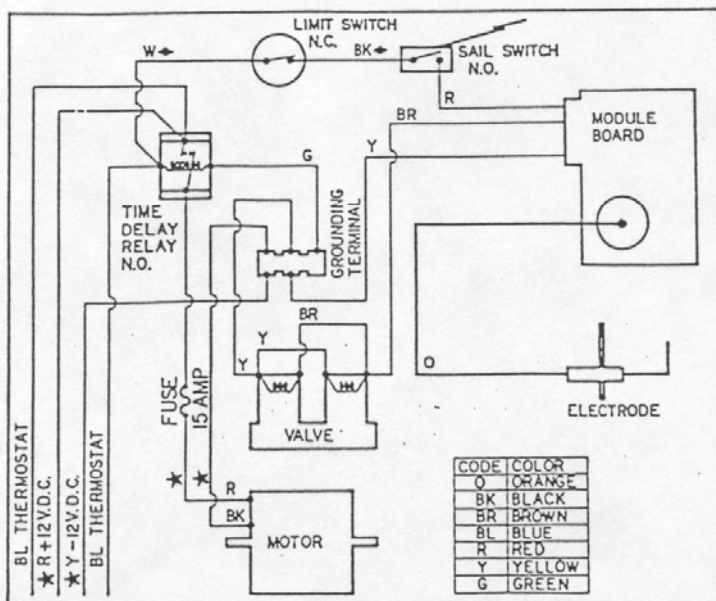
Effective immediately, motors on furnace models SF-42 and SF-42F beginning on serial number 940101886 are protected by an external (15) amp fuse in the positive leg of the motor circuit. This fuse provides overload protection and is an alternative to the built-in internal overload supplied with all other Suburban furnace motors. This change is limited to the "42" model due to a new motor supplier. The wiring diagram below shows the fuse and location. Please contact the factory Service Department if you have any questions, phone 615-775-2131.

<input type="checkbox"/> Chassis Components					<input type="checkbox"/> Plumbing & Bath Components				
<input type="checkbox"/> Construction Components					<input type="checkbox"/> Windows, Awnings, Vents, & Doors				
DESCRIPTION OF PROBLEM									
Adding 15 amp fuse to Suburban SF 42 & SF 42F.									
RECOMMENDED SOLUTION									
Suburban has added 15-amp fuse to add to the protection for overload. Refer to Suburban Service Bulletin, which is attached, for fuse location.
