TECHNICAL SERVICE BULLETIN

DATE ISSUED	MODEL YEAR(S) AFFECTED	TSB #
09/29/2014	2014 & 2015 Dutch Star DP	Recall # 14V-485 TSB 410

CORRECTIVE ACTION FOR DSDP HEADLIGHT HARNESS

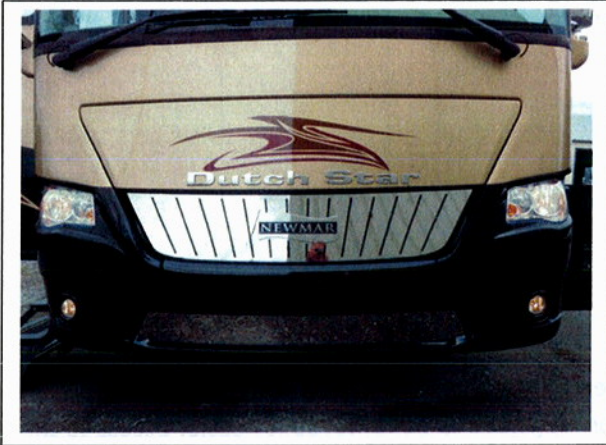
1. Turn on the lo-beam headlights and fog lights. Verify that both Left and Right lights are on. Turn off headlights and fog lights.

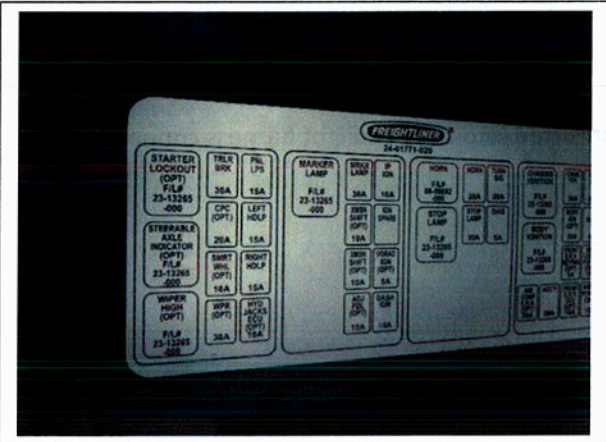
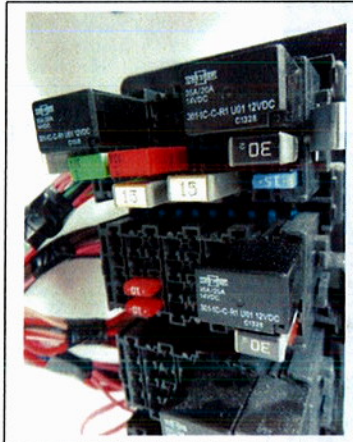
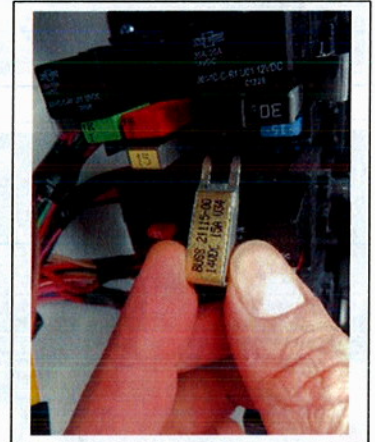
2. Locate the Left Headlight 15 Amp circuit breaker (CB) and remove it from the fuse panel. Turn on the lo-beam headlights and fog lights. If both Left and Right lights are on, the unit needs corrective action. If only the Right lights are on, no further action is needed. Turn off headlight and fog lights. Replace CB in the fuse panel.

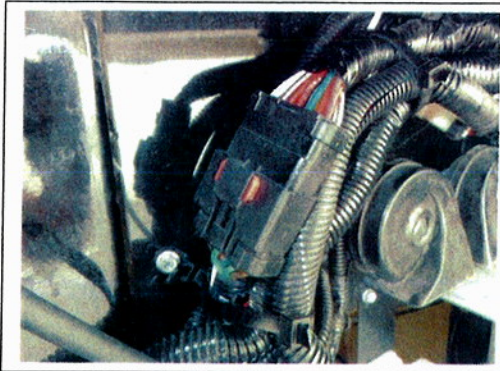
1. Locate where the headlight harness mates with the chassis harness behind the front hood door.

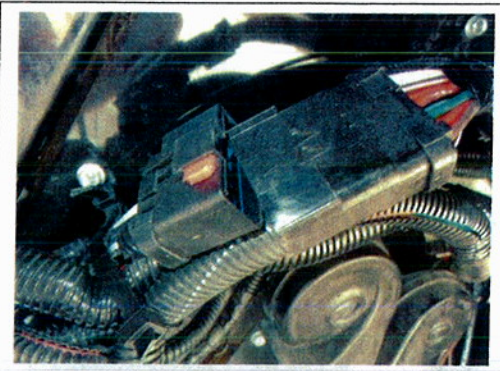
2. Disconnect the headlight harness connector from the chassis harness. Tie wraps may need to be removed for easier access to the headlight harness connector.

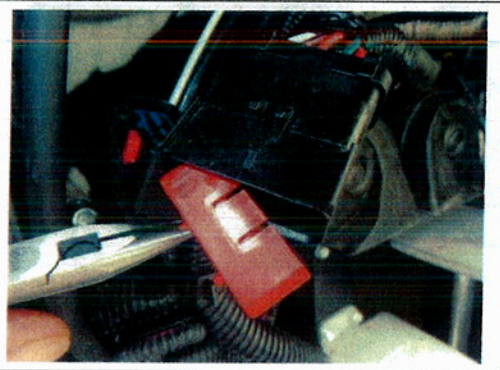
3. Remove the TPA inserted into the headlight harness connector.

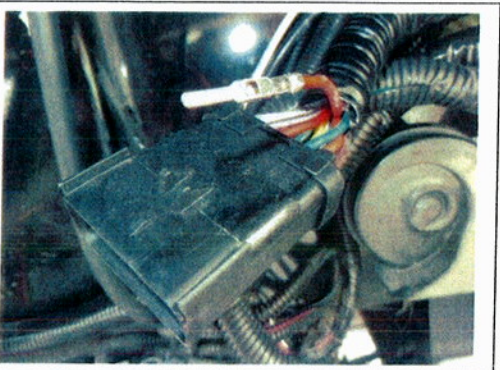
4. Remove 6 pins from the headlight harness connector as follows:
 - a. Pin 3 – 065 RED/BLK (Left Low-Beam)
 - b. Pin 4 – 067 RED/BLK (Right Lo-Beam)
 - c. Pin 6 – 069 RED (Right Fog)
 - d. Pin 10 – 064 GRN/BLK (Left Hi-Beam)
 - e. Pin 11 – 066 GRN/BLK (Right Hi-Beam)
 - f. Pin 13 – 068 RED (Left Fog)

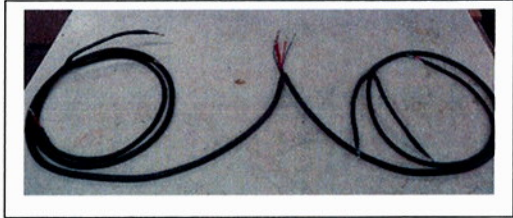
5. Acquire auxiliary headlight harness (NM P/N: 127676) to run parallel with the headlight harness. The shorter end runs to the left side and the longer end runs to the right side.

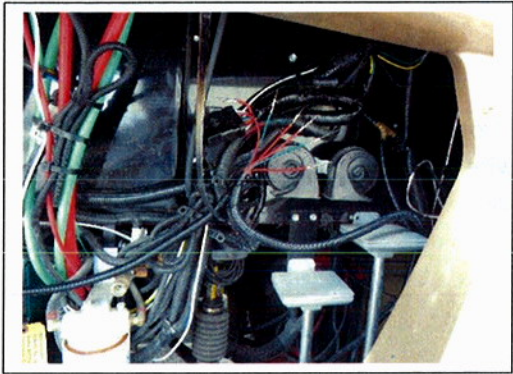
6. Loosely install and route the auxiliary harness along the headlight harness.

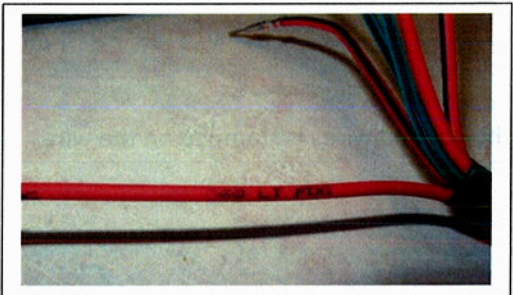
7. Identify each of the six wires with terminals at the center of the auxiliary harness. Each wire is stamped with the circuit name as shown above in Step #4.

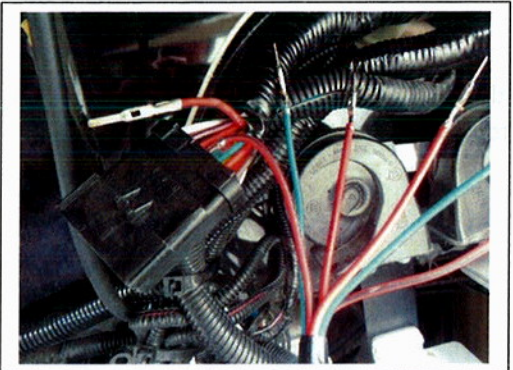
8. Insert the terminal of each wire of the auxiliary harness into its corresponding pin location of the harness connector.

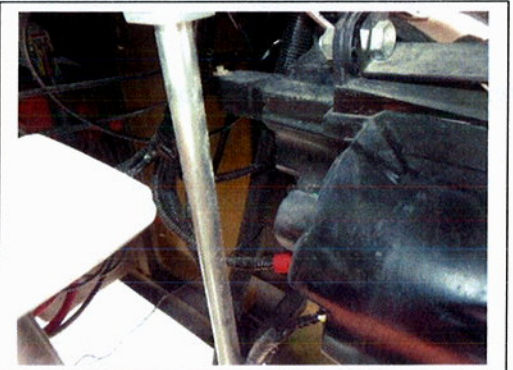
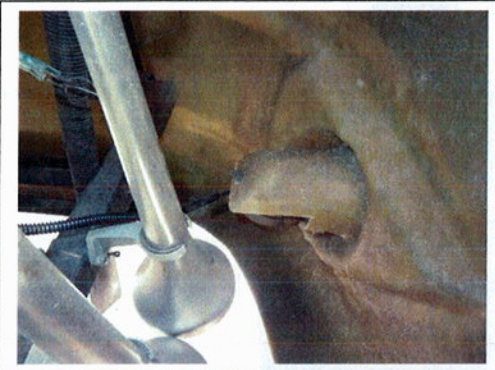
9. Locate the headlight and fog light fixtures on the left side of the unit.

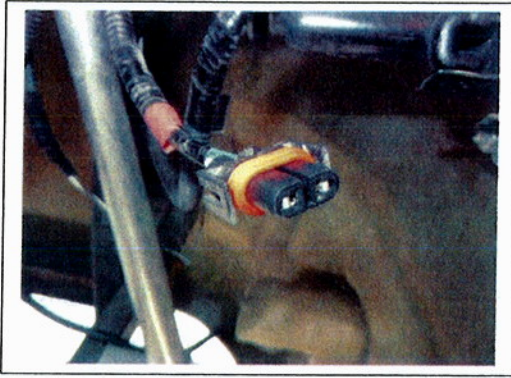
10. Remove the harness connectors that plug into the Lo-Beam, Hi-Beam and Fog lights.

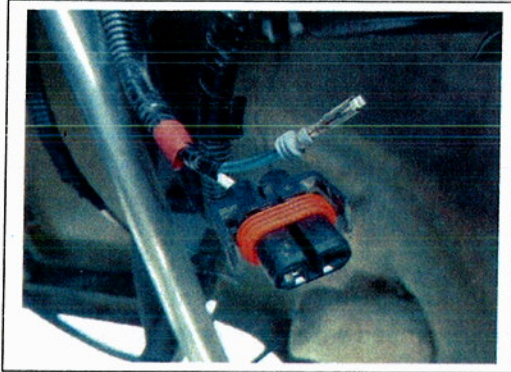
11. Remove the colored wire from each of the connectors as follows:

- Hi-Beam – GRN/BLK wire
- Lo-Beam – RED/BLK wire
- Fog light – RED wire

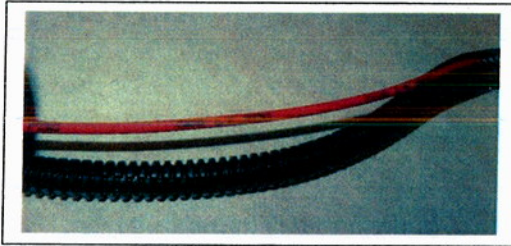
12. Identification for each of the colored wires is stamped on the wire.

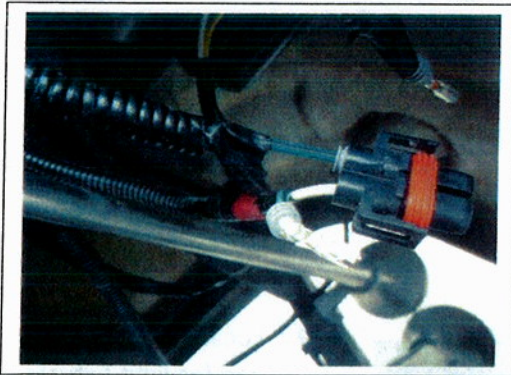
13. Insert the colored wire of the auxiliary harness into its corresponding connector for each light.

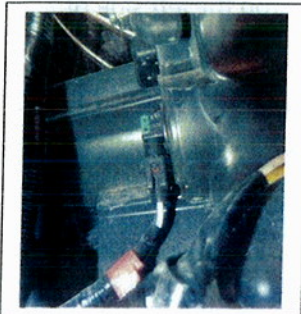
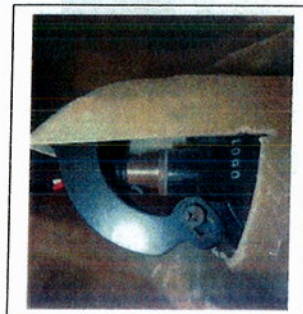
14. Reinstall the corresponding harness connectors to each of the lights.

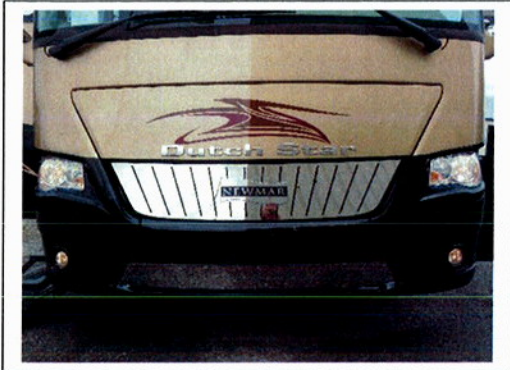
18. Turn on the lo-beam headlights and fog lights. Verify that both Left and Right lights are on. Turn off headlights and fog lights.

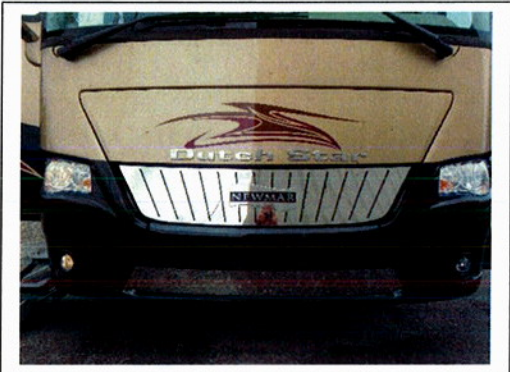
19. Locate and remove the Left Headlight 15 Amp CB from the fuse panel. Turn on the lo-beam headlights and fog lights. Verify that only the Right lights are on. Repeat for Hi-Beam lights. Turn off headlight and fog lights. Replace CB in the fuse panel.
