# Newmar Corporation

### Technical Service Bulletin

Date Issued	Model Year(s) Affected	TSB #
6/29/15	2016	424

## TSB 424 Instructions

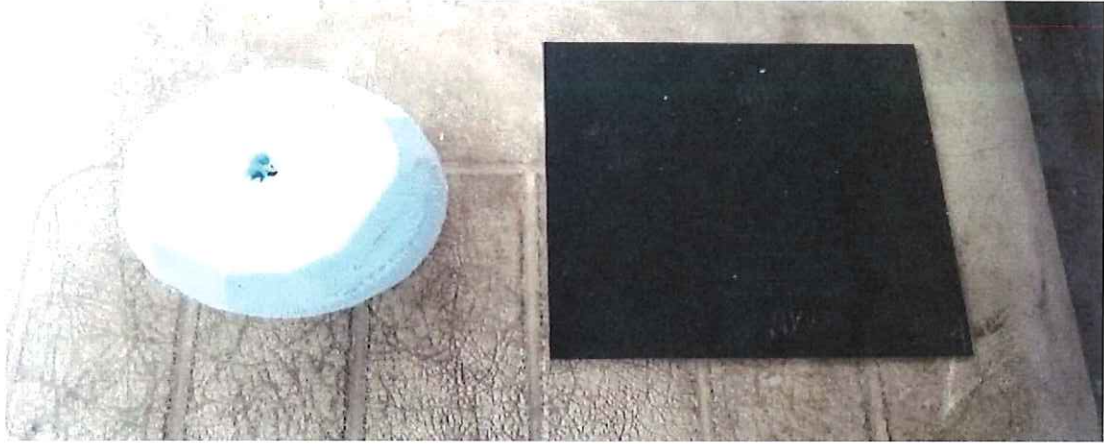
*Foam plug and black abs cover panel*

1. Using 5 ¼" hole saw cut a plug out of 2" dense Styrofoam. Then cut a square ( 6" x 6") piece of black abs plastic for cover, drill 1 hole in each corner for a screw to attach to ceiling.
2. Lower bedroom ceiling feature to access a/c discharge vents

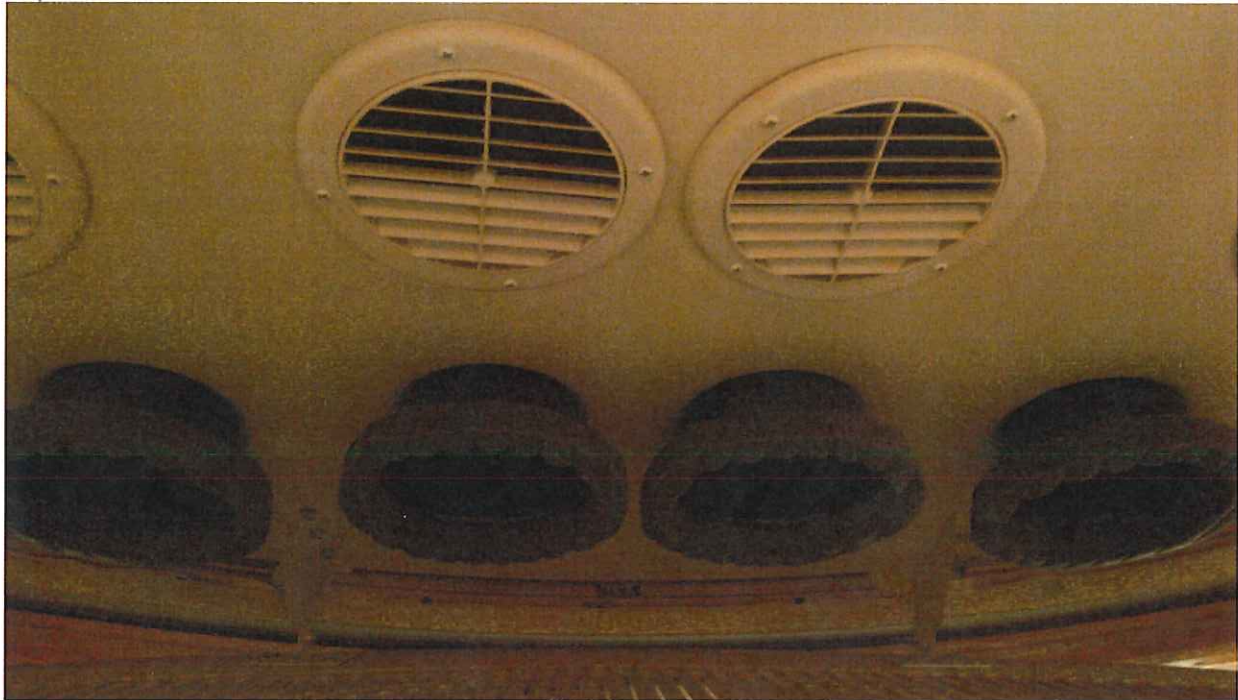
*Ceiling feature opened exposing discharge vents*

3. Remove discharge vent (third from front) with right-angle drill/ screw gun or right-angle attachment remove screws securing vent and discard.

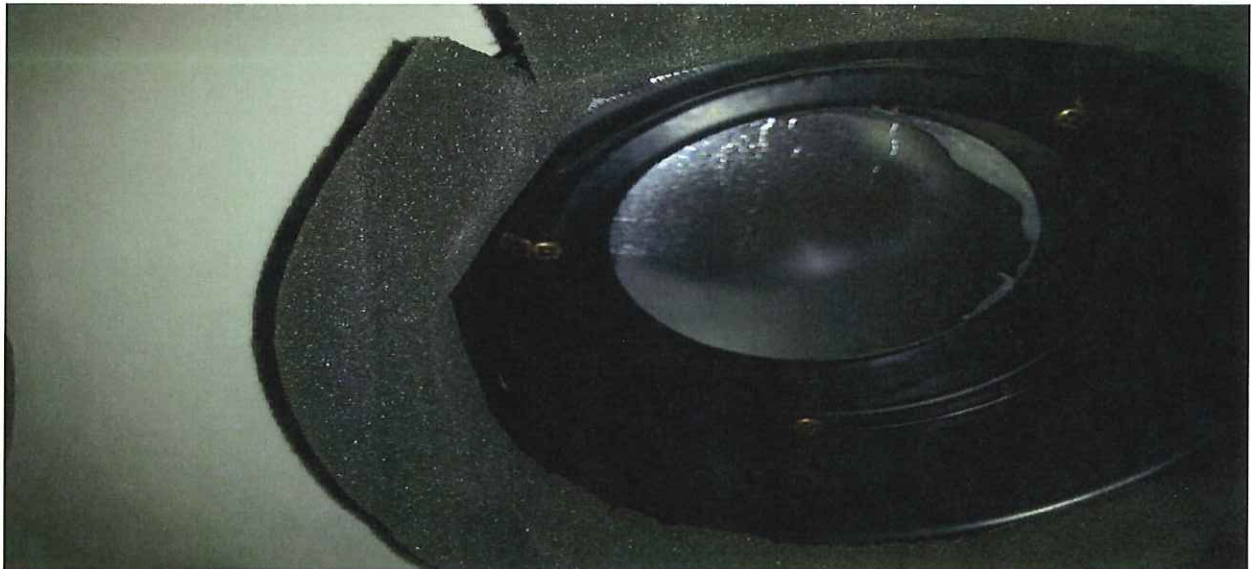
*Discharge vent showing screws to be removed*

4. Test Styrofoam, check for fit. Taper slightly if needed. Apply a bead of silicone to plug for sealing to duct. Insert into old discharge hole. Then secure abs cover over plug to ceiling.

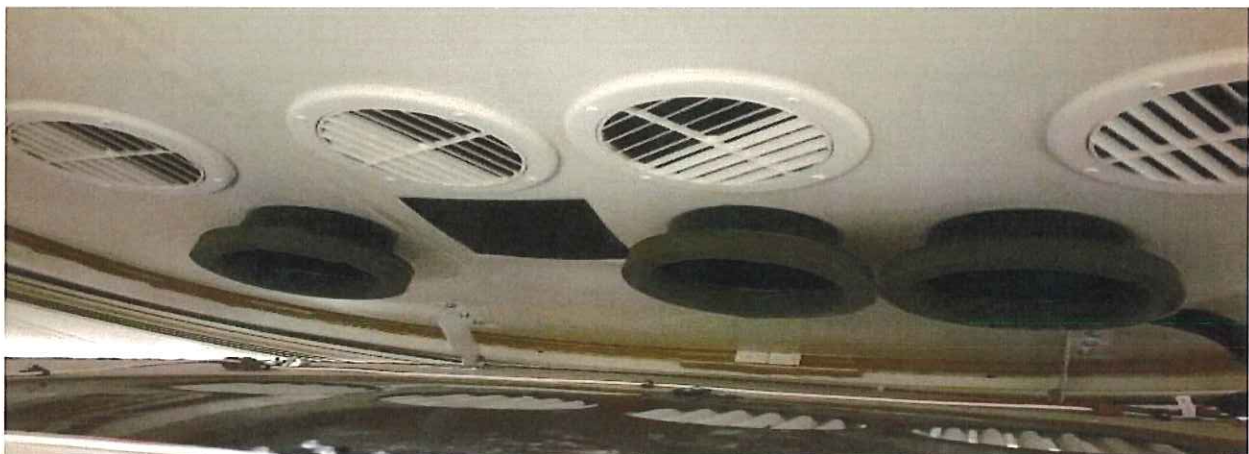
*Plug and abs cover installed*

4. Close and secure ceiling feature.
