NEWMAR CORPORATION

PRODUCT INFORMATION BULLETIN

2015 - 2016 ESSEX & KING AIRE

How to Reground a Shade Module

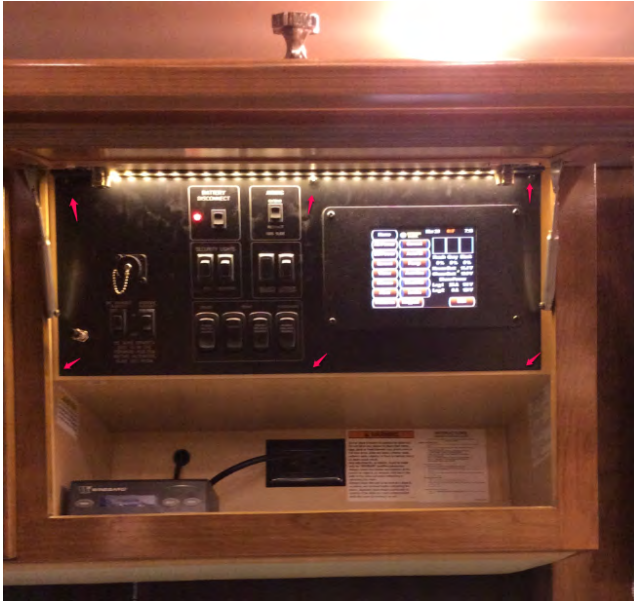
Front Overhead Cabinet

Locate the SilverLeaf display in the front overhead cabinet. Remove the screws and panel to provide easy access to the ground wire.

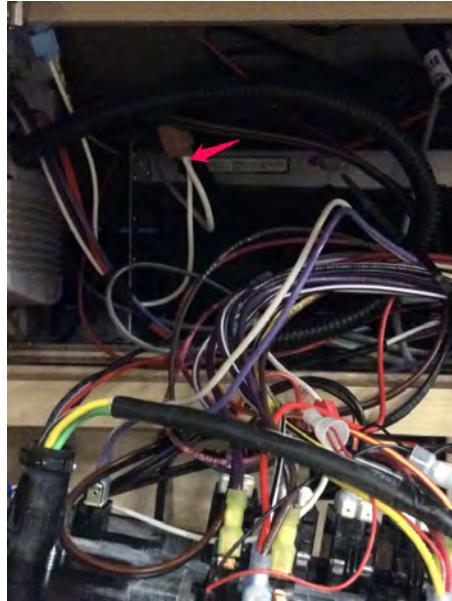
View from Behind the Panel

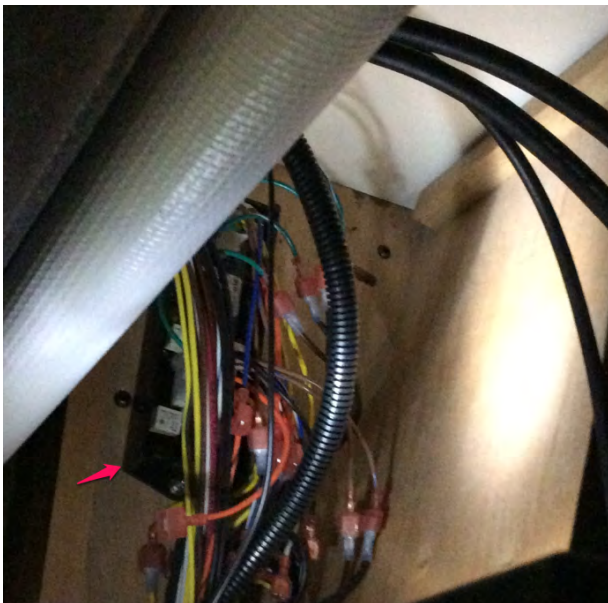
Shade Module Located Behind the Television on the Passenger Side

Find the white 12 gauge ground wire. Then, locate the shade modules and the ground wire to each shade module.

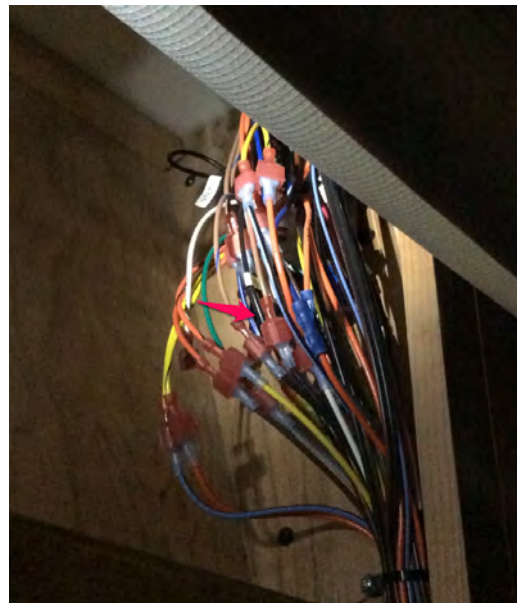
Shade Module Located Behind the Television on the Driver Side

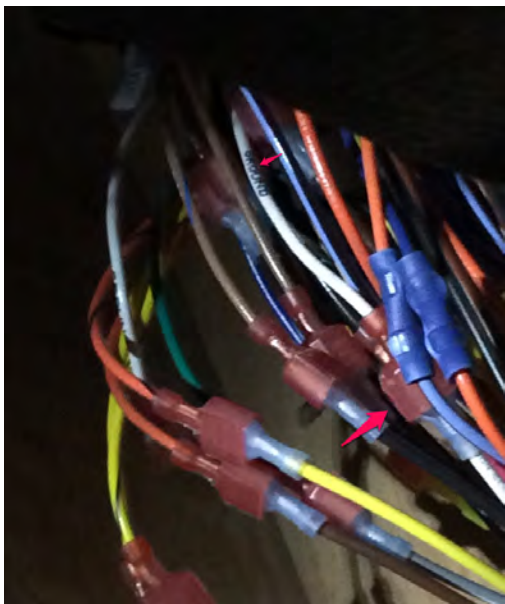
Shade Module Ground Wire

Install a new piece of 12 gauge wire, and connect it to the 12 gauge white ground wire located behind the overhead SilverLeaf panel. Unplug the existing ground wire and connect the new wire to each of the shade modules. Run the new wire across the back side of the cabinet using the existing holes (if applicable), and secure the wire if necessary.

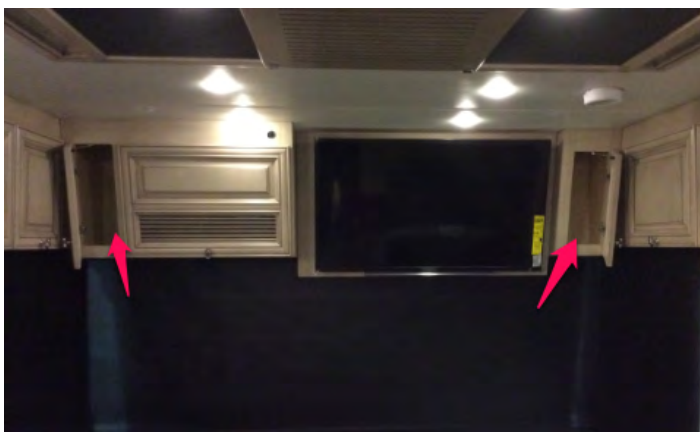
The shade modules may be located behind the television, behind a false panel in the side cabinets, or, on older coaches, in a false cabinet next to the front overhead television.

Possible Shade Module Locations
