NEWMAR CORPORATION WARRANTY DEPARTMENT

RECALL SERVICE BULLETIN

DATE ISSUED	MODEL YEAR(S) AFFECTED	RSB #
3/23/2017	2015-2017	463 Amended

How to Add the Ignition Lock Out Feature to a Power Wheelchair Door

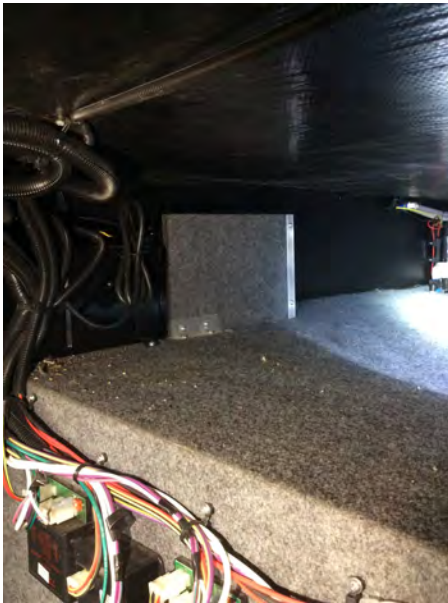
Remove the cover around the door control. The control assembly is usually located in one of the storage compartments near the handicap door and in front of the rear axle on the passenger side.

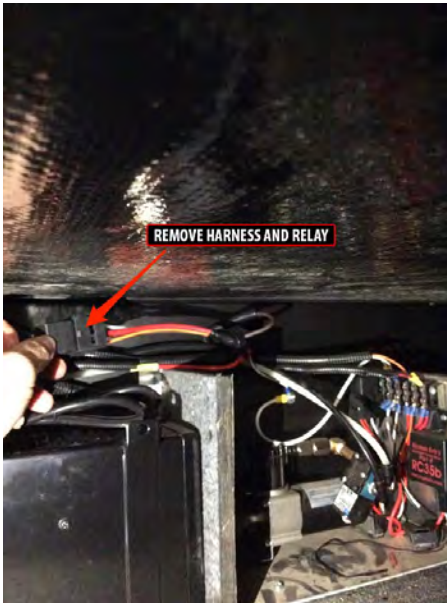
Remove relay and harness if needed.

If the coach has had a relay installed to interrupt the main power wire (as previously outlined in the prior recall instructions), then it will need to be removed to provide constant power to the terminal block. If the relay was not installed, skip the removal outlined below.

To remove it, disconnect the relay from the ground and ignition wire, and then reconnect the main power wire together with a yellow butt connector. Discard the previously installed relay and harness, then reconnect the power wire at the end of the following procedure.

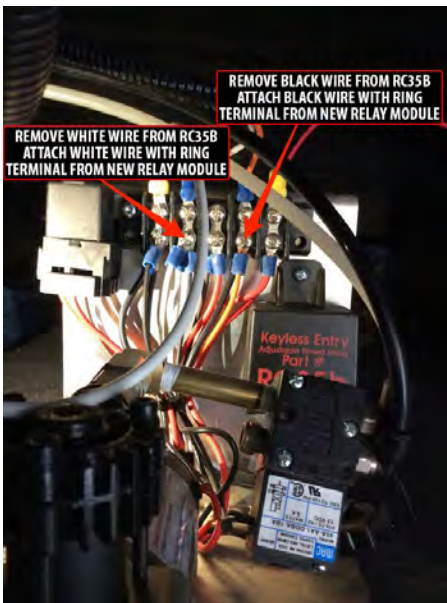
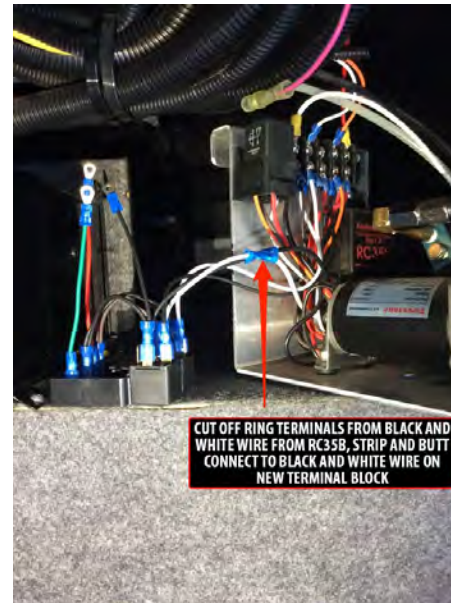
Install the new module.

Disconnect the black and white wires from the RC35B terminal block.

Cut the two ring terminals off of the black and white wire from the RC35B, and then strip them back.

Connect the black and white wires to the new relay with butt connectors (black-to-black and white-to-white).

Connect the black wire with a ring terminal from the new relay to the terminal block (where the black wire was previously removed).

Connect the white wire with a ring terminal from the new relay to the terminal block (where the white wire was previously removed).

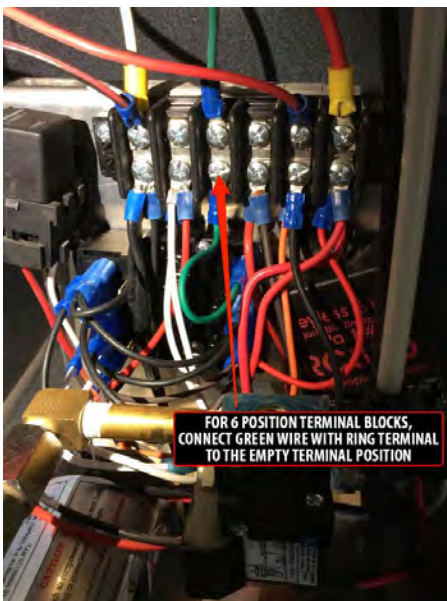
On coaches equipped with a 6-position terminal block, hook up the green wire to the open space in the terminal block.

Then hook up the green ignition wire to the top terminal in same space on the terminal block.

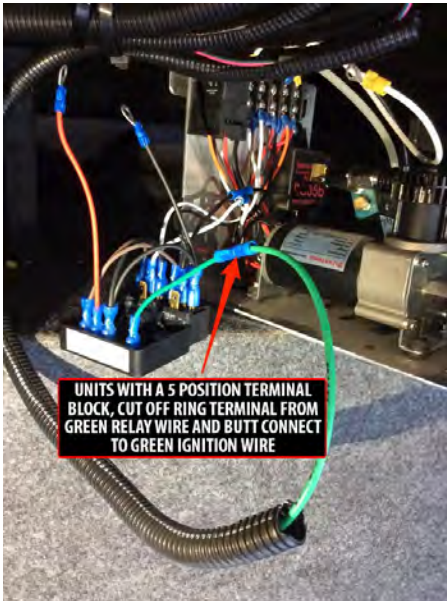
On coaches equipped with a 5-position terminal block, cut the ring terminal off the new relay. Then strip the insulation and connect it to the green wire using a blue butt connector.

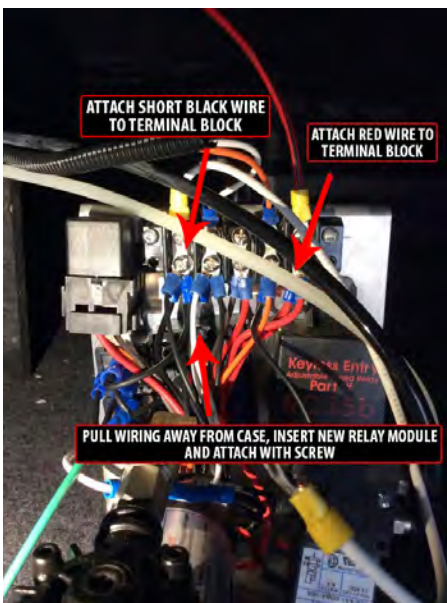
Move the wiring around, and install the new relay delay assembly against the metal housing under the terminal block.

Secure it with a one inch self-tapping screw, making sure you do not pinch the other wiring.

Hook up the red wire with a ring terminal from the new relay module to the red wire located at the terminal block connected to the main power wire.

Hook up the short black wire with ring terminal to the terminal position with ground wires.

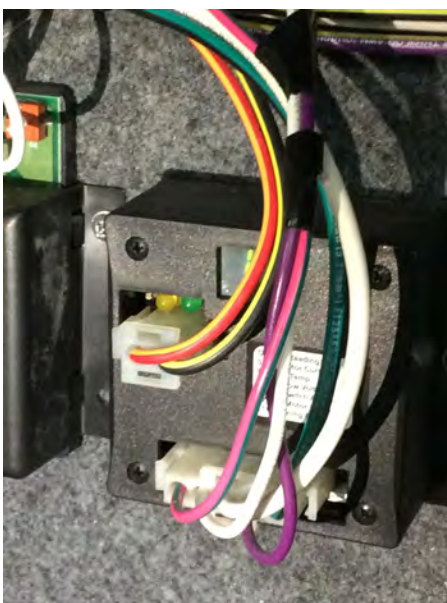
Locate the pink wire with a green stripe (ignition wire) connecting to the slideout modules nearby.

Trace the wire back in loom to find a convenient spot to connect the green wire from the terminal block or the green wire on the new delay module.

Modify the length of the green wire (if necessary). The length will depend on where you can attach it to the pink wire with the green stripe (ignition wire).

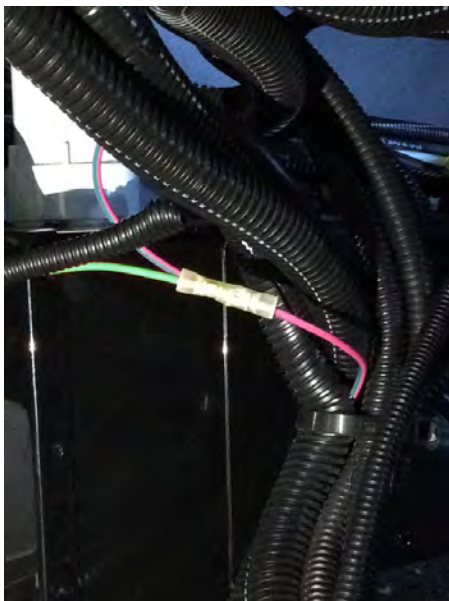
Cut the pink and green wire, and strip the insulation from both ends.

Use a yellow-to-blue butt connector to attach the green wire to the pink wire with green stripe wires.

Crimp two wires to the yellow side and one wire to the blue side.

Strap the green wire with loom when necessary.

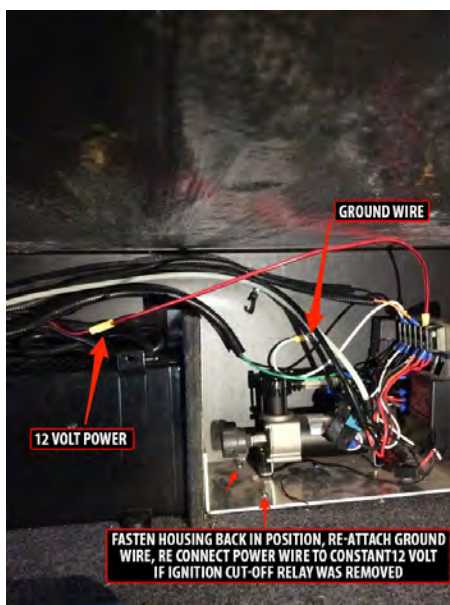
Place the control assembly back into position. Then refasten it with screws, and reattach the ground wire.

Connect power if it was disconnected during the relay and harness removal. If the relay and relay harness were removed in one of the beginning steps, reconnect the power wire. If you did not need to remove the relay and harness, the power wire should already be connected.

Loom, strap, and tape the wires and looms as needed.

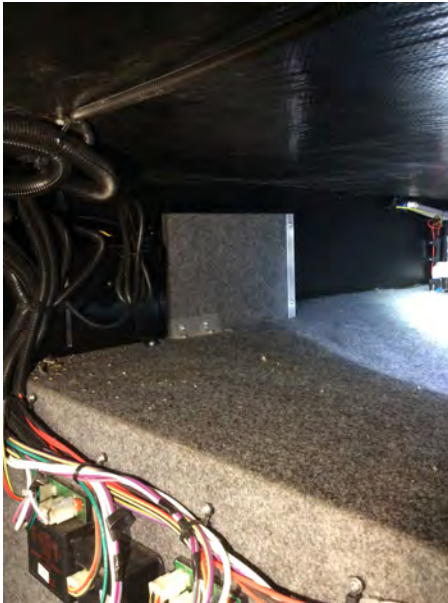
Test the operation of the power door and key fob with the key in the 'off' position. Make sure it works.

Test the operation of the power door and key fob with the key in the 'run' position. Make sure it does not work.

Test the delay function with the ignition on.

Then turn the ignition off, and press the unlock on the key fob as soon as you shut the key off. It should not open.

Press the unlock button over and over, ensuring that it does not open until after approximately 10 seconds. Then it should function normally until the ignition key is activated again.

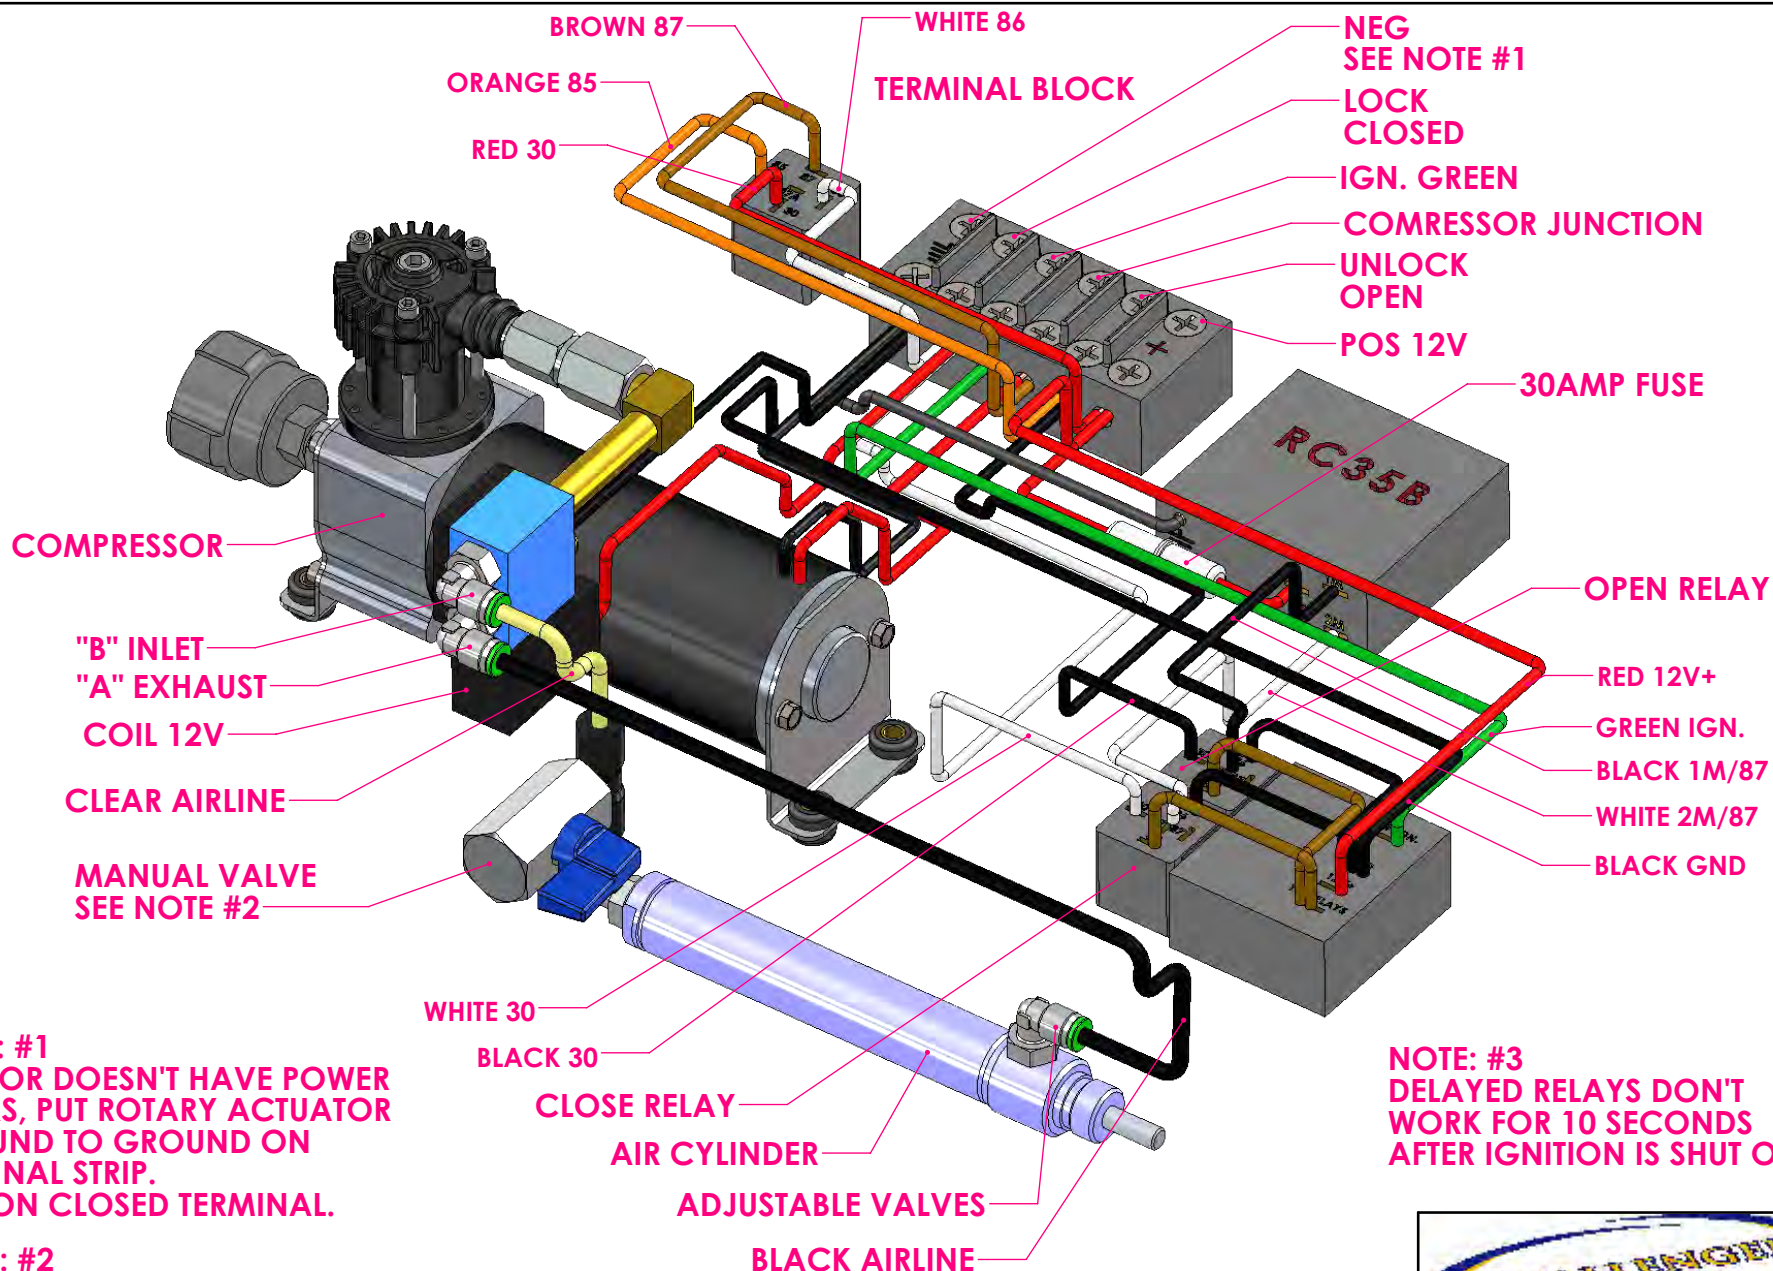
Wiring Diagram

NOTE: #1
IF DOOR DOESN'T HAVE POWER
LOCKS, PUT ROTARY ACTUATOR
GROUND TO GROUND ON
TERMINAL STRIP.
NOT ON CLOSED TERMINAL.

NOTE: #2
IF COMPRESSOR FAILS.
OPEN MANUAL VALVE,
TO ALLOW DOORS TO MOVE
MANUALLY.
(VALVE USUALLY IN STORAGE
COMPARTMENT)

NOTE: #3
DELAYED RELAYS DON'T
WORK FOR 10 SECONDS
AFTER IGNITION IS SHUT OFF.

DESCRIPTION
AIR SYSTEM WIRING
