# NEWMAR CORPORATION WARRANTY DEPARTMENT

## RECALL SERVICE BULLETIN

DATE ISSUED	MODEL YEAR(S) AFFECTED	RSB #
12/08/2016	2017	471
<b>BRAND</b>		
Bay Star Sport <input type="checkbox"/>	Ventana <input type="checkbox"/>	Essex <input checked="" type="checkbox"/>
Bay Star <input type="checkbox"/>	Dutch Star <input type="checkbox"/>	King Aire <input checked="" type="checkbox"/>
Canyon Star <input type="checkbox"/>	Mountain Aire <input type="checkbox"/>	Other <input type="checkbox"/>
Ventana LE <input type="checkbox"/>	London Aire <input checked="" type="checkbox"/>	
<b>DESCRIPTION</b>		
<p>Newmar Corporation has decided that a defect relating to motor vehicle safety exists in specific motorhomes. NHTSA # 16v 768 TC # 2016-524</p> <p><b>Issue:</b> On certain motorhomes, the HWH hydraulic entry step controller is not functioning as designed and may allow the step to retract unexpectedly in some circumstances with the entry door open. If the step controller is not operating as intended, it may increase the risk of an accident and/or injury.</p> <p><b>Correction:</b> Authorized Newmar service facilities will inspect the step and correct the controller with a software update when necessary.

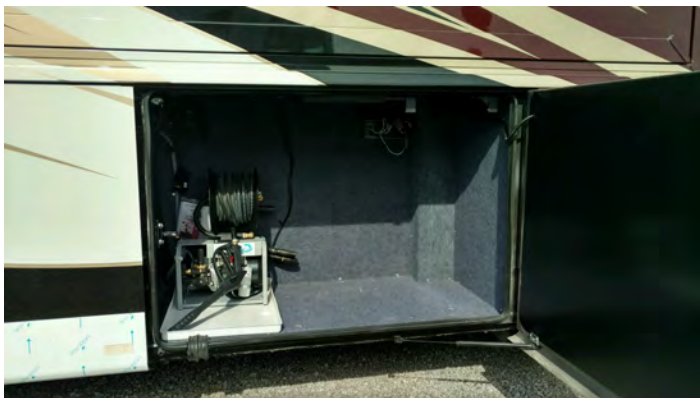
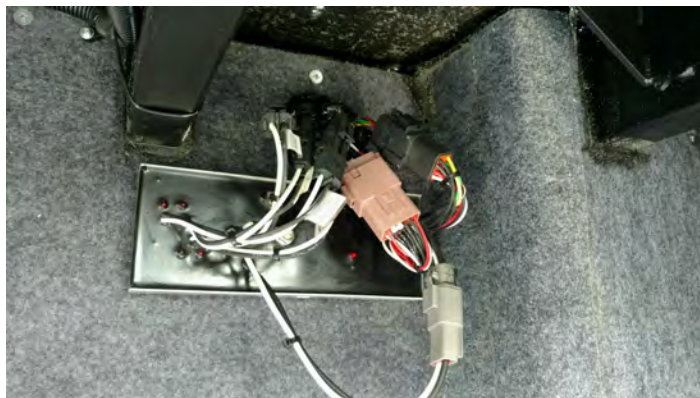
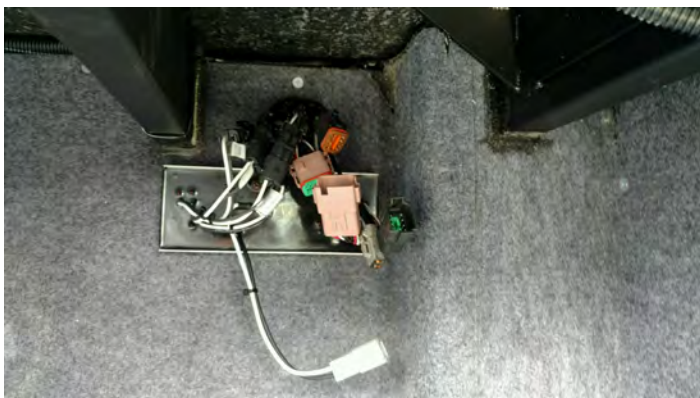
### Preparing for the Software Update

1. Make sure both house and chassis power is being supplied to the coach, and place the key ignition in the run position.
2. Locate the circuit board and power connectors in the upper corner of the first storage bay on the passenger side of the coach.
3. Unplug the two large connectors (one is black and one is tan), along with the smaller grey connector.

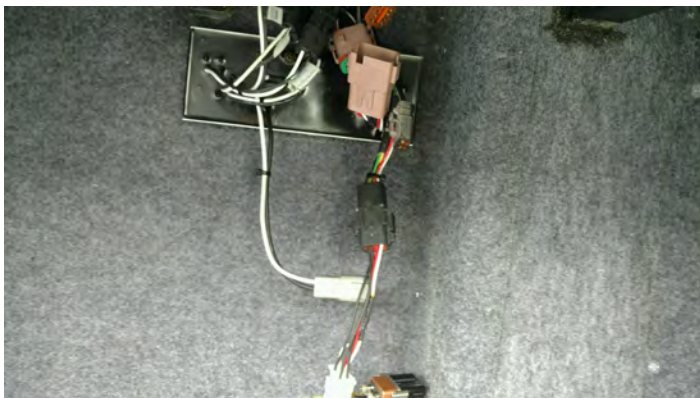
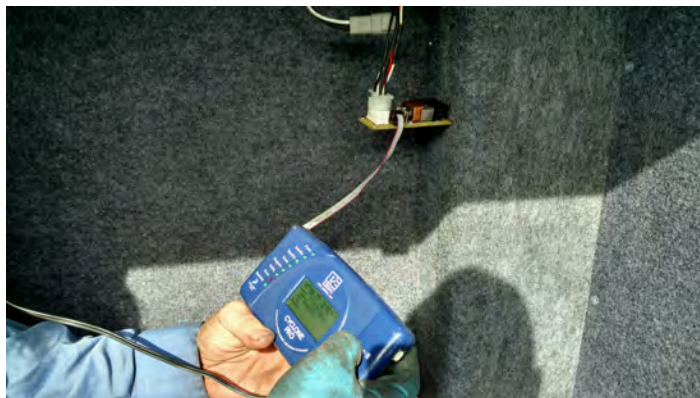
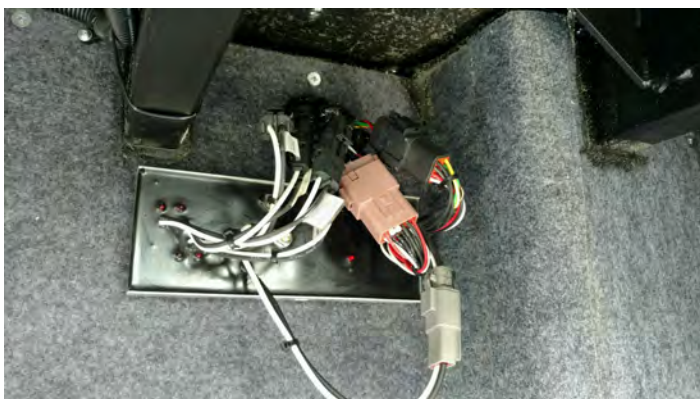
### Performing the Software Update

4. Plug the Step Module Programmer into the larger black connector to reset the system. Note: Use the 110 volt outlet in the bay compartment to supply power to the programmer.
5. Once the led indicates success the update is complete, plug in all of the connectors in their original locations.

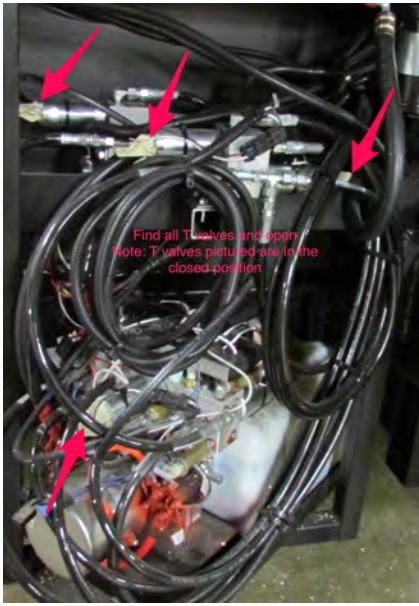
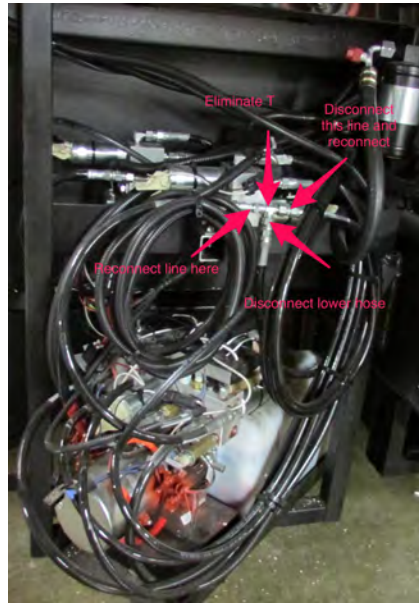
## Correcting the Hydraulic Plumbing Lines at the Front Lower Manifold

6. Open the generator door to access the HWH pump located on the passenger side of the coach.
7. Open all T-valves on the pump and manifolds to relieve the pressure in the lines.
8. You may need to cut the lower two wire zip ties on the bundle of hydraulic hoses. This bundle connects to the pump and may need to be loosened for the rest of the repair.
9. Remove the two hydraulic hoses located on the right side and bottom of the T-connection, which is on the front of the lower manifold.
10. Remove the T-connector.
11. Reconnect the hose from the right side of the connector. Leave the bottom hose loose.

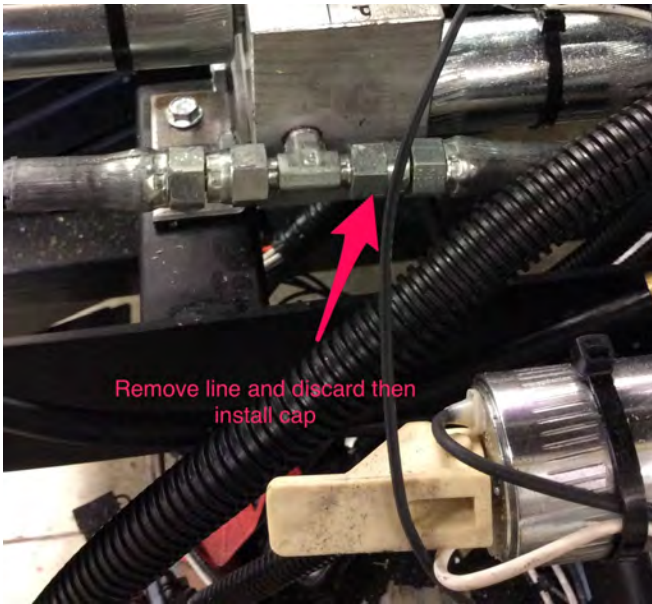
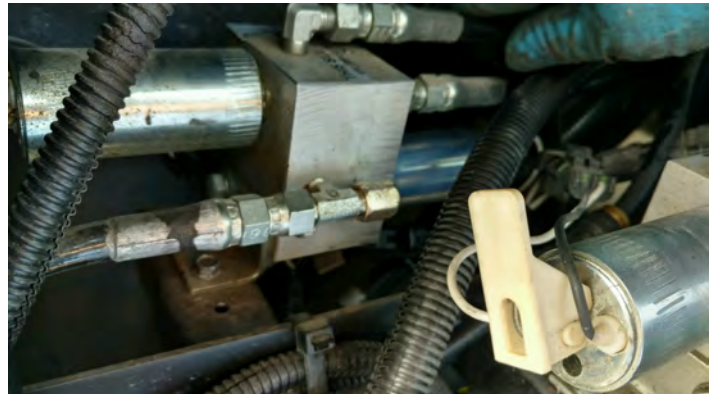
## Correcting the Hydraulic Plumbing Lines at the Rear Manifold

12. From the rear manifold, disconnect the loose hose, and install a cap.
13. Discard the removed hose.

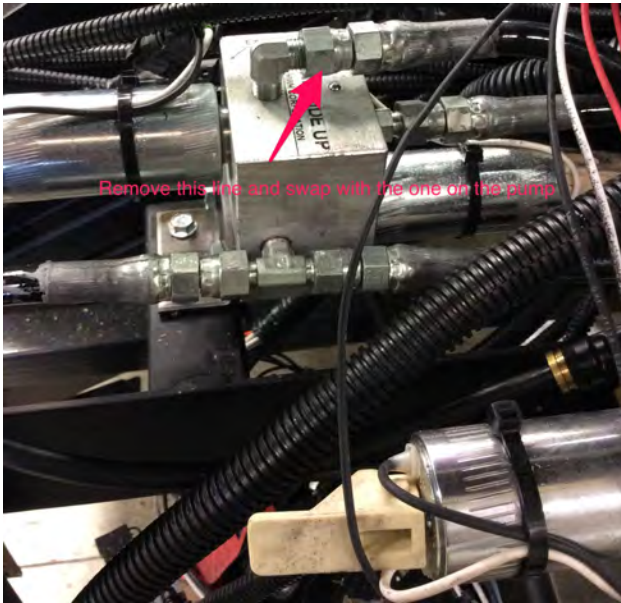
14. From the top of the rear manifold, remove the hose from the elbow connection.

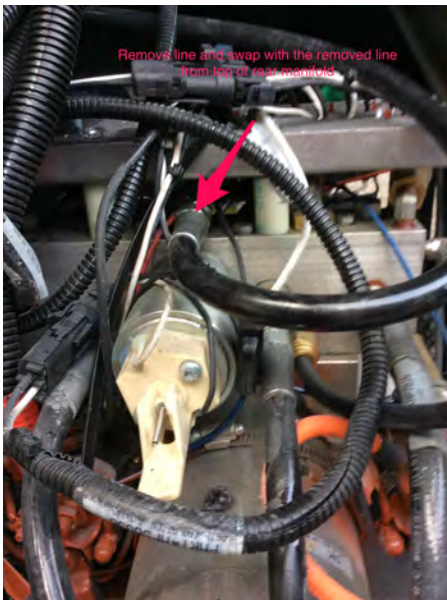
### Correcting the Plumbing Lines at the Hydraulic Pump

15. Remove the hose from the center of the hydraulic pump, and replace it with the hose that was removed from the elbow connection.

16. Connect the hose from the pump to the elbow on the top of the rear manifold.
