## RECALL SERVICE BULLETIN

RSB #

477

## Recall Service Bulletin

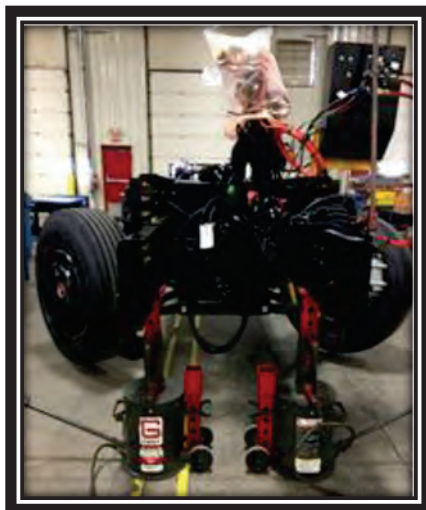
3. Steer wheels completely to the left.

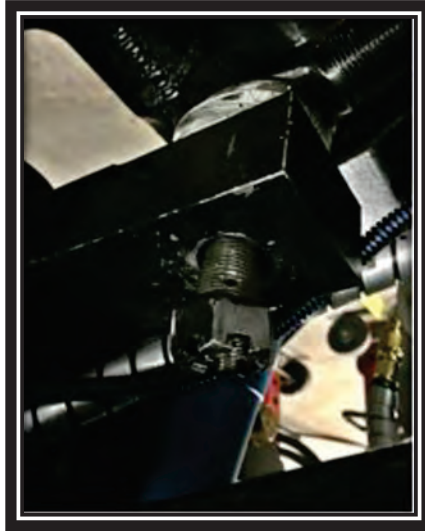
4. Beginning on the right side of the vehicle, remove castle nut from tie rod end that is connected to the relay rod.

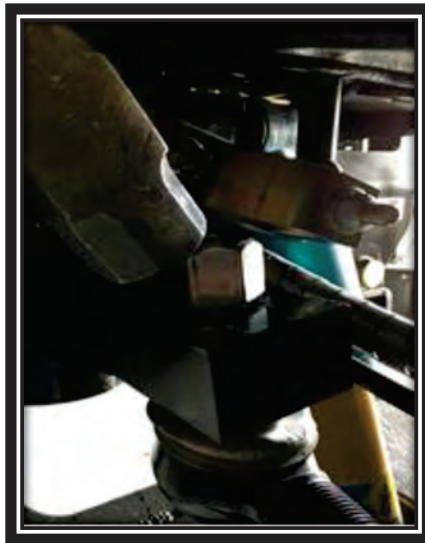
5. Place sacrificial 7/8"-14 nut on rod end stud and strike with hammer to un-seat tapered connection.

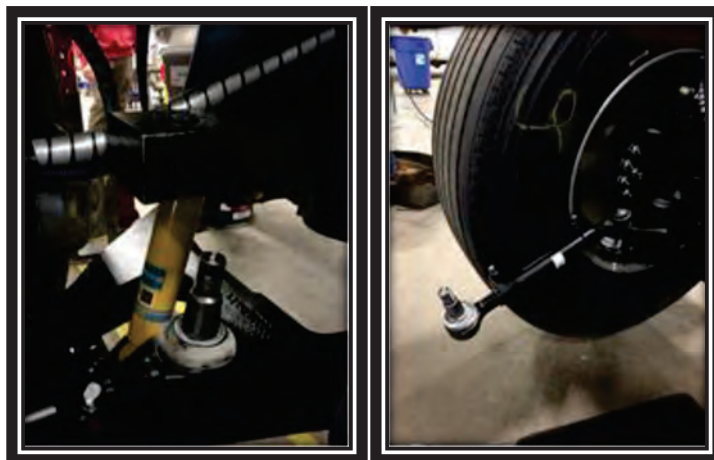
6. Remove tie rod end from relay rod assembly and position tie rod against wheel.

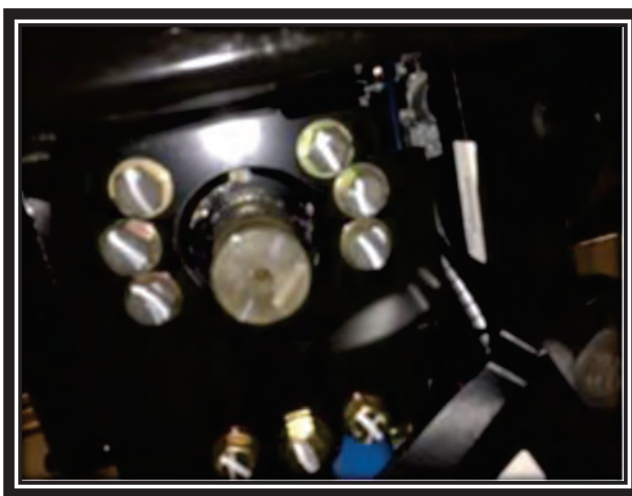
12. Lower pitman arm and position arm to where it is parallel with the relay rod.

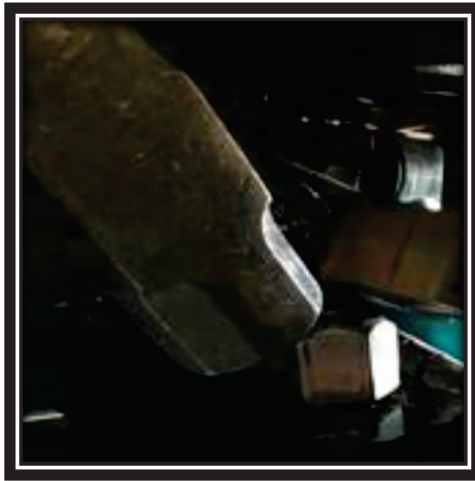
17. Remove the castle nut from the ball joint stud, retain for reinstallation. Ensure all washers found under castle nuts are re-installed in their original position.
18. Place sacrificial M20 1.5 nut on ball joint stud. Roll assembly over so sacrificial nut is on bottom resting on a solid surface. Strike relay rod downward with hammer to un-seat tapered connection.

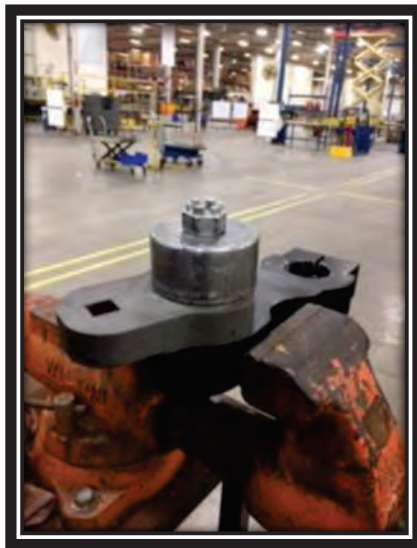
21. Using 40 mm ball joint tool and castle nut, place over ball joint.

**USE CAUTION TO NOT TEAR BOOT**

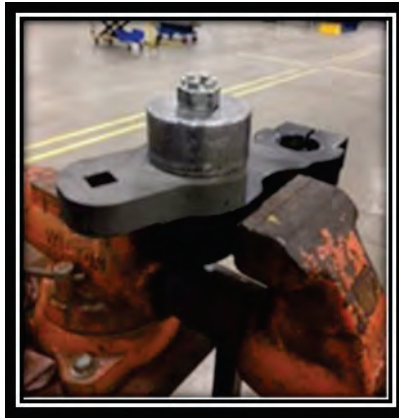
30. Using 50 mm ball joint tool and castle nut placed over ball joint (Use caution to not tear boot) torque the ball joint to 350 lbf-ft.

31. Be sure that tooling set up is not binding when tightening.
32. Castle nut should come off freely after ball joint is torqued.
33. Ensure that the ball joint is fully seated into the pitman arm.
34. Reinstall the relay rod to the front suspension in reverse order to removal using new cotter pins and the following torque specs:
- Tie rod castle nut – 90-100 lbf-ft.**
- Ball joint castle nut – 155-170 lbf-ft.**
- Pitman arm attachment bolt – 295-315 lbf-ft.**
- If applicable the drag link castle nut – 90 - 100 lbf-ft.**
35. When tightening castle nuts ensure specified torque is achieved. Advance the nut to align the castle slot with the thru hole to allow cotter pin to be installed. **DO NOT BACK CASTLE NUTS OFF TO INSTALL COTTER PINS.**
