NEWMAR CORPORATION

TECHNICAL SERVICE BULLETIN

DATE ISSUED	MODEL YEAR(S) AFFECTED	TSB #
12/27/2017	2018	500

How to Remove and Replace King Aire Push-Button Cargo Door Switches

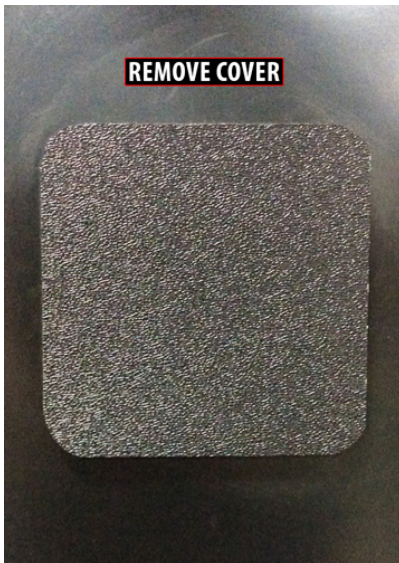
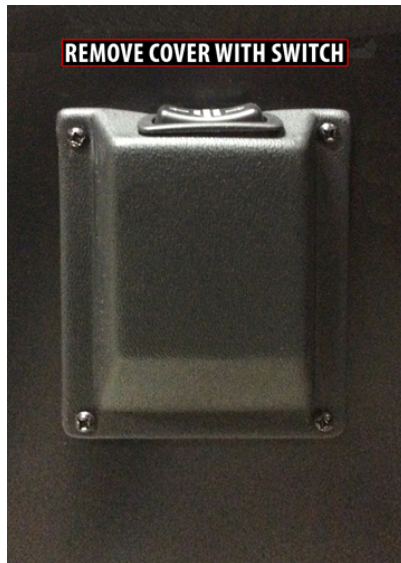
How to Remove the Old Switches and Covers

1. Remove the cover from the inside of the door. Some covers will be flat and are installed with double-faced foam tape. Other covers may contain the power cargo tray switch and are installed with screws.

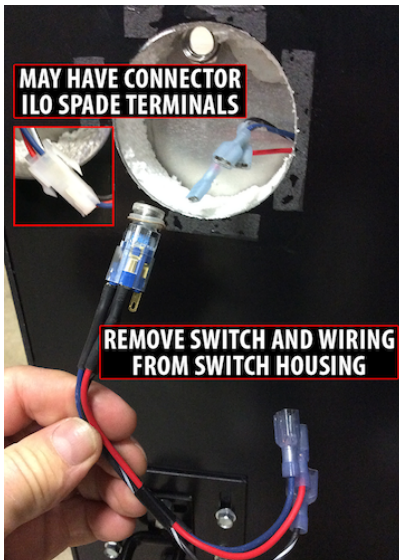
2. Unplug the switch wires from the harness inside the door.
3. Pull the switch and wires out of the housing (to make it easier to work on the switch housing).
4. Using a 3/4" wrench or deep socket, loosen and remove the nut from the back of the push button switch housing.
5. Carefully remove the switch housing from the front of the door.

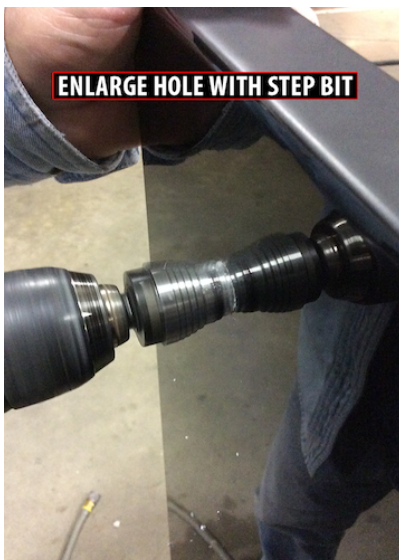
How to Drill the Door Skin for the New Switch

6. Using the drill and a step bit, start drilling the hole for the switch from the painted side of the door. Drill slow to prevent damage to the paint.

7. Check the hole size and button fit frequently as you drill the hole to 3/4" to prevent over drilling. Drilling the hole too big will ruin the baggage door.

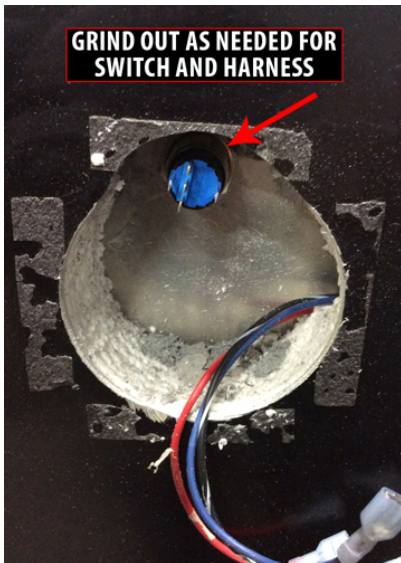
How to Enlarge the Opening on the Back Side of the Compartment Door

8. The hole in the front of the door may be slightly higher than the opening on the back side of the door. As needed, take the Dynafile to the top center of the large hole on the back side of the door.

9. Remove roughly 3/16 of the material in an arch-shape roughly one inch wide.

10. Test fit the new switch and plug on the back to make sure the plug has a little clearance from the opening on the backside of the door.

11. Once the harness connector clears the hole, while connected to the switch, the Dynafile is no longer needed. Do not make the hole too large for the new round cover.

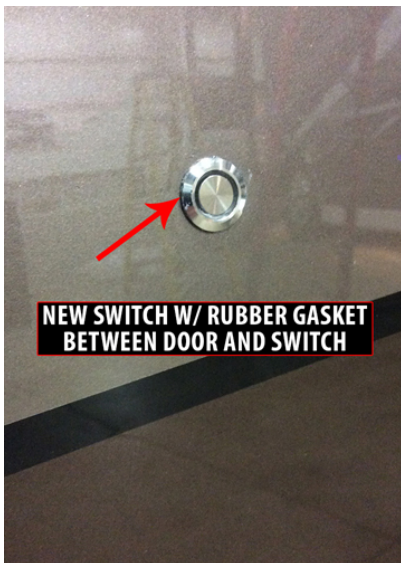
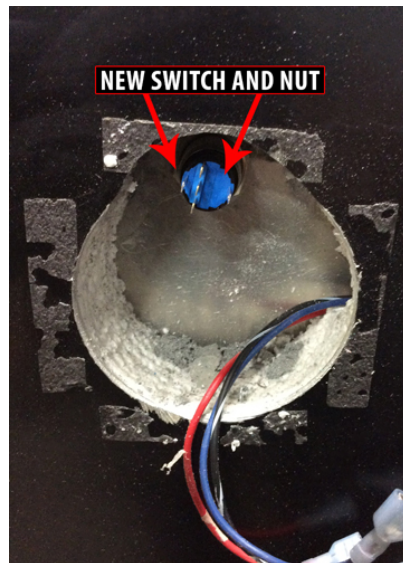
How to Install the Door Switch

12. Make sure the rubber gasket is installed on the switch.

13. Push the switch inside the door through the front, making sure the gasket is in contact with the door.

14. Start the nut on the back of the switch with your fingers.

15. Tighten the nut with a 7/8" wrench or deep socket.

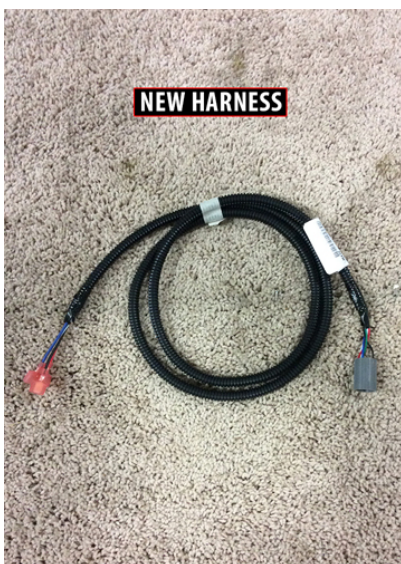
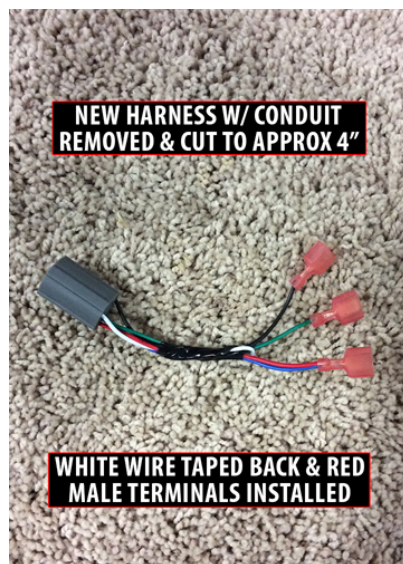
How to Modify the New Harness

16. Remove the conduit from the new harness.

17. Cut the harness plug off leaving approximately four inches of wire attached to the plug.

18. Fold over the white wire approximately half-way, and tape it along with the other wires.

19. Strip approximately 3/8" from the ends of the remaining four wires.

20. Twist the red and blue wires together, and attach a red male connector.

21. Install a red male connector on the green wire.

22. Install a red male connector on the black wire.

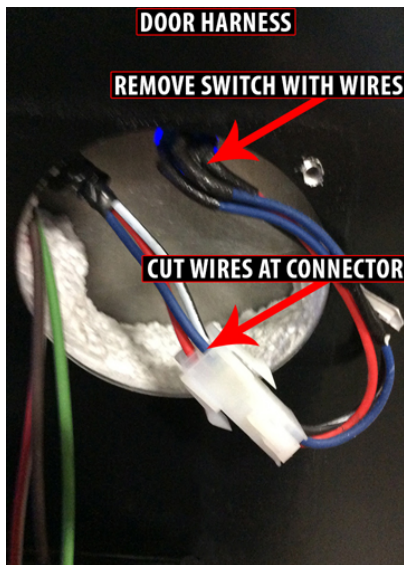
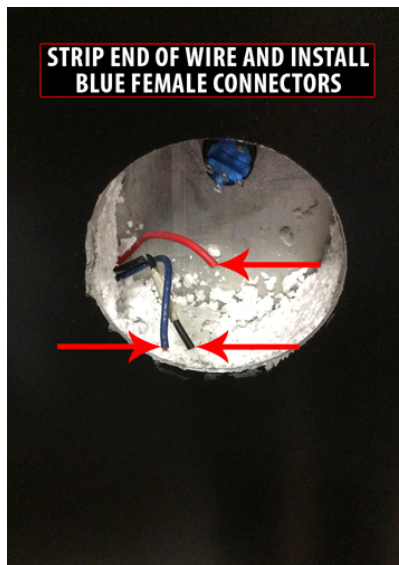
How to Modify the Old Harness in the Door

23. Cut the three-wire plug one wire at a time off while leaving as much wire as possible.
24. Strip approximately 3/8" from the ends of the remaining four wires.
25. Twist the end of the blue wire, and install a blue female connector.
26. Twist the end of the black (or black with white stripe) wire, and install a blue female connector.
27. Twist the end of the red wire, and install a blue female connector.

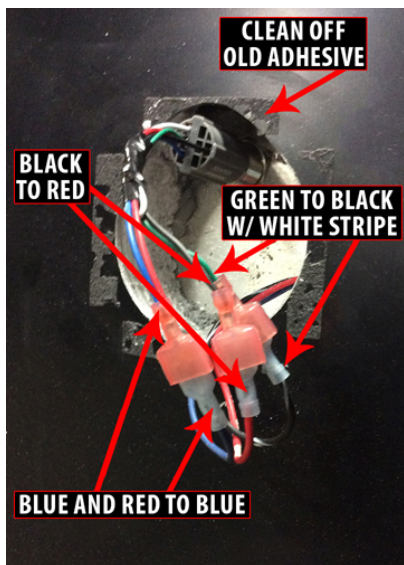
How to Connect the Modified Harnesses

28. Connect the red terminal on the combined blue and red wire from the short modified harness to the door harness' blue wire.
29. Connect the red terminal on the green wire from the short modified harness to the door harness' black with white stripe wire.
30. Connect the red terminal on the black wire from the short modified harness to the door harness' red wire.

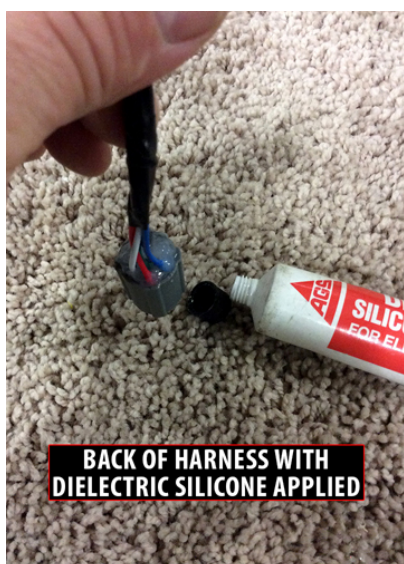
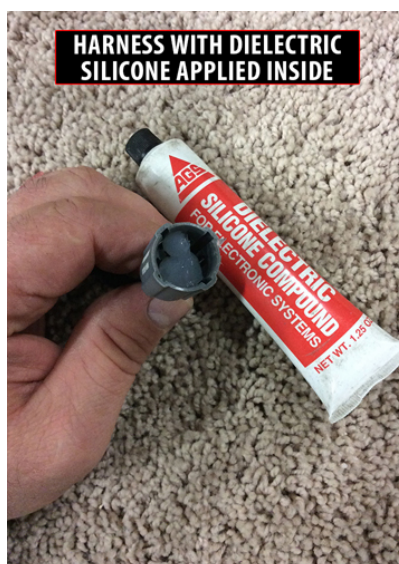
How to Connect to the New Switch

31. Apply dielectric grease to the back side and inside of the harness connector that connects to the switch, as well to the terminals on the switch that plugs into the connector.
32. Look inside the harness, and make sure that the harness connector terminals line up with the push button switch terminals.
33. Plug the new harness connector into the switch.

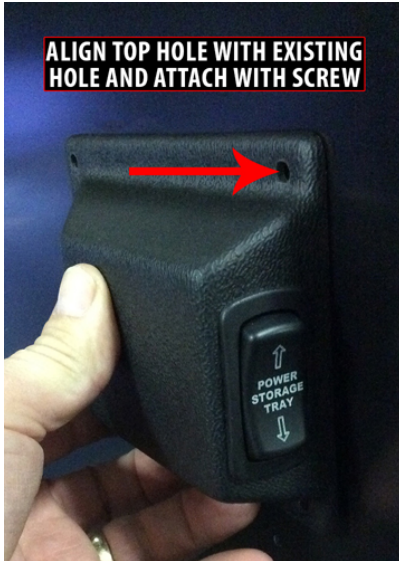
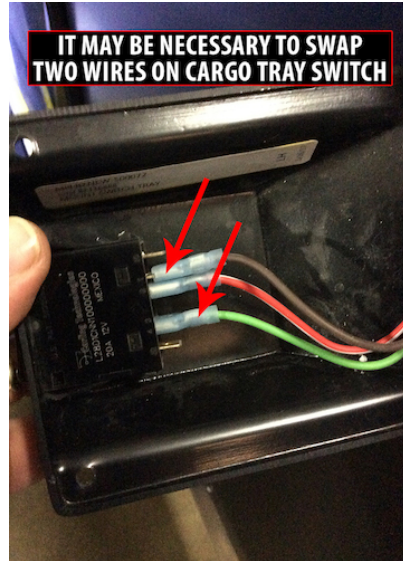
How to Install Covers with Switches

37. Clean any remaining adhesive or double-faced tape around the hole on the back side of the door where the cover was removed.

38. Covers containing the power cargo tray switch will need to be rotated 90 degrees out toward the edge of the door.

39. In order for the text on the switch to be upright, the switch may need to be removed and turned in the cover.

40. Once the switch is oriented correctly, the wiring may need to be flipped so that when the arrow is pushed up, the cargo tray retracts, and when pushed down, the cargo tray extends.

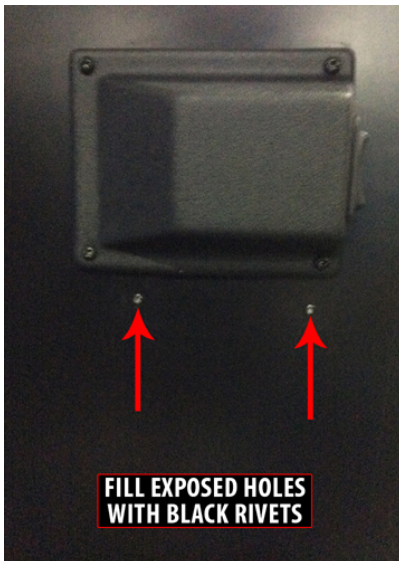
41. Fill any remaining holes with black rivets.
