NEWMAR CORPORATION

TECHNICAL SERVICE BULLETIN

525

HOW TO MOUNT A BOSE 300 SOUND BAR

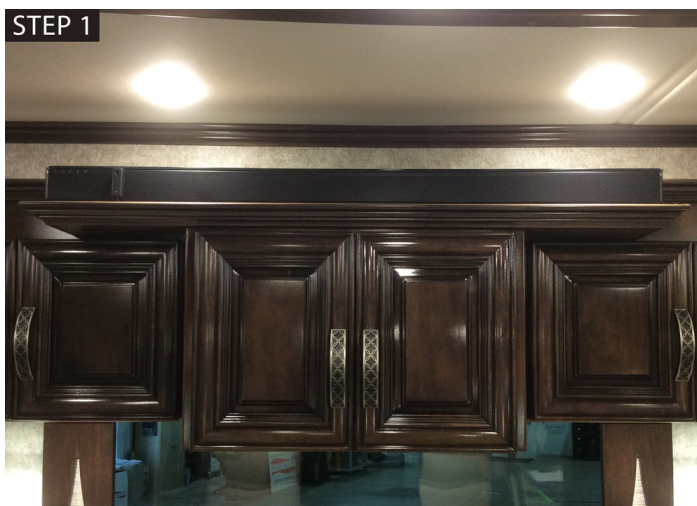
1. Check to see how the speaker is mounted to the bracket. If the speaker is mounted to the bracket with screws, the following procedure does not need to be completed. If the speaker is mounted to the bracket with Velcro, perform the following steps.
