# Newmar Corporation

RSB 613  
November 1, 2024

## RECALL SERVICE BULLETIN

## Instructions for Valve Stem Extension Recall 24V 787

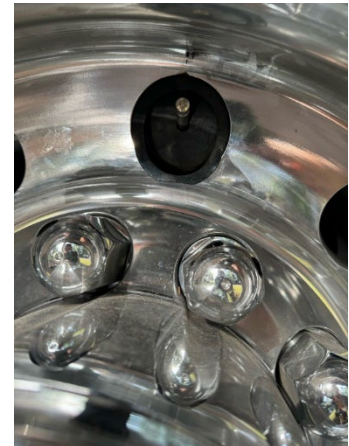
1. Remove the valve stem cap.
2. Remove the rubber grommet from the outer rim.
3. Remove the valve stem extension from the rear inner dual tire by rotating the extension counterclockwise.
4. Test and adjust the rear inner tire pressure to ensure correct air pressure and that air loss did not occur while removing the extension. This can be checked using a long, truck-style tire pressure gauge and a long, truck-style air chuck.
5. Install the valve stem cap you previously removed using long nose pliers or a valve capper tool.
6. Take a photo of the rear tire and rim showing the extension and grommet have been removed.
7. Scan the QR code or use web link below to fill out the recall form. Remember to attach the pictures you took to verify the recall has been completed.

Inspect the rear wheels to see if valve stem extensions are installed on your coach.

If valve stem extensions are installed, take pictures of each wheel. Then submit your information and the photos via Newmar's recall form. If valve stem extensions are installed, proceed with the following recall instructions to remove the valve stem extension(s). There is no need to take the coach to a dealership to have the recall completed.

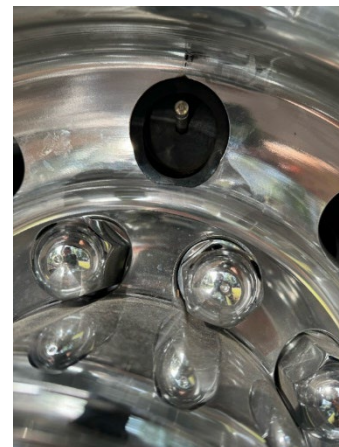
1. Retirez le capuchon de la tige de la vanne.
2. Retirez l'œillet en caoutchouc de la jante extérieure.
3. Retirez l'extension de la tige de soupape du pneu double intérieur arrière en faisant pivoter le extension dans le sens antihoraire.
4. Testez et ajustez la pression intérieure arrière des pneus pour assurer une pression d'air correcte et cet air la perte ne s'est pas produite pendant le retrait de l'extension. Cela peut être vérifié à l'aide d'un long, manomètre de pneu de style camion et un long mandrin à air de style camion.
5. Installez le capuchon de tige de soupape que vous avez précédemment retiré à l'aide de longues pinces à nez ou d'une vanne outil capper.
6. Prenez une photo du pneu arrière et de la jante montrant l'extension et l'œillet ont été supprimé.

Inspectez les roues arrière pour voir si des extensions de tige de soupape sont installées sur votre voiture.

Si des extensions de tige de soupape sont installées, prenez des photos de chaque roue.
