NEWMAR CORPORATION WARRANTY DEPARTMENT

TECHNICAL SERVICE BULLETIN																	
DATE ISSUED		MODEL YEAR(S) AFFECTED		MODEL(S) AFFECTED		TSB #											
11/18/04		2005		Essex		249											
BRAND						TYPE											
All	<input type="checkbox"/>	American Star	<input type="checkbox"/>	Mountain Aire	<input type="checkbox"/>	All	<input type="checkbox"/>										
		Dutch Star	<input type="checkbox"/>	Kountry Aire	<input type="checkbox"/>	F W	<input type="checkbox"/>										
		Kountry Star	<input type="checkbox"/>	Essex	<input checked="" type="checkbox"/>	D P	<input checked="" type="checkbox"/>										
Scottsdale	<input type="checkbox"/>	Northern Star	<input type="checkbox"/>	London Aire	<input type="checkbox"/>	D B	<input type="checkbox"/>

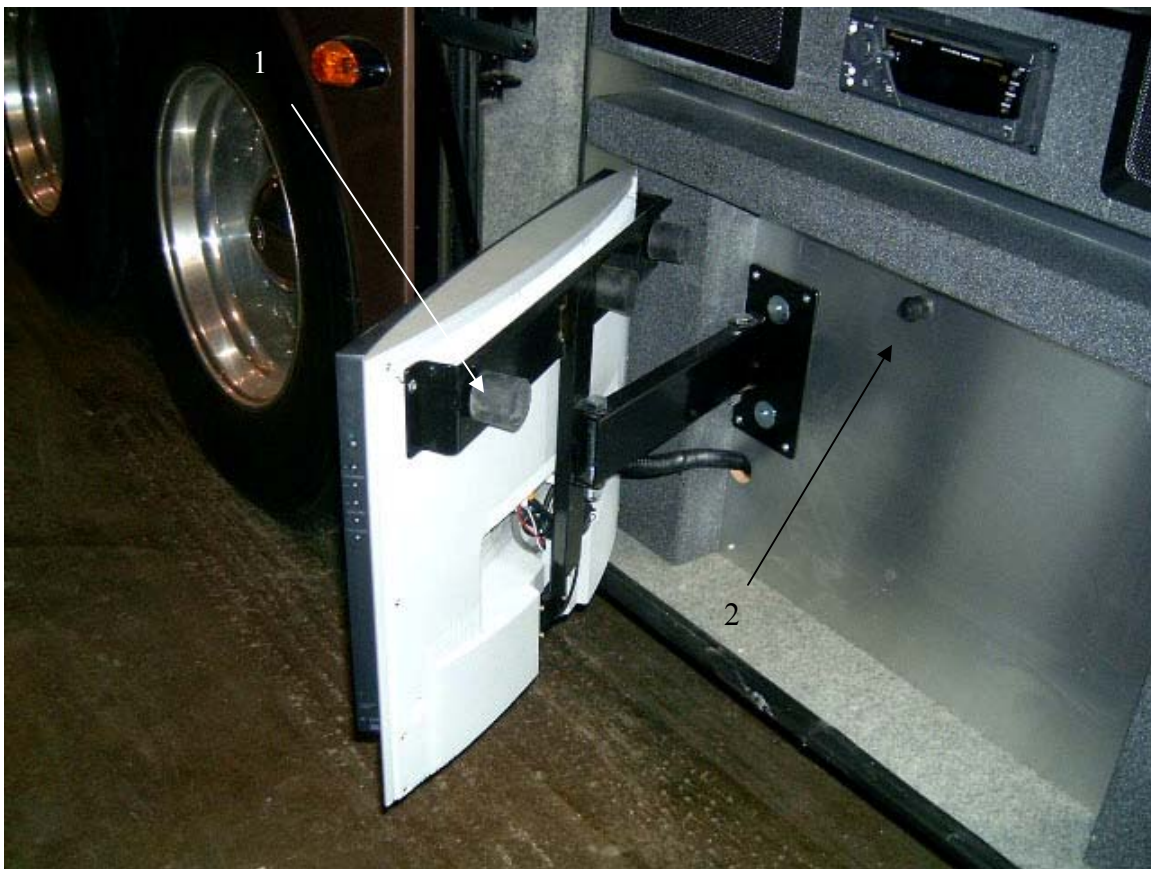
Picture 1 illustrates how the bracket should look after installing 1) a second rubber bumper, and 2) after relocating the rubber bumper / plunger stop

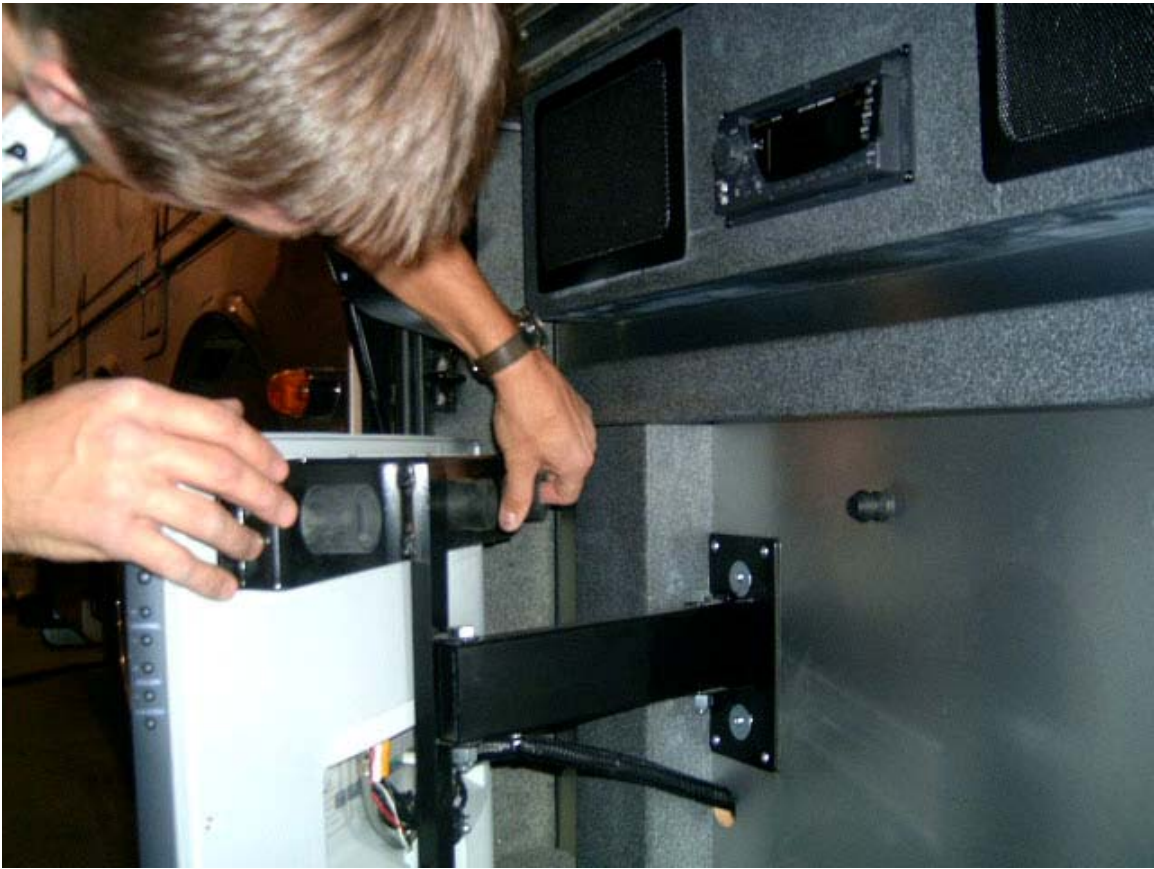
Picture 2 illustrates how to rotate the rubber stops on the threaded bolts to make soft contact with the rear compartment wall.

6) Swing the TV out to access the stops on the ends of the bracket. Rotate the rubber stops in or out accordingly to provide soft contact with the back panel, providing soft but firm contact. This will prevent excess motion of the TV, and minimize it’s ability to break free. It also keeps the TV symmetrical in the opening, assuring neither end can allow the TV to move into contact with the back side of the basement door.
