Technical Service Bulletin			
Date Issued	Model Year(s) Affected	Model(s) Affected	TSB #
7/13/09	2009-present	Diesel Pusher/Bus	362
Brand		Type	
All Star <input checked="" type="checkbox"/>	Bay Star <input type="checkbox"/>	Canyon Star <input type="checkbox"/>	Grand Star <input type="checkbox"/>
Ventana <input checked="" type="checkbox"/>	Dutch Star <input checked="" type="checkbox"/>	Dutch Aire <input checked="" type="checkbox"/>	Mountain Aire <input checked="" type="checkbox"/>
Essex <input checked="" type="checkbox"/>	King Aire <input checked="" type="checkbox"/>	London Aire <input type="checkbox"/>	
<input type="checkbox"/> Air Conditioning & Heating <input type="checkbox"/> Appliances & Accessories <input type="checkbox"/> Cabinets & Furniture <input type="checkbox"/> Chassis Components <input type="checkbox"/> Construction Components		<input type="checkbox"/> Electrical Components <input type="checkbox"/> Exterior Components <input type="checkbox"/> Interior Components <input type="checkbox"/> Plumbing & Bath Components <input type="checkbox"/> Windows, Awnings, Vents, & Doors

RECALL SERVICE BULLETIN

SUBJECT: Brake System – Haldex QR1 & QR1C Valves

APPLIES TO: Certain Spar

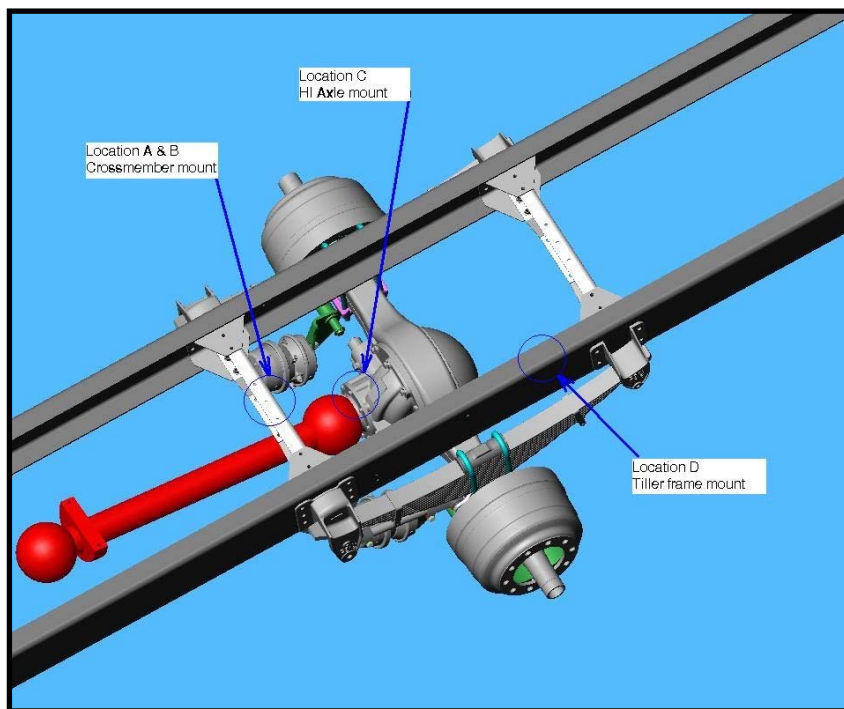
MOUNTING LOCATIONS FOR QR1C VALVE
FIG. 3-3

NOTE: Refer to FIG. 3-1, 3-2, 3-3. Some Firetruck Cab/Chassis may be equipped with 1 (one) QR1 and/or 1 (one) QR1C valve. Valve mounting location may vary, from front crossmember near transmission for QR1 Valve to Rear Axle for QR1C Valve and in certain cases both locations.

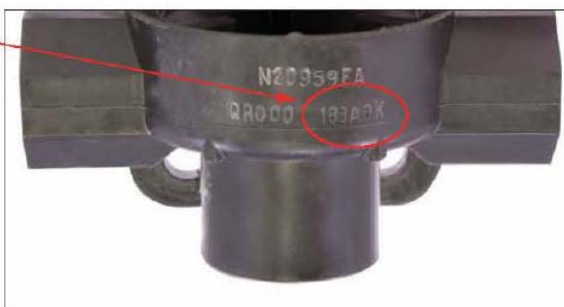
The Date Code on the
Haldex QRV Valve shown
here indicates:

Gregorian Date -183 (July 1st)

Shift - A (First Shift)

Year - 8 (2008)

Location - K (Iola, Kansas)

2. Refer to Haldex Bulletin Pgs. 4-6. Locate and Inspect quick release valve(s) to identify date code. If valve date code is in the specified range of May 27, 2008 through October 15, 2008, with production date codes of 148 through 289. The QR1 & QR1C valve(s) will need to be replaced.
3. Disconnect brake drop hoses and/or air lines from quick release valve(s).
4. Loosen and remove quick release valve(s) from relay valve assembly or crossmember. Retaining mounting hardware for reuse.

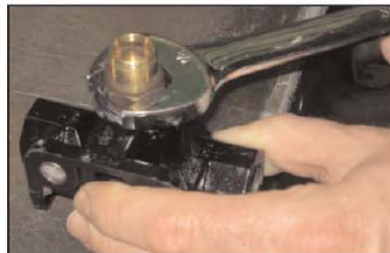
Fig. 4 shows installation of the fittings.

If required, assemble the appropriate size D.O.T.-approved fittings into the new QRV. Haldex recommends lightly coating the threads of the new fittings with a PTFE (Teflon) thread sealant. Do NOT use Teflon tape. Torque the fittings to a range of 75 to 200 in-lbs.

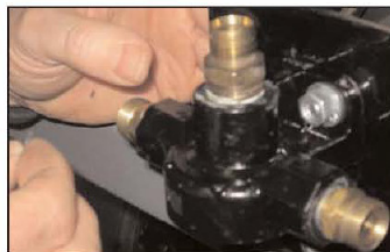
Fig. 5 shows the QRV being mounted onto the vehicle.

Install the QRV onto the vehicle with 5/16 inch bolts. Recommended bolt torques:

- 5/16"-18 Grade 5 bolts = 17 ft-lbs
- 5/16"-24 Grade 5 bolts = 19 ft-lbs
- 5/16"-18 Grade 8 bolts = 24 ft-lbs
- 5/16"-24 Grade 8 bolts = 27 ft-lbs

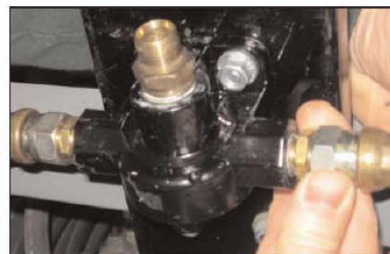
Fig. 6 shows a hose being connected.

Install the vehicle air hoses onto the valve. Use wrenches on both the fitting and the hose to make certain that fitting torques into the QRV remain in the range of 75 to 200 in-lbs.

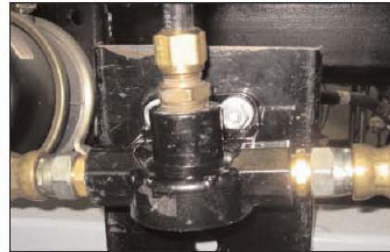
Fig. 7 shows a correctly replaced Quick Release Valve.

Verify that all connections are tight.

Pressurize the air system and check the connections for leaks.

Check the brake system for proper operation before driving the vehicle. Road test the vehicle.
