## Technical Service Bulletin

TSB Number: 380

### **Safety Recall Campaign Replacement of Bosch Service Brake Calipers**

**SUBJECT: Replacement of Bosch Service Brake Calipers**

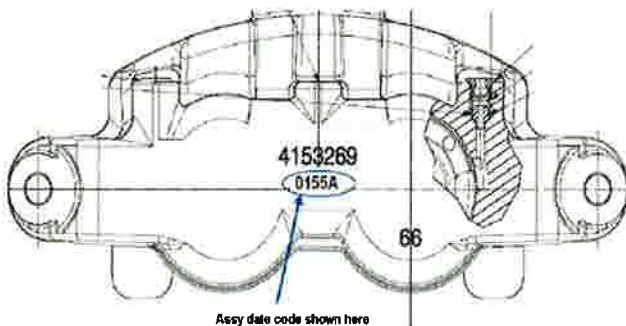
**Part Number W8006753 (Caliper Kit)**

**Remedy Bosch Brake Caliper Identification**

The first date code was 0155A.

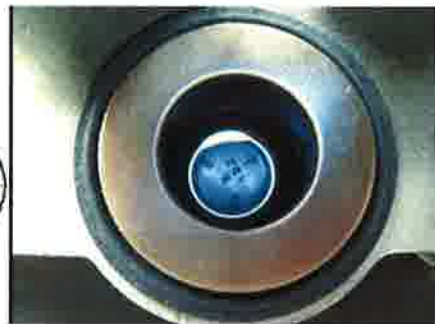
The pistons have the letter "B" molded in three locations at the bottom of the piston.

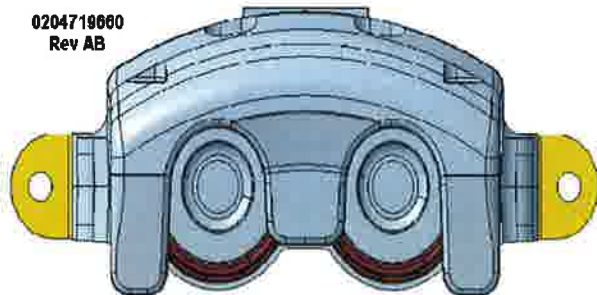
0204719660  
Rev AB

Caliper machined areas shown in yellow are not plated.

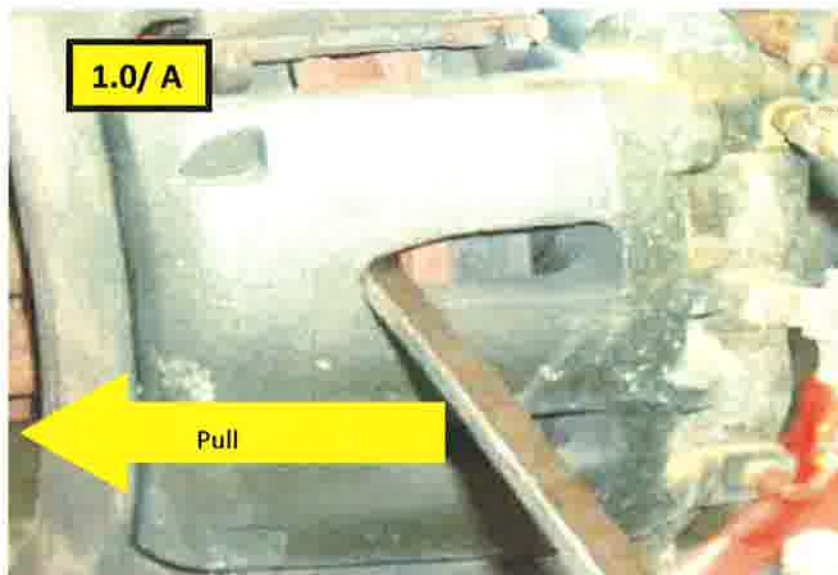
1. Remove two thirds of brake fluid from master cylinder.
2. Raise the vehicle, Refer to *Lifting and Jacking the Vehicle* in General Information in the service manual.
3. Support the vehicle with safety stands.
4. Mark relationship of the wheel to hub.
5. Remove the tire and wheel assembly, Refer to *Tire and Wheel Removal and Installation* in the service manual.
6. Compress caliper pistons using a disc brake caliper pad spreader, caliper dual piston compressor tool, c-clamp, pry bar, or other similar equipment. Compress until the pistons bottoms in the bore. (Shown in photo 1.0 / A)

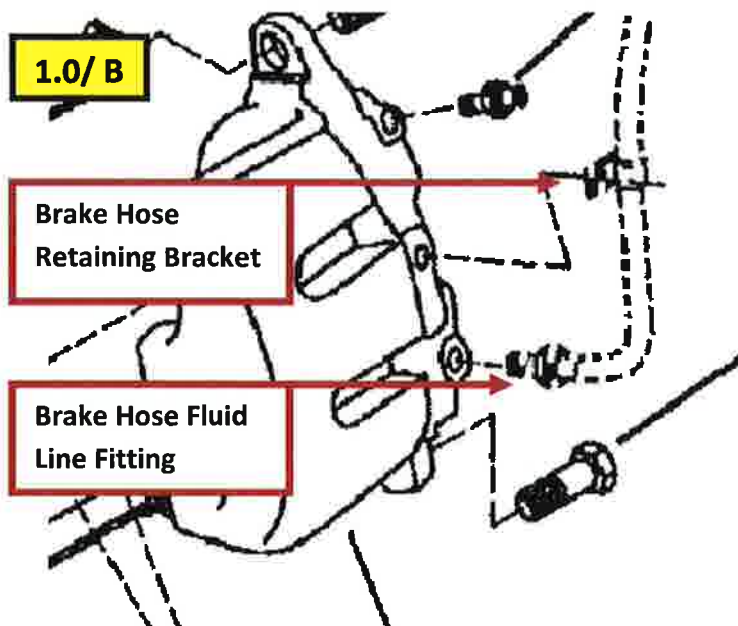
7. Remove the tool used to compress the caliper pistons.
8. Remove the brake hose retaining bracket fastener from the caliper. (View Illustration 1.0/ B)

9. Disconnect brake hose fluid line fitting from caliper and cap off to prevent brake fluid leakage or contamination in the line. Do not allow the brake line hose to become pinched or kinked during the remedy procedure. (View Illustration 1.0/ B)
10. Remove the upper (top) caliper mounting bolt securing the caliper to the upper guide pin. (Shown in Photo 1.0/ C)
11. Remove the lower (bottom) caliper mounting bolt securing the caliper to the lower guide pin.

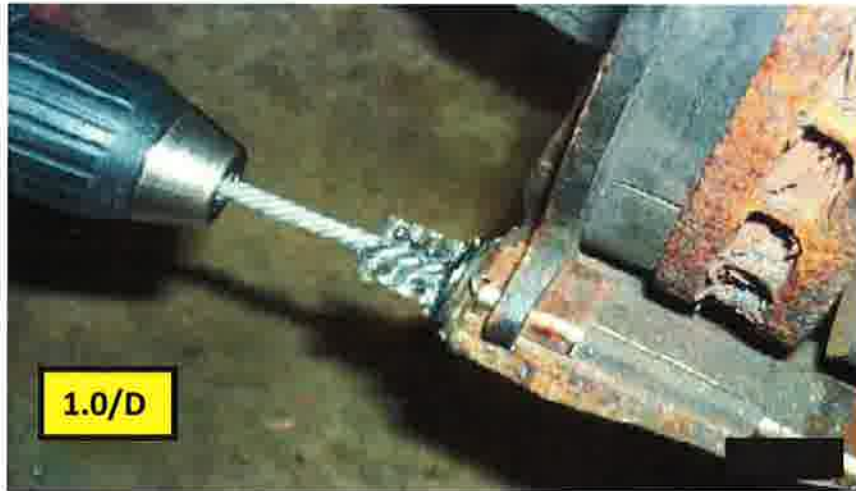
14. Clean the machined surface of the anchor plate with wire brush. (See photo 1.0/D)
15. Clean and lubricate the anchor plate bores with silicone brake grease.

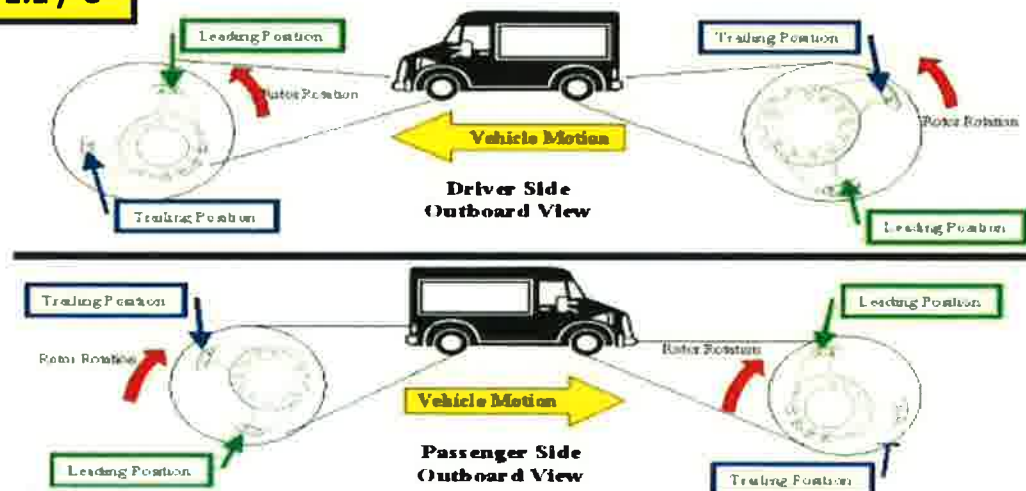
**1.1 / C**

3. If the bolt thread is fine and the bolt dark in color as shown below it is a ZOH-T type slide pin shown in illustration (1.1/B). The leading and trailing pin are different and required to be in the correct position shown in illustration (1.1/C).

**Identifying Slide Pin Leading and Trailing Positions**

**IMPORTANT:** The ZOH-T leading bolt must be tightened first during the assembly process after both leading and trailing bolts are installed finger tight.

6. Torque the ZOH-T mounting bolts as follows:
  - a. Torque leading bolt to 93-107 lb-ft (126-145 N-m)
  - b. Torque trailing bolt to 93-107 lb-ft (126-145 N-m)
  - c. See Leading and Trailing bolt position illustration (1.1 / C)
7. Connect the brake hose fitting to the fluid inlet port on the caliper and torque to 14-17 lb-ft (20-24 N-m). (See illustration 1.0 / B)
8. Reconnect the brake hose retaining bracket to the caliper using the original bolt removed. (See illustration 1.0 / B)
9. Bleed brake system torque bleeder screw to 8-15 lb-ft. (10-20 N-m)
10. Install the tire and wheel assembly and torque the wheel lug nuts to 450-500 lb-ft.
11. Lower the vehicle.

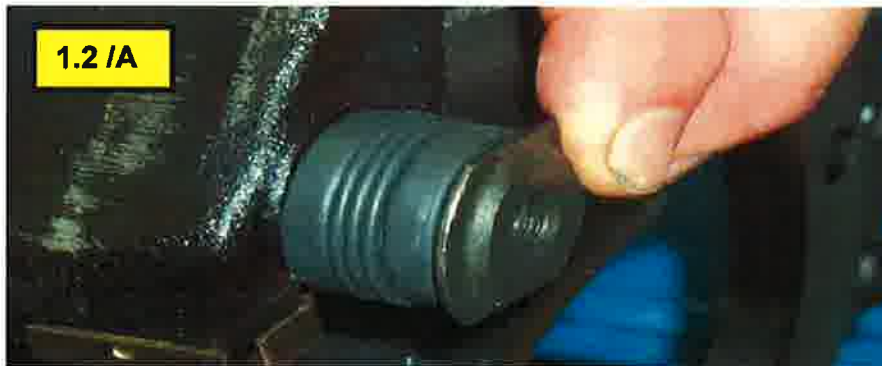
1. Inspect and lubricate the caliper slide pins with silicone brake grease.
2. When reusing the ZOH-T slide pin mounting bolt clean the threads and apply Loctite 2440 adhesive on bolt threads.
3. Align flat on upper (top) slide pin boss with the flat on the caliper housing upper (top) guide pin boss. Be careful when positioning caliper over disk brake pads, rotor and upper (top) guide pin to avoid tearing or dislodging piston boots or guide pin boots. (View Photo 1.2 / A)

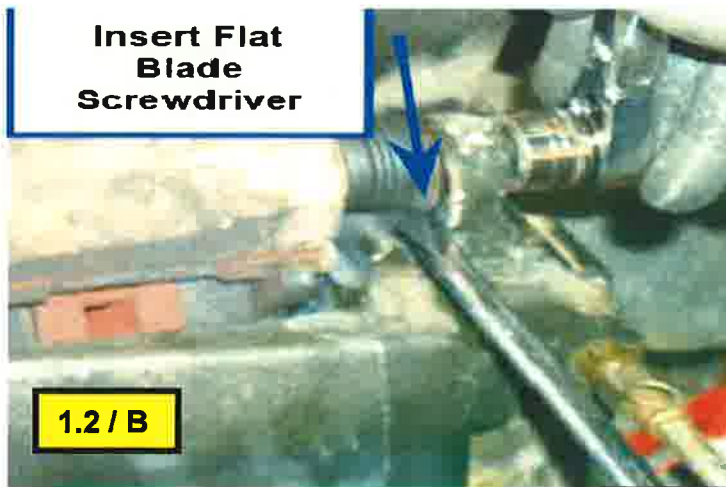
4. Install upper (top) mounting bolt "finger" tight.
5. Align the flat on the lower pin flange, and then carefully rotate the caliper closed and install lower mounting bolt "finger" tight. Utilize a flat blade screwdriver to retain the slide pin during the torque procedure. (Shown in photo 1.2 / B)

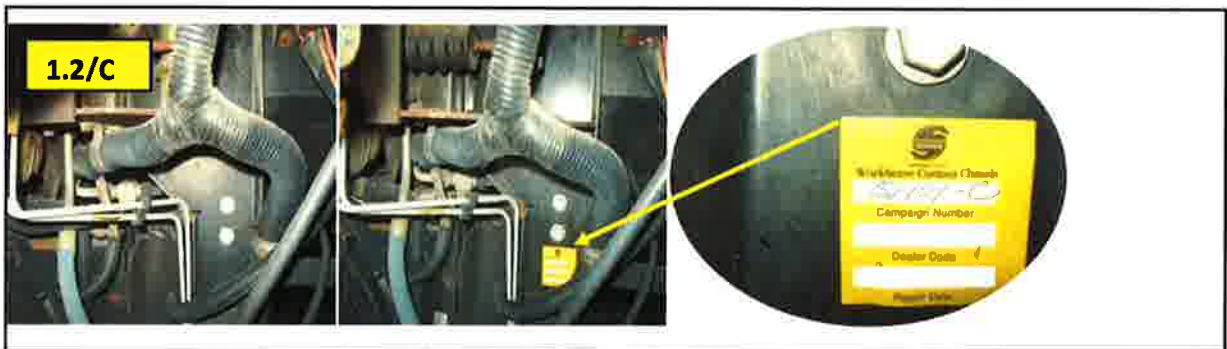
12. Complete the Recall Campaign Completion label and attach to the vehicle bulk head in a visible area near the chassis fuse box / Maxi Booster mounting bracket (Shown in photo 1.2/ C). One completion label (PN W8001493) will be shipped with every two caliper kits ordered.
