TECHNICAL SERVICE BULLETIN							
MODEL YEAR(S) AFFECTED)	MODEL(S) AFFECTED			TSB #	
2002			DUTCH	STAR DP		229	
BRAND				Түре			
can Star 🛛	Kountry Star 🛛	Dut	ch Star	All 🗖	ТТС	FW 🗖	
tain Aire 🗖 🗄	Kountry Aire 🛛	Lon	don Aire□	САП	DP	DB 🗖	
□ Air Conditioning & Heating □ Electrical Components							
Image: DescriptionImage: DescriptionImage: DescriptionImage: DescriptionImage: DescriptionDescriptionExterior Control				omponents			
□ Cabinets & Furniture □ Interior 0				omponents			
Chassis Components			Plumbing & Bath Components				
Construction Components			Windows, A	ows, Awnings, Vents, & Doors			
DESCRIPTION OF PROBLEM							
RECOMMENDED SOLUTION							
Replace the original grommet with a plastic grommet and kazoo tube. First, remove the grommet from the bottom of the air intake box and install a plastic grommet over the existing hole. Apply sealant to the edges and sides of the grommet. Slide the kazoo rubber over the grommet until it is seated into the sealant. Seal around the top outside edge of the kazoo material and allow it to dry. The flat rate code for this replacement is #40450308 and the time allowed is .8. To complete this repair you will need a plastic grommet, part #

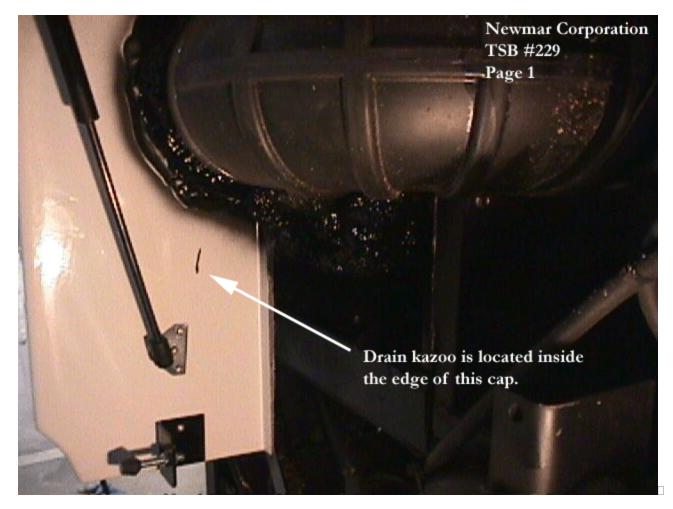
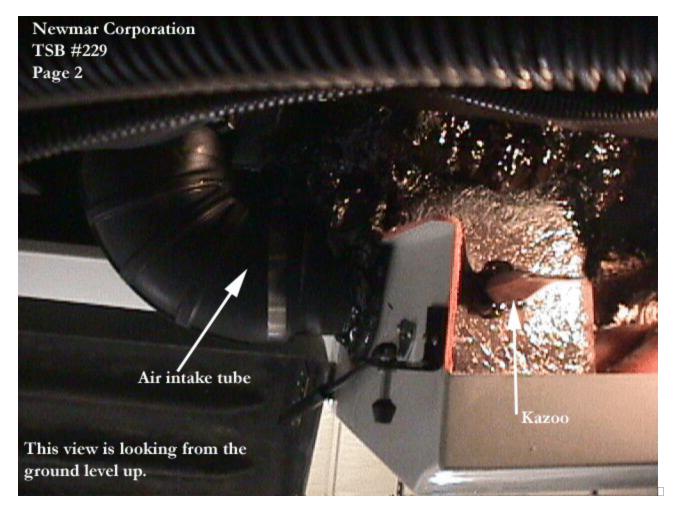
MODEL YE BRA can Star can Star cain Aire % Heating essories ure nts ponents or the air intake or the air intake or the air intake	MODEL YEAR(S) AFFECTED 2002 BRAND can Star □ Kountry Star □ can Star □ Kountry Aire □ can Aire □ Kountry Aire □ can Aire □ Kountry Aire □ Country Aire □ & Heating essories Ure Its DESCRIPTION (Or the air intake box. RECOMMENDE Ommet with a plastic grommet and e box and install a plastic grommet and e box and install a plastic grommet folide the kazoo rubber over the gr the kazoo material and allow it to his replacement is #40450308 and	MODEL YEAR(S) AFFECTED 2002 BRAND can Star Kountry Star Dute can Star Kountry Aire Lon & Heating Image: Sories Image: Sories Image: Sories ure Image: Sories Image: Sories Image: Sories ure Image: Sories Image: Sories Image: Sories ure Image: Sories Image: Sories Image: Sories oponents Image: Sories Image: Sories Image: Sories oponents <t< td=""><td>MODEL YEAR(S) AFFECTED MODEL(S) 2002 DUTCH is BRAND </td><th>MODEL YEAR(S) AFFECTED MODEL(S) AFFECTED 2002 DUTCH STAR DP BRAND </th><th>MODEL YEAR(S) AFFECTED MODEL(S) AFFECTED 2002 DUTCH STAR DP BRAND TYPI can Star Kountry Star Dutch Star All TT can Star Kountry Aire London Aire C A D P & Heating Electrical Components essories Exterior Components ure Interior Components nts Plumbing & Bath Components nponents Windows, Awnings, Vents, & DO DESCRIPTION OF PROBLEM DESCRIPTION OF PROBLEM or the air intake box. State or ubber over the existing hole. Apply sealant to Slide the kazoo rubber over the grommet until it is seated into the sealant. the kazoo material and allow it to dry. his replacement is #40450308 and the time allowed is .8. To complete this</th></t<>	MODEL YEAR(S) AFFECTED MODEL(S) 2002 DUTCH is BRAND	MODEL YEAR(S) AFFECTED MODEL(S) AFFECTED 2002 DUTCH STAR DP BRAND	MODEL YEAR(S) AFFECTED MODEL(S) AFFECTED 2002 DUTCH STAR DP BRAND TYPI can Star Kountry Star Dutch Star All TT can Star Kountry Aire London Aire C A D P & Heating Electrical Components essories Exterior Components ure Interior Components nts Plumbing & Bath Components nponents Windows, Awnings, Vents, & DO DESCRIPTION OF PROBLEM DESCRIPTION OF PROBLEM or the air intake box. State or ubber over the existing hole. Apply sealant to Slide the kazoo rubber over the grommet until it is seated into the sealant. the kazoo material and allow it to dry. his replacement is #40450308 and the time allowed is .8. To complete this
