Technical Service Bulletin

Date Issued	Model Year(s) Affected	Model(s) Affected	TSB #
02/04/2011	2010-2011	Diesel Pushers	382
Brand			Type
All <input type="checkbox"/>	American Star <input type="checkbox"/>	Mountain Aire <input checked="" type="checkbox"/>	All <input type="checkbox"/> T T <input type="checkbox"/>
Cypress <input type="checkbox"/>	Dutch Star <input checked="" type="checkbox"/>	Kountry Aire <input type="checkbox"/>	F W <input type="checkbox"/> C A <input type="checkbox"/>
Northern Star <input type="checkbox"/>	Kountry Star <input type="checkbox"/>	Essex <input checked="" type="checkbox"/>	D P <input checked="" type="checkbox"/> D B <input type="checkbox"/>
Scottsdale <input type="checkbox"/>	King Aire <input checked="" type="checkbox"/>	London Aire <input type="checkbox"/>	
All Star ME <input type="checkbox"/>	Ventana <input checked="" type="checkbox"/>	Bay Star <input type="checkbox"/>	
<div style="display: flex; justify-content: space-between;"> <div> <input type="checkbox"/> Air Conditioning & Heating <input type="checkbox"/> Appliances & Accessories <input type="checkbox"/> Cabinets & Furniture <input checked="" type="checkbox"/> Chassis Components <input type="c

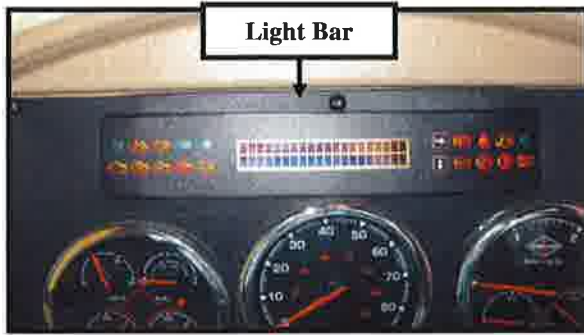
FIG. 3-1

LIGHT BAR

3. Refer to FIG. 3-1. Loosen and remove instrument panel screws, retain screws for reuse.
4. Refer to FIG. 3-1. Tilt instrument panel outward to gain access to backside of light bar.

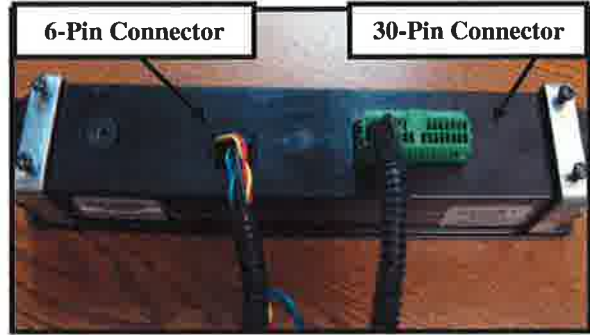
FIG. 3-2

LIGHT BAR CONNECTIONS

5. Refer to FIG. 3-2. Unplug green, 30-pin connector from light bar.
6. Refer to FIG. 3-2. Unplug black, 6-pin connector from light bar.
7. Refer to FIG. 3-2. Remove (4) screws holding the light bar U-clamps, retain screws for reuse.
8. Remove light bar from instrument panel. For replacement components, you will need to contact Spartan Chassis, Inc.
9. Install new light bar from kit. Attach (4) screws to new light bar with the U-clamps thus attaching light bar to instrument panel.
10. Refer to FIG. 3-2. Connect black, 6-pin connector into light bar.
11. Refer to FIG. 3-2. Connect green, 30-pin connector into light bar.
