NEWMAR CORPORATION

TECHNICAL SERVICE BULLETIN							
DATE ISSUED		MODEL YEAR(S) AFFECTED		MODEL(S) AFFECTED		TSB #	
10/11/2013		2013 & 2014		King Aire, Essex & Mountain Aire		407	
BRAND						TYPE	
All	<input type="checkbox"/>	American Star	<input type="checkbox"/>	Mountain Aire	<input checked="" type="checkbox"/>	All	<input type="checkbox"/>
Cypress	<input type="checkbox"/>	Dutch Star	<input type="checkbox"/>	Kountry Aire	<input type="checkbox"/>	T T	<input type="checkbox"/>
Northern Star	<input type="checkbox"/>	Kountry Star	<input type="checkbox"/>	Essex	<input checked="" type="checkbox"/>	F W	<input type="checkbox"/>
Scottsdale	<input type="checkbox"/>	King Aire	<input checked="" type="checkbox"/>	London Aire	<input type="checkbox"/>	C A	<input type="checkbox"/>
All Star ME	<input type="checkbox"/>	Ventana	<input type="checkbox"/>	Bay Star	<input type="checkbox"/>	D P	<input checked="" type="checkbox"/>
<div style="display: flex; justify-content: space-between;"> <div> <input type="checkbox"/> Air Conditioning & Heating <input type="checkbox"/> Appliances & Accessories <input type="checkbox"/> Cabinets & Furniture <input type="checkbox"/> Chassis Components <input type="checkbo

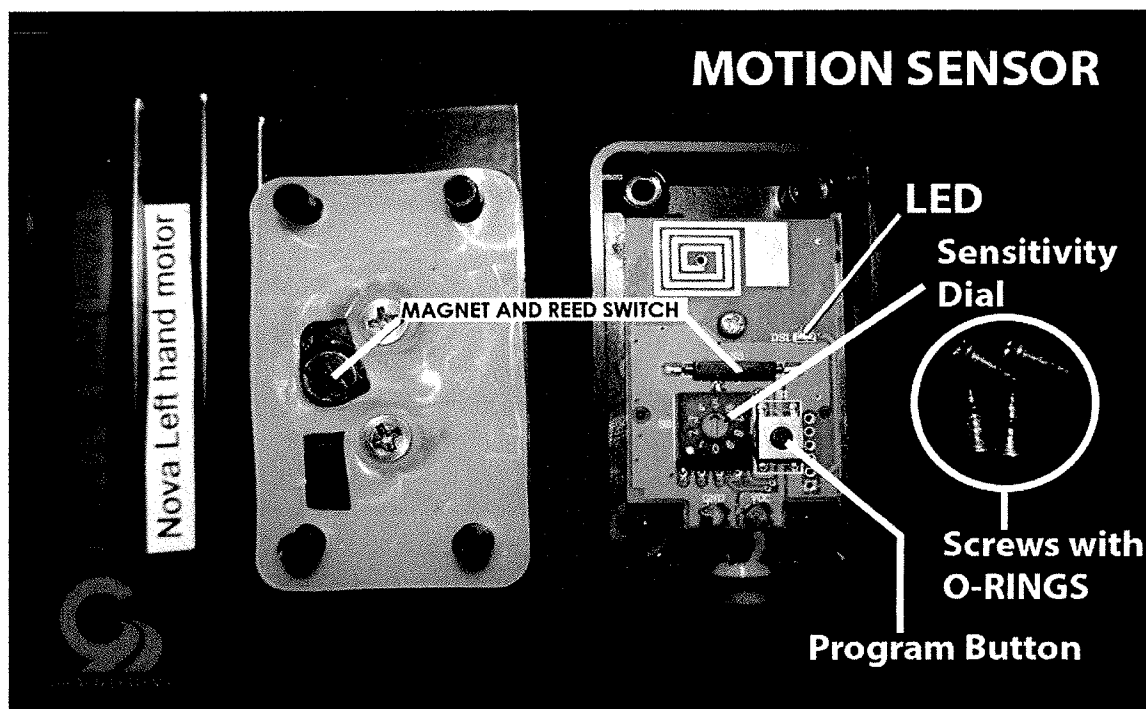
Figure 3

NOTE: THE O-RINGS ARE A CRITICAL PART OF THE NEW MOTION SENSOR AND MUST BE USED (Figure 3).

- C. Locate the Sensitivity Dial and carefully adjust to the **#5** Position (Figure 3).
 - D. Place the Motion Sensor cover upside down and back onto the base (Figure 4). The reed switch must be located directly over the magnet to operate the Motion Sensor.
 - E. Apply a 12V Power Source to the 12V Motion Sensor. The Purple LED will turn on solid and then will flash intermittently. The Motion Sensor is now ready to program.
- NOTE: IF THERE IS NO POWER TO THE 12V MOTION SENSOR IT WILL NOT TRANSMIT THE PROGRAMMING.**
- F. Using a small screwdriver or end of a paper clip press the **Program Button** on the GC136 Controller. The Green LED on the GC136 Controller will begin to flash.
 - G. Press the **Stop Button** on the GC136 Controller. The Green LED on the GC136 Controller will turn solid.

C. Locate the Sensitivity Dial and carefully adjust to the **#5** Position (Figure 3).
