# NEWMAR CORPORATION

### TECHNICAL SERVICE BULLETIN

RE: Notice of Campaign Service Bulletin: **CSB18-560-001**

Attached is a copy of Campaign Service Bulletin **CSB18-560-001** regarding the digital dash and data collector module.

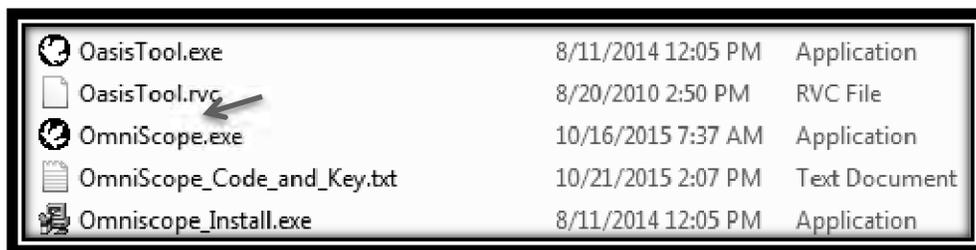
**FIG. 5-1**

1. To update dash, connect Omniscope Adapter’s USB cable to USB port of laptop being utilized for update and connect vehicle connector to RV-C diagnostic port.
2. Launch OmniScope.exe Refer to Fig 5-1

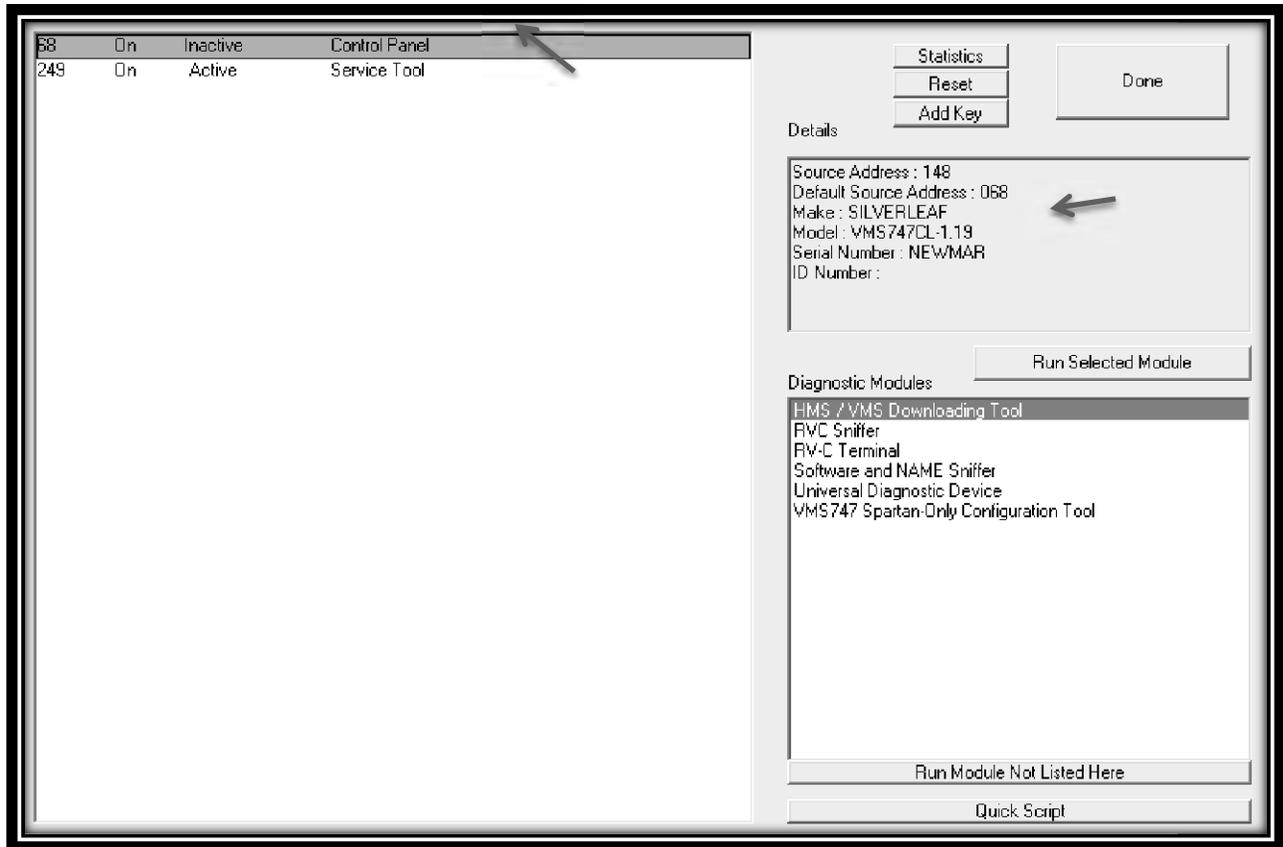
FIG. 6-1

3. Select item in left window that says, 'Control Panel'. If multiple items say control panel, find one that in details side window states model is a "VMS747CL-1.XX". The xx will be whatever version number is loaded on that dash. Refer to FIG. 6-1.

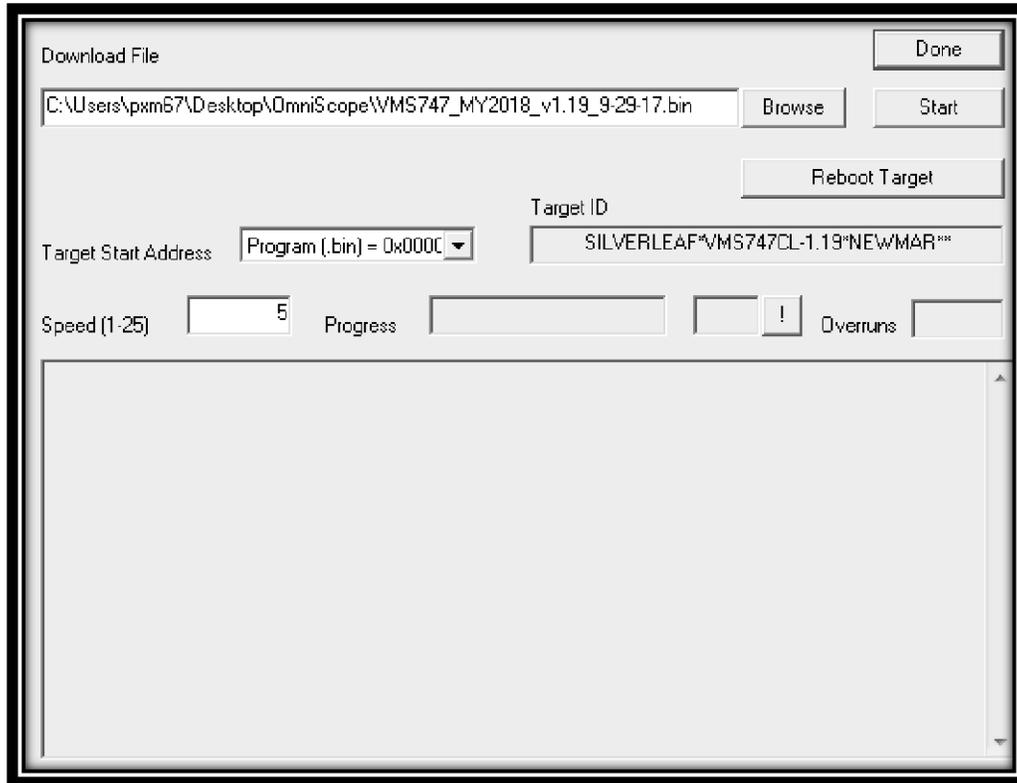
**FIG. 7-1**

4. Select 'HMS/VMS Downloading Tool' in right pane and press 'Run Selected Module'
  - a. If Diagnostic Modules list is blank, select another item in left list and then select control panel again
5. In file downloader window, select version that needs to be installed and speed download should run at.
  - a. Browse to where software has been saved and select flash file (VMS747\_MY2018\_v1.19\_9-29-17.bin).
  - b. Set speed to a low value such as 4-10. Speeds higher than this can cause errors that slow down process significantly.
6. Once speed and file are set, press 'Start' button to begin download. Refer to FIG. 7-1.

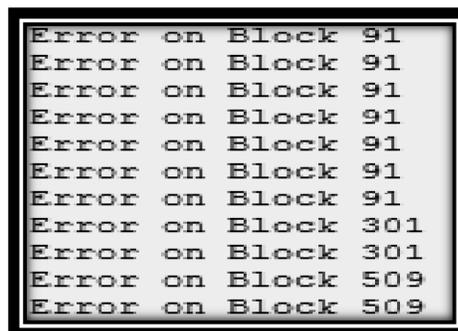
**FIG. 7-2**

7. On a fully built coach, this process can take up to 30 minutes due to overruns. No interaction is required during this time.
  - a. Make sure that computer updating dash has adequate power. If power failed during an update then dash could be corrupted, requiring a replacement part.
  - b. During updates, multiple error messages will appear. These are normal and when system hits one, it will simply retry sending data until it succeeds. The most common one follows format of "Error on Block #". Refer to FIG. 7-2

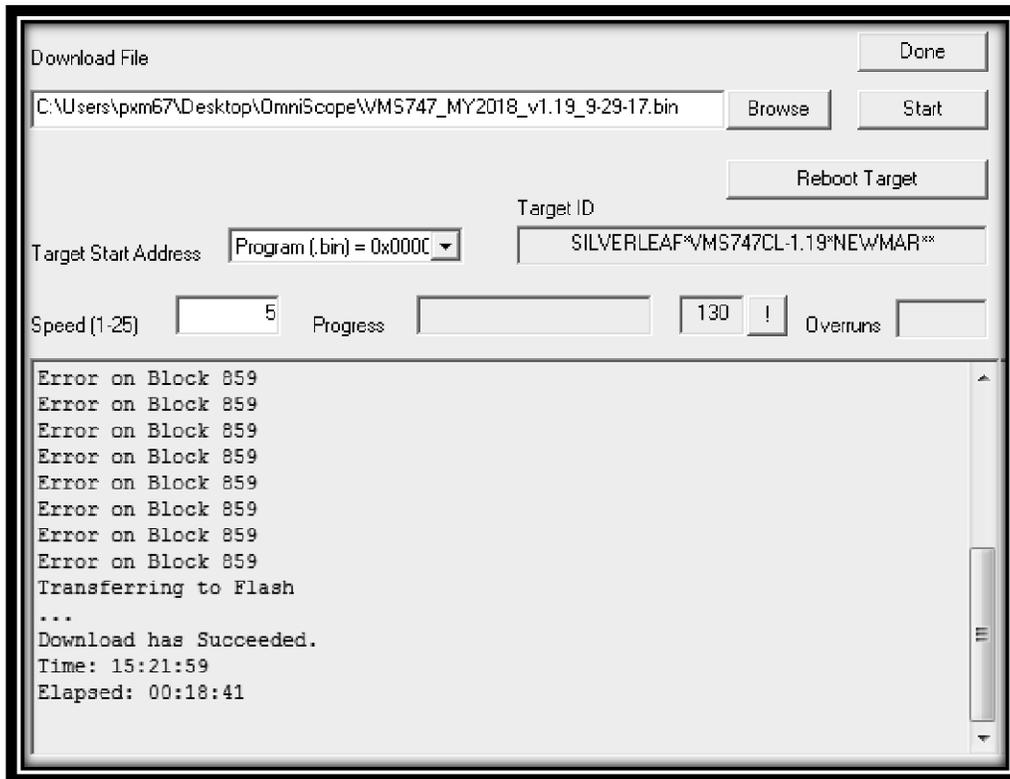
FIG. 8-1

- 8. Once software has downloaded, program will indicate it has been transferred to flash and that 'Download has Succeeded.' Then press 'Reboot Target' button. Refer to FIG. 8-1.

- a. In some cases, downloader will not indicate that download has succeeded and will just continue to print the dots. The downloader can be safely closed, in this situation if dash has reset. You can tell if dash was reset when during dot printing dash flashed off and on again. Another indicator is if dash can be interacted with and is showing any sort of updates on screen (messages, changing gauge values, etc.). In general, if more than 5 or 6 dots have been printed then dash is almost guaranteed to have reset itself.
- 9. From here dash should restart. To ensure it is correct software version, hold down DRIVE and SCAN buttons on keypad. Towards middle of screen dash should list its version. At this point it should state it is version 1.19, if it does not reattempt flash. If this does not correct issue, contact Spartan CPS for assistance.
