NEWMAR CORPORATION WARRANTY DEPARTMENT

TECHNICAL SERVICE BULLETIN			
DATE ISSUED	MODEL YEAR(S) AFFECTED	MODEL(S) AFFECTED	TSB #
1/30/08	2007-2008	All with Oasis Heat	331
	BRAND		Түре
AllICypressINorthern StarIScottsdaleIAll Star MEI	American StarIDutch StarIKountry StarIKing AireIVentanaI	Kountry Aire	All \Box $T T \Box$ $F W \Box$ $C A \Box$ $D P \blacksquare$ $D B \Box$
All Star ME I Ventana I Image: A conditioning & Heating Electrical Components Appliances & Accessories Exterior Components Cabinets & Furniture Interior Components Chassis Components Plumbing & Bath Components Construction Components Windows, Awnings, Vents, & Doors DESCRIPTION OF PROBLEM			
	RECOMMENDED	SOLUTION	
Oasis has issued a Technical Service Bulletin to address concerns of an Oasis heating system that exhibits High Fault Limits. This procedure changes the "cycling auquastat" to and updated version. Any questions regarding this TSB should be directed to Oasis at (604) 278-1272, or Toll Free at 1-800-755-1272. READ THE PROCEDURE THOROUGHLY AND COMPLETELY PRIOR TO BEGINNING DIAGNOSIS OR REPAIRS.

Heating Systems	November 13, 2007	Bulletin Identification No.: MTB-102-22
Release Type: Public		Standard Repair

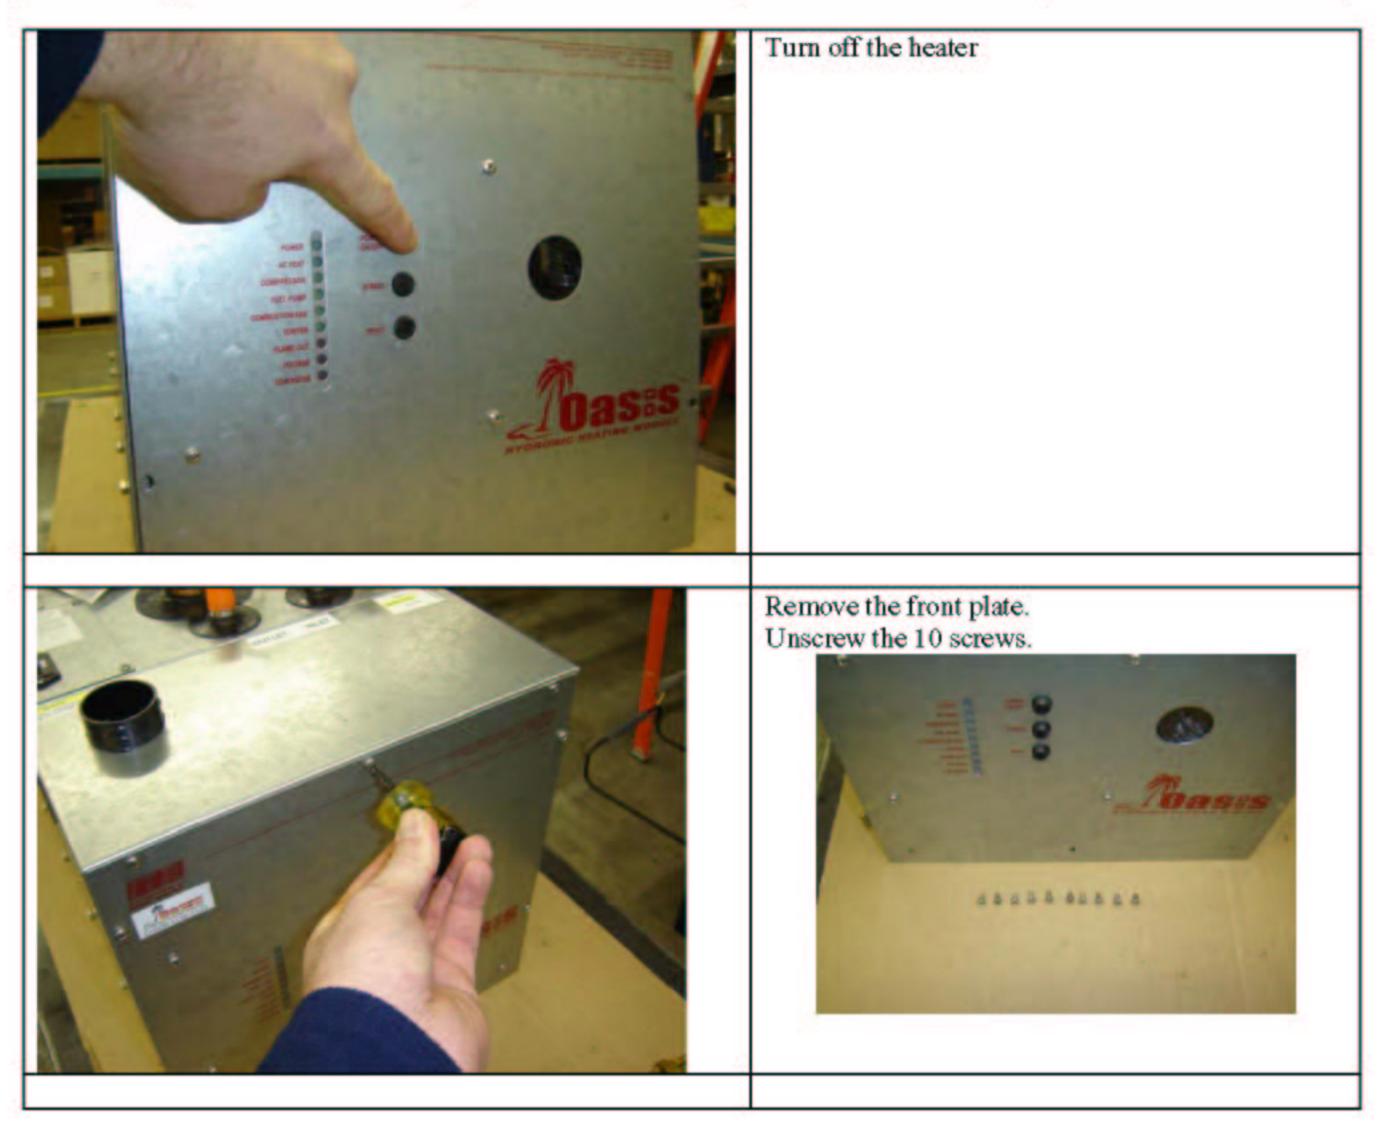
The cycling aquastat has been changed to a faster responding aquastat. If an Oasis, prior to this change, has had a problem with high limit faults, change the cycling aquastat by following the instructions below:
