Newmar Corporation Warranty Department

Technical Service Bulletin							
Date Issued		Model Year(s) Affected		Model(s) Affected		TSB #	
10/19/2006		11/8/05 – 3/2/06		All Spartan Chassis		267	
Brand						Type	
All	<input checked="" type="checkbox"/>	American Star	<input type="checkbox"/>	Mountain Aire	<input type="checkbox"/>	All	<input type="checkbox"/>
		Dutch Star	<input type="checkbox"/>	Kountry Aire	<input type="checkbox"/>	F W	<input type="checkbox"/>
		Kountry Star	<input type="checkbox"/>	Essex	<input type="checkbox"/>	D P	<input checked="" type="checkbox"/>
Scottsdale	<input type="checkbox"/>	Northern Star	<input type="checkbox"/>	London Aire	<input type="checkbox"/>	D B	<input checked="" type="checkbox"/>
<div style="display: flex; justify-content: space-between;"> <div> <input type="checkbox"/> Air Conditioning & Heating <input type="checkbox"/> Appliances & Accessories <input type="checkbox"/> Cabinets & Furniture <input checked="" type="checkbox"/> Chassis Components <input type="checkbox"/> Construction Components </div> <div> <input checked="" type="checkbox"/> Electrical Components <input type="checkbox"/> Exterior Components <input type="checkbox"/> Interior Compon

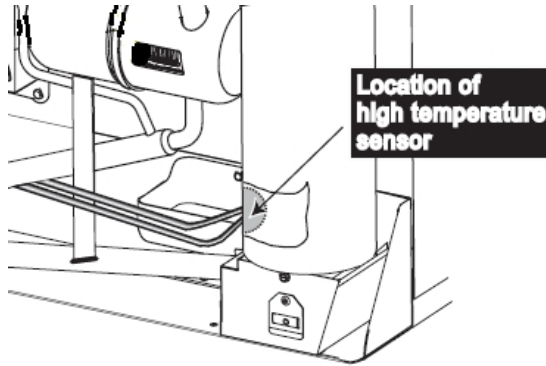
The purpose of High Temperature Performance Monitor system is to detect improper operation of the cooling unit. The system responds to the temperature in the boiler area of the cooling unit and shuts off the refrigerator if abnormally high temperatures are experienced. Once the refrigerator shuts down it is not possible to reset the unit and a qualified technician must inspect the cooling unit and installation.

The High Temperature Performance Monitor was implemented in production on 9/20/2005 beginning with serial number 8432073. No retrofit kit for 12XX models manufactured before this change will be available.

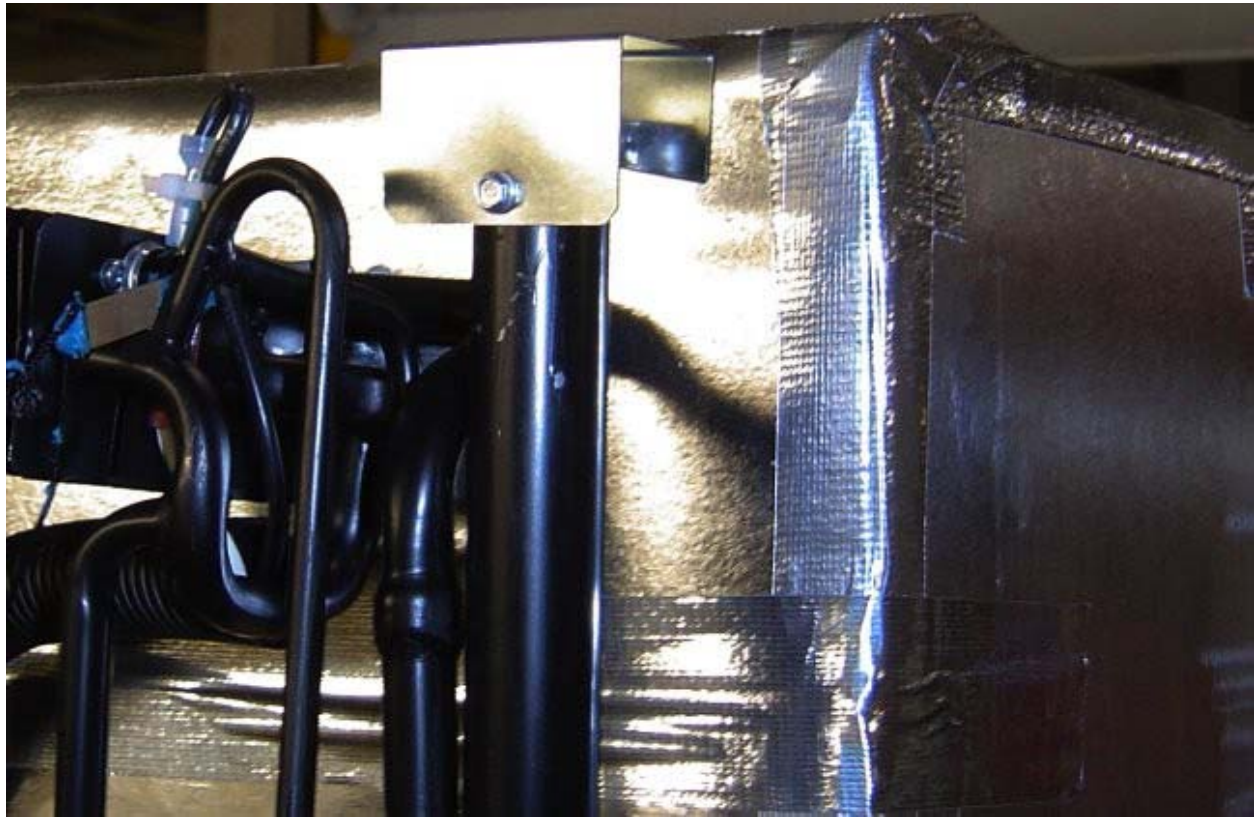
CORRECT INSTALLATION

The long edge of flue cap IS parallel with the refrigerator cabinet back.

3. Install the modified flue cap on the end of the flue tube (See Art01768):

- Make sure the mounting hole of the modified flue cap is located away from the refrigerator cabinet back.
- Push the modified flue cap onto the end of the flue tube.

- Make sure that the long side of the modified flue cap is parallel with the refrigerator cabinet back.
 - At the center of the mounting hole, drill a .136 in. dia. (#29-bit) pilot hole through the flue tube.
 - Put the #8 self-drilling sheet-metal screw (supplied) through the mounting hole and into the pilot hole.
 - Securely tighten the screw.
4. Close the door of the upper side-wall exhaust vent.
