NEWMAR CORPORATION

TECHNICAL SERVICE BULLETIN												
DATE ISSU	JED	MODEL YEA	MODEL YEAR(S) AFFECTED									
9/14/201	7		2018									
MODEL												
Bay Star Sport		Ventana		Essex								
Bay Star		Dutch Star		King Aire								
Canyon Star		Mountain Aire		New Aire	X							
Ventana LE		London Aire		Other								
DESCRIPTION

New Aire Breaker Box and TM250 Update

Provides work instructions for TSB 492.

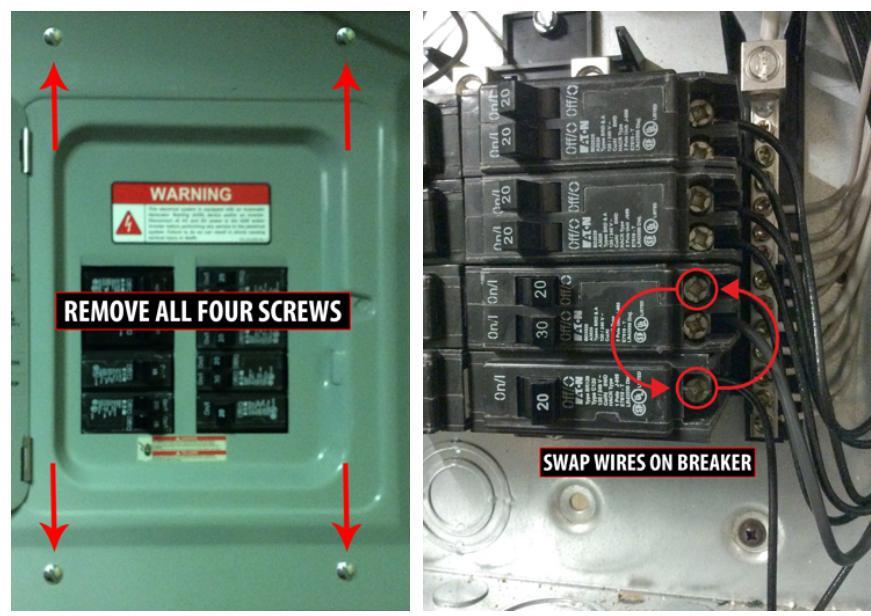
BREAKER BOX LABELING BEFORE ACCE

9. Remove the wire from the breaker marked floor heat.

10. Hook the wire up to the breaker marked "cooktop," and place the wire from the cooktop location into the breaker marked "floor heat."

11. Remove the label marked "floor heat" and the label marked "cooktop" and swap their positions. If they do not stick well, use clear tape to adhere them.

Note: Do not flip the breaker positions to move the floor heat.
