(R200) Sheet Checked by: Revision: MOVE STRUT BRACKET LOCATION TO 34 ILO 32 5/8 (PCR #151248) By: J. S. Model: Drawn by: NEWMAR CORP CS CA 3911 2 OF 2 J. S. R. R. Date: 6/27/14 P.O. Box 30, I.D. # 2015\ CA\PROFILE\ DOOR_WHEELCHAIR_ Nappanee, IN. 46550 Date: Date: Revision: Ву: 5/5/14 5/7/14 DOOR, WheelChair Lift Title block--1TB Date:

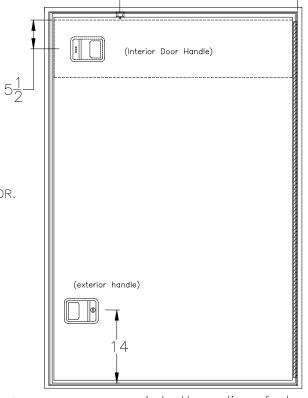
- 1. PRINT IS SHOWING DOOR CLOSED & FROM EXTERIOR.
- 2. DOOR HAS DUAL LATCH SYSTEM
- 3. OUTER FRAME OF DOOR TO BE BLACK.

interior of door frame

Enlarged View of bottom lip of door frame

cut bottom lip of door frame to be $\frac{1}{2}$ "— $\frac{5}{8}$ " long;
