# Newmar Corporation

### Technical Service Bulletin

| Date Issued | Model Year(s) Affected | TSB # |
|---|---|---|
| 11/09/2015 | 2010, 2012, 2013 | 429 |

## Recall Service Bulletin

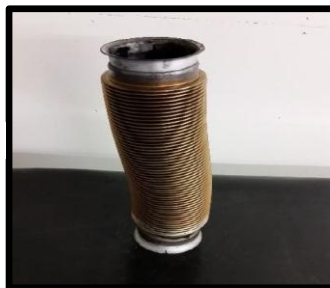
**FIG. 2-1**

5. The tubes joining bellows must meet the following alignment requirements stated in the installation guidelines. Voids in center of the two tubes are where the bellows are located.
6. Remove bellows and make note on the shape of the bellows that may indicate any misalignment. Refer to FIG. 2-1.

1. Read Tru-Flex installation guidelines found with supplied bellows.
2. If installed, remove heat shields that may limit access to bellows. Retain for reuse.
3. Inspect exhaust bellows for damage.
4. Using a straight edge check for alignment of bellows.
  - a. Alignment should be checked in (2) two quadrants on bellows that are 90° from each other. Ex. Top and Side.

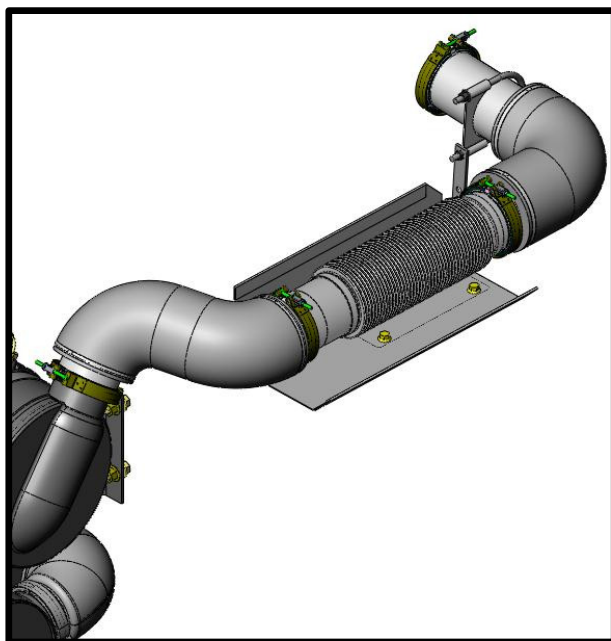
**FIG. 3-1**

ISL installation (shown with bellows as reference)

7. After completing alignment checks for the bellows/mating exhaust tubes and exhaust bellows has been removed: If alignment passes checks proceed to **step #9**. If alignment failed checks move to **step #8**.
8. Loosen clamps, support brackets, and v-band clamps that secure tubes to allow for adjustment of the tubes. Refer to 7<sup>th</sup> digit in VIN number for engine identification. If 7<sup>th</sup> digit is D, engine is an ISL: refer to FIG. 3-1. If 7<sup>th</sup> digit is E, engine is an ISX: refer to FIG. 3-2.

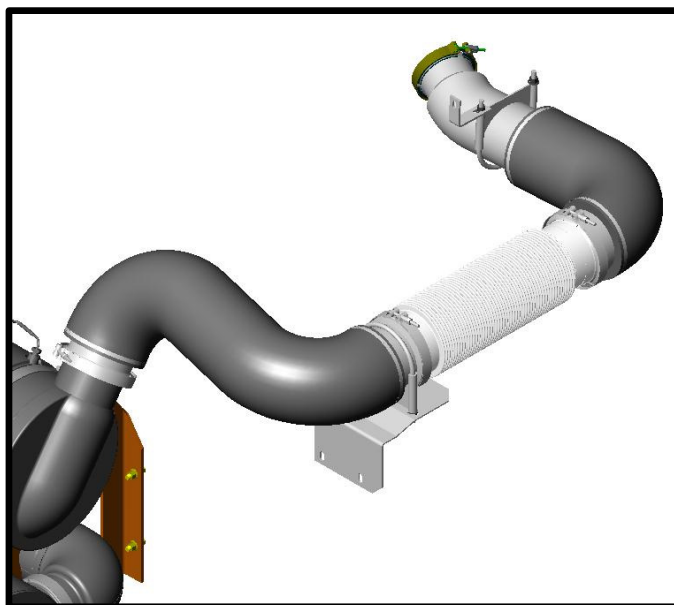
**FIG. 3-2**

ISX installation (shown with bellows as reference)

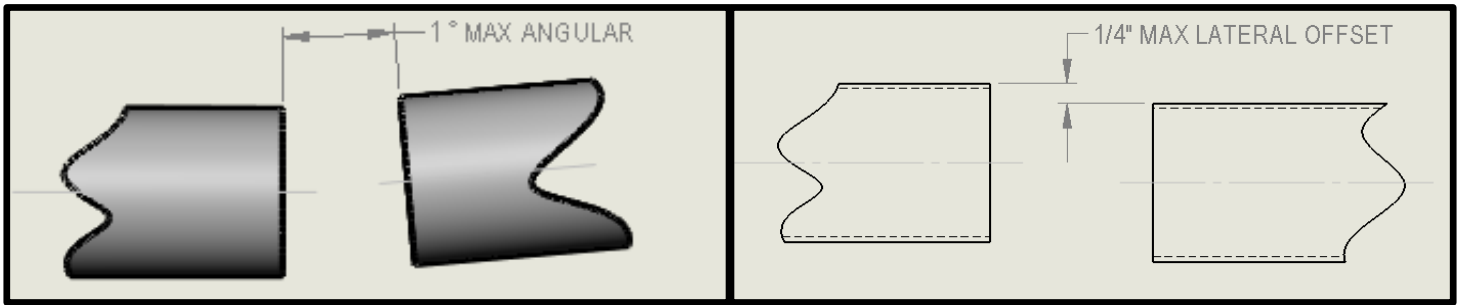
**FIG. 4-1**

9. Install supplied bellows using supplied v-band clamps and gaskets. Leave clamps loose enough to allow for adjustment if required.
10. Using a straight edge, align tubes and exhaust bellows so they meet requirements for both angularity and lateral offset. The alignment must be checked in (2) two quadrants that are 90° apart. If **step #8** was skipped and proper alignment cannot be achieved **step #8** will need to be completed. Refer to FIG. 4-1.

**Alignment of the tubes and bellows are critical.**

11. Once alignment requirements are met secure all clamps and brackets.
12. Torque (4) v-band clamps to 90 lbs. in.
13. Ensure all other hardware has been tightened.
14. Recheck alignment to ensure no shifting has occurred.
15. Reinstall retained heat shields (if required).
